The roofs at Flanders Elementary School consist of modified bitumen multi-ply built membranes with a granulated cap sheet. The roofs are relatively flat with a minimum pitch to the drains but no major areas of ponding water were observed. The roofs do not have a system of secondary drains to evacuate the water in case of emergency.

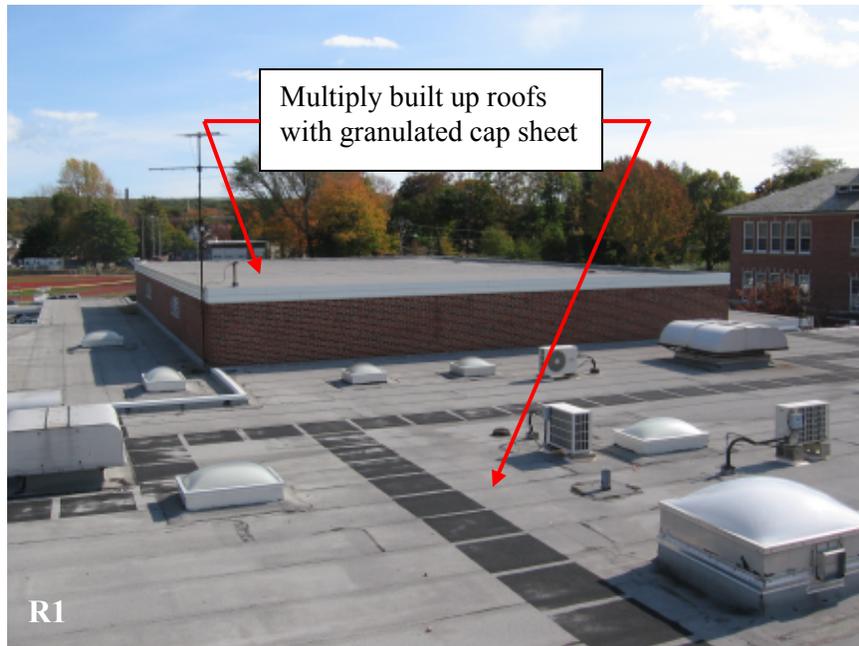
The multi-ply built-up roofs appear to be approximately 10 years old and are generally in good condition.

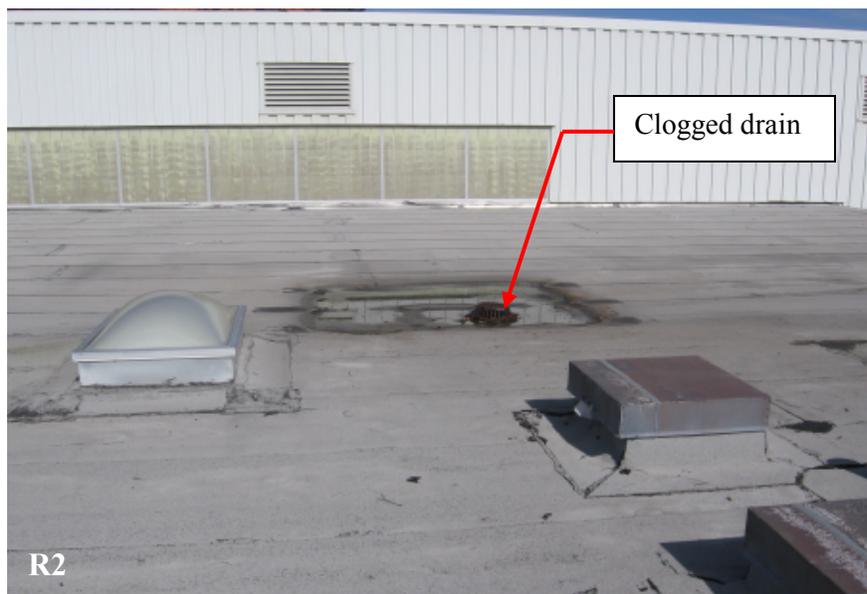
One drain appears clogged with debris creating a pool of water at the sump.

Periodically snake and clean out all drains and storm drain leaders.

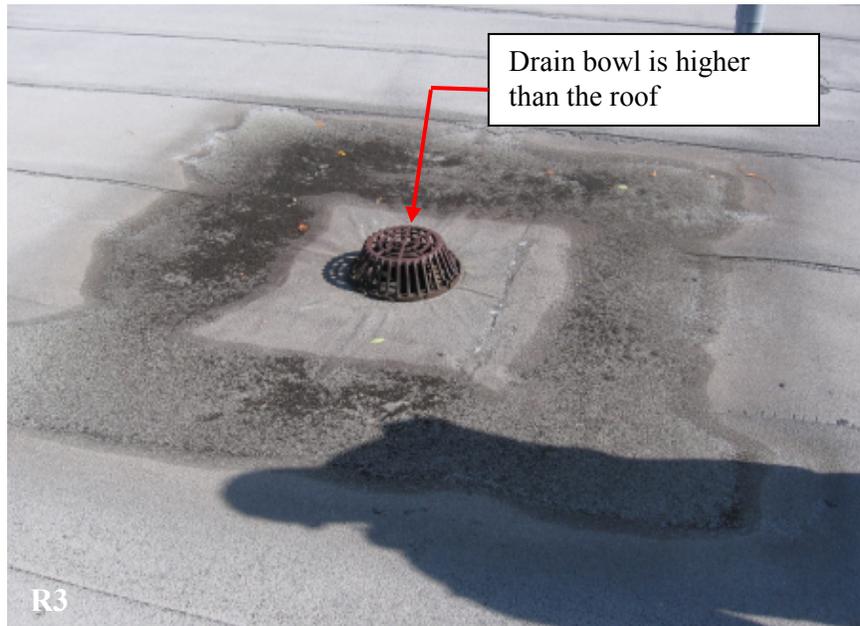
A drain bowl is higher than the surrounding roof creating a pool all around the drain bowl.

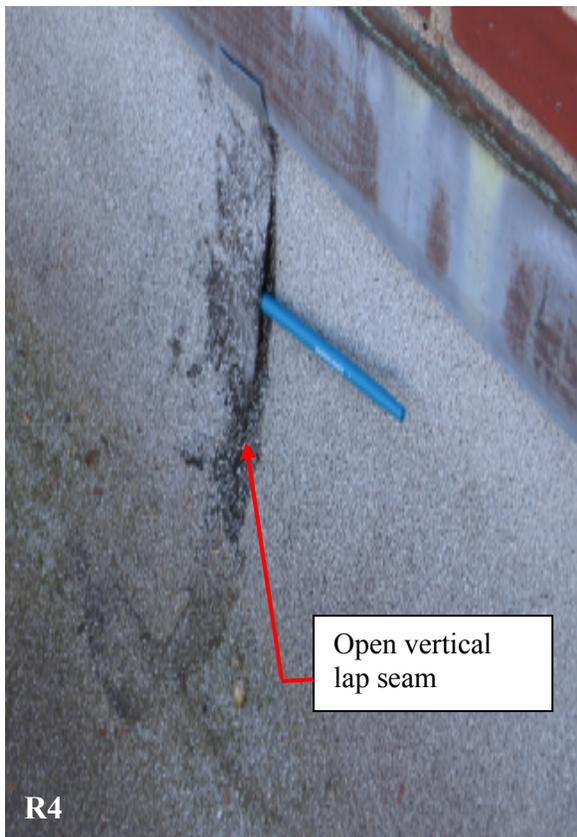
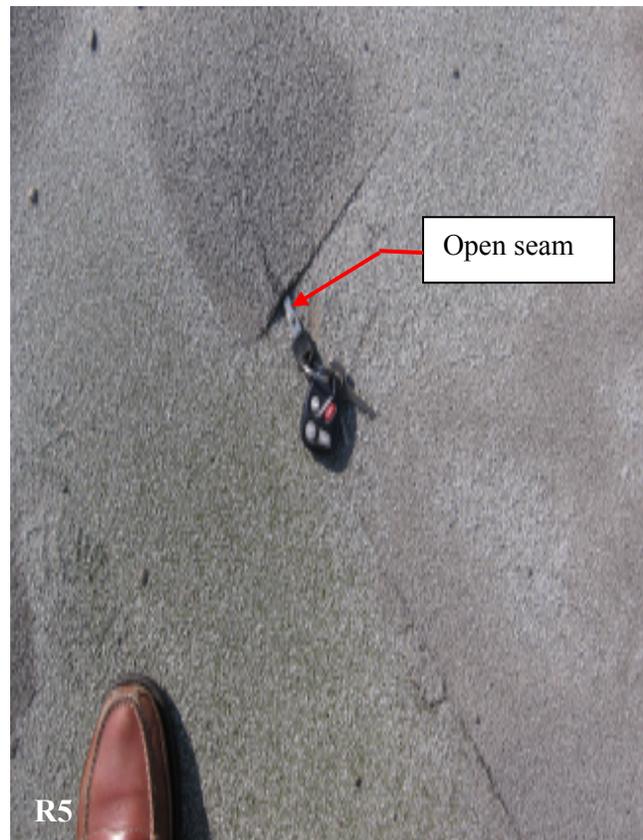
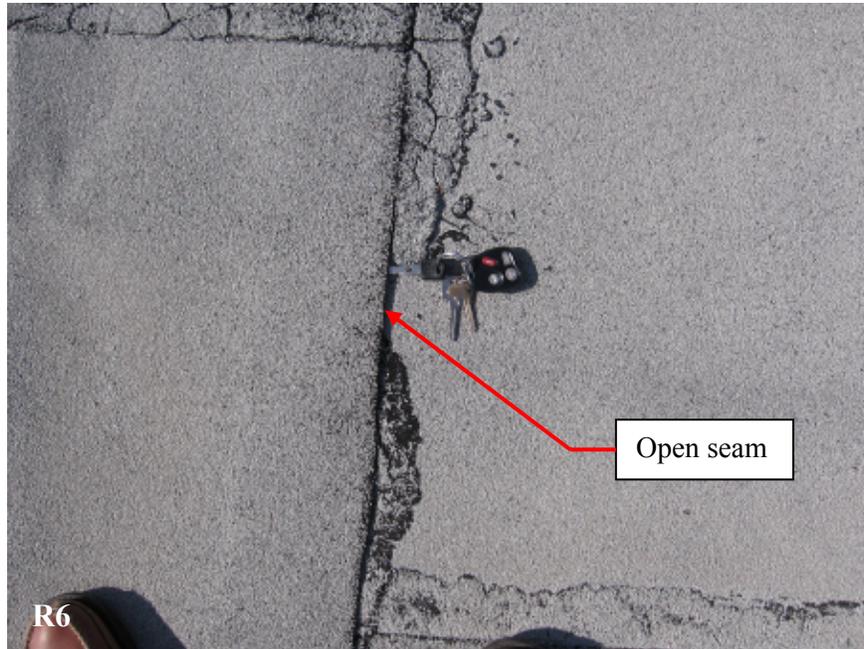
Several lap seams are open allowing water to enter the facility.

Reseal all open lap seams.

Some manufacturers offer a product to coat all the lap seams with a liquid flashing membrane that will extend the warranty an additional 5 years. This would be a good low cost upgrade to insure the ability of the roof to extend its protection from the elements.

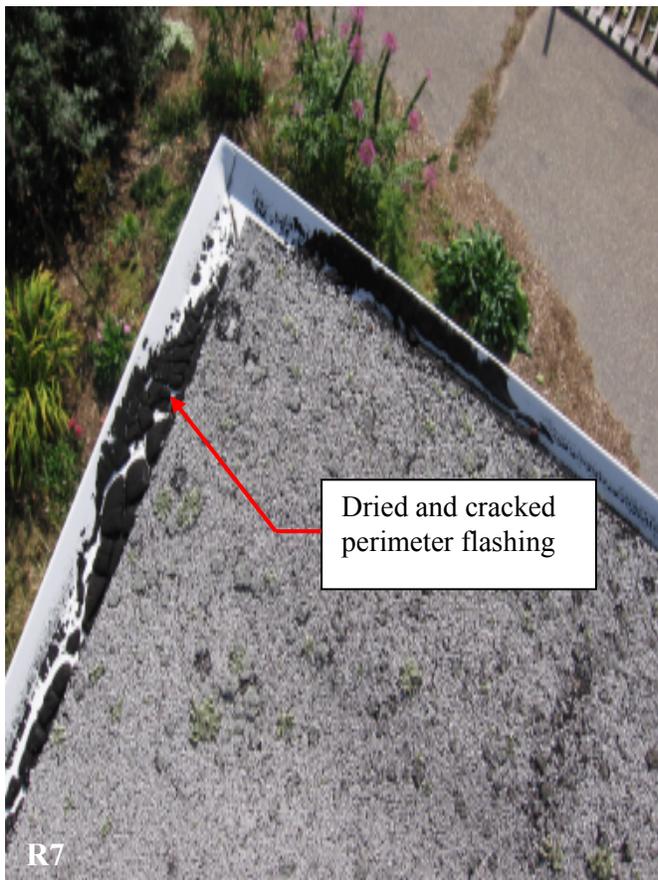
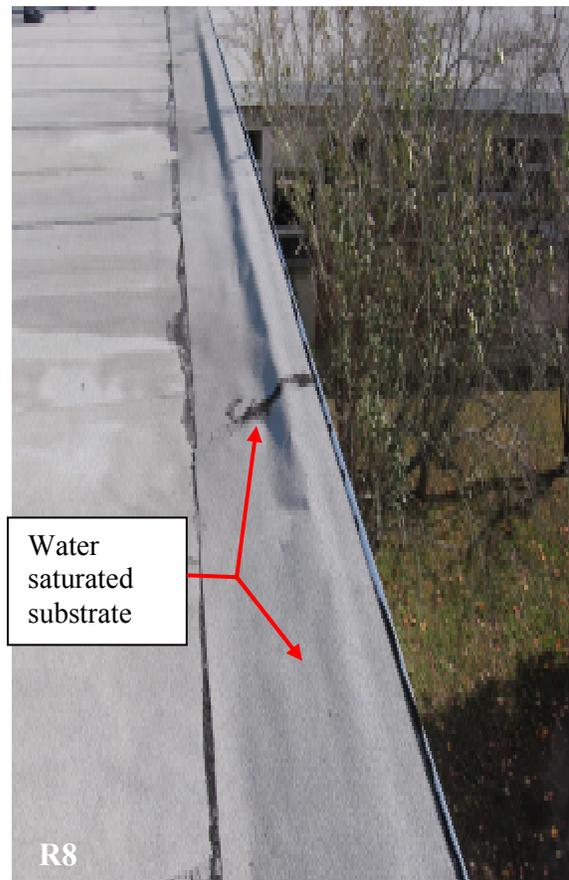
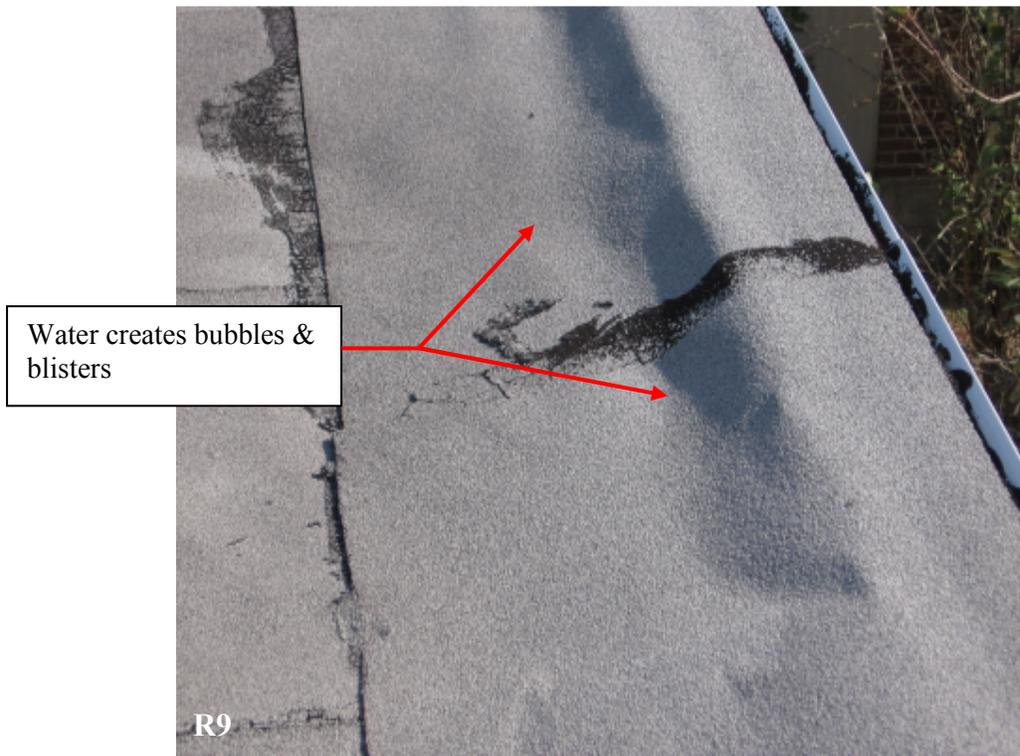
Areas of perimeter flashing are dried and cracked allowing water to migrate below the membrane creating blisters and bubbles. The trapped moisture will eventually compromise the insulation as well as the roof deck.

Reseal all deteriorated perimeter flashings.

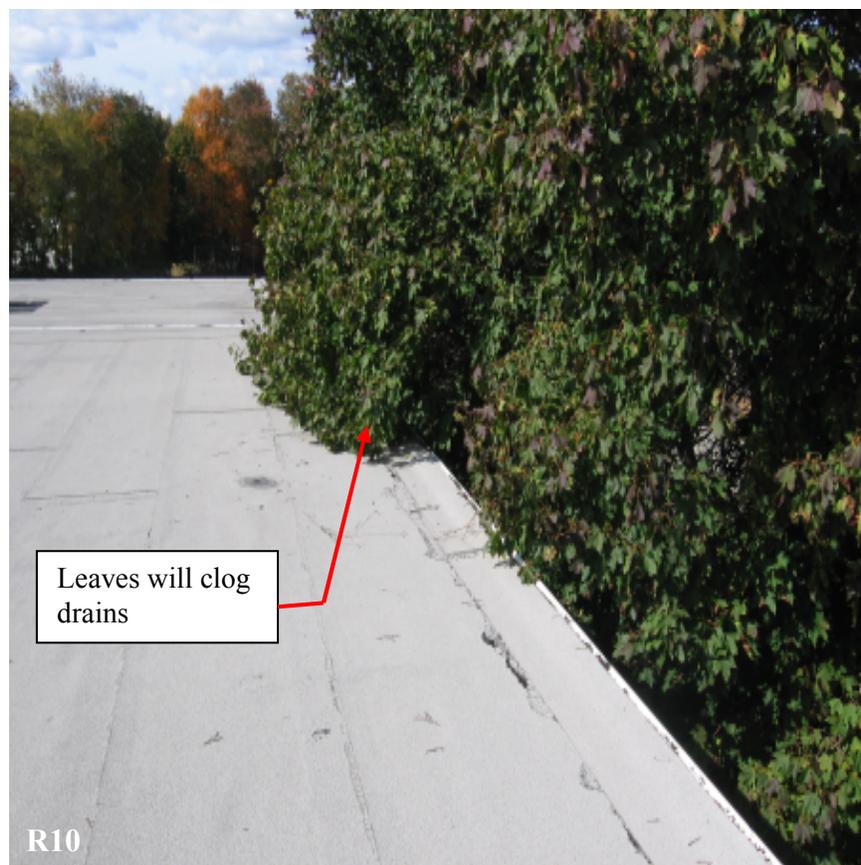
The leaves from low tree branches that rest directly on the roof clog drains and storm drain pipes.

Cut back tree limbs that overhang onto the roofs.

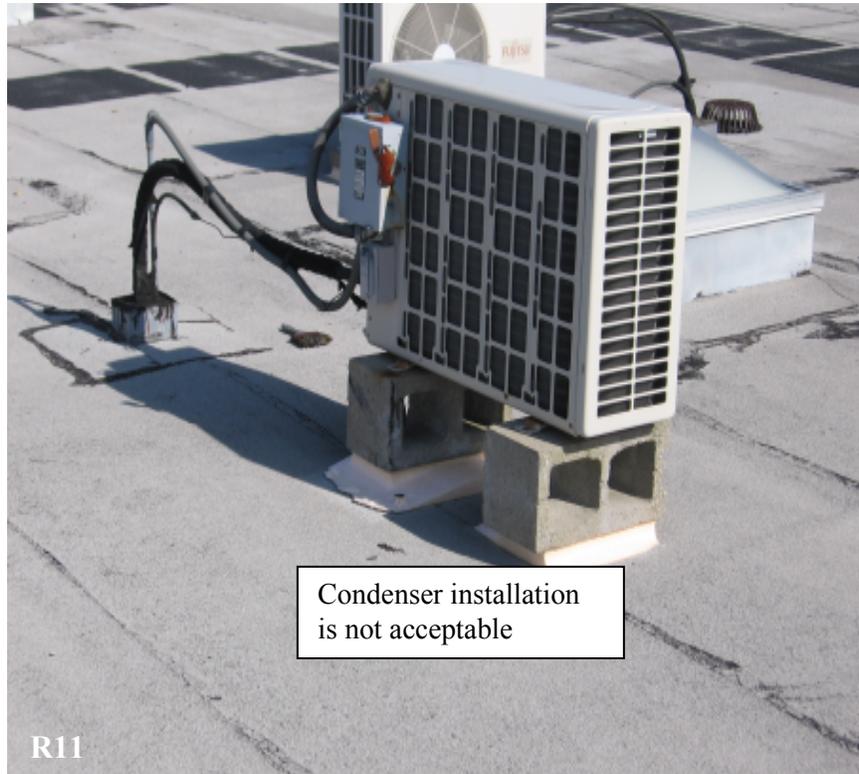
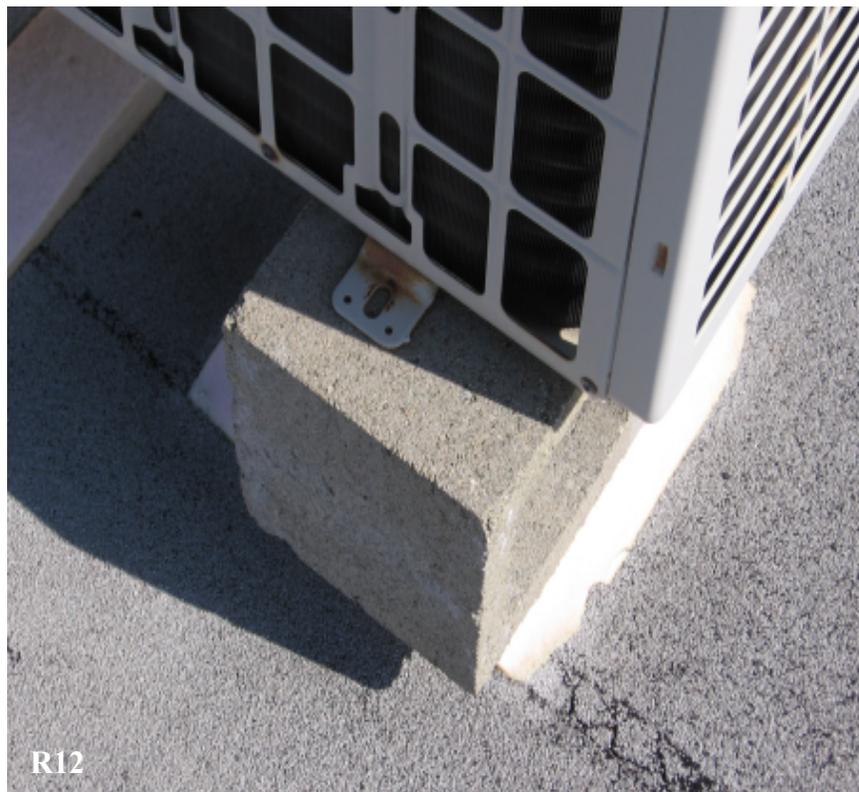
Condenser units sit unsecured on concrete blocks . The units can easily be blown over in a high wind event and the installation violates the mechanical code.

Lag bolt the condenser units onto 4x4 pressure treated wood sleepers that sit perpendicular to the orientation of the condenser units for greater stability.

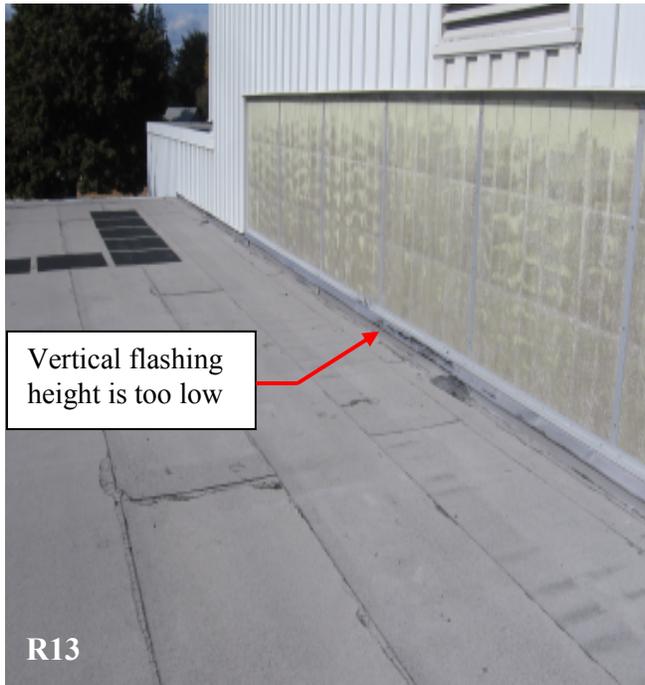
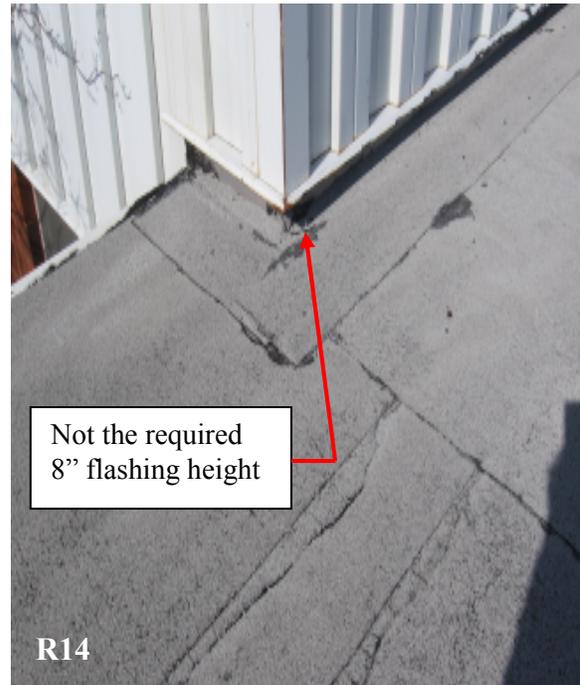
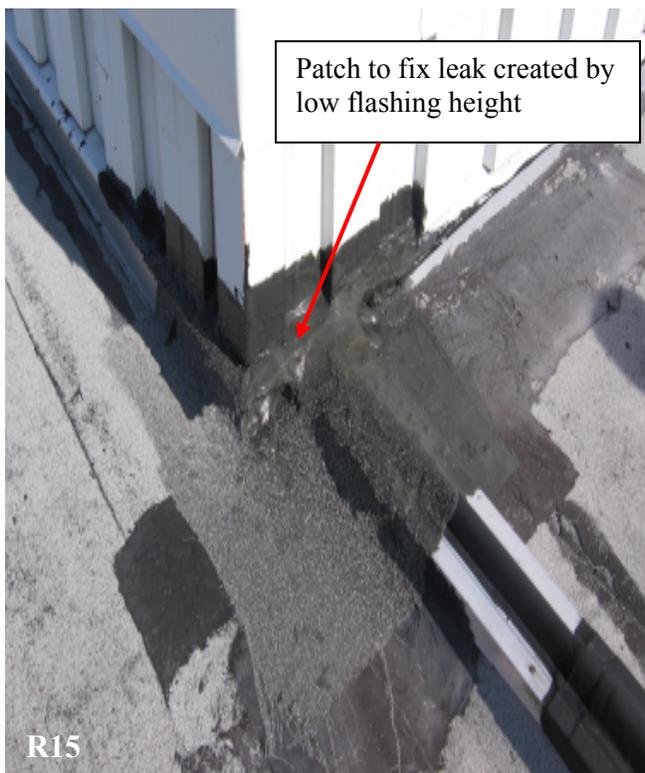
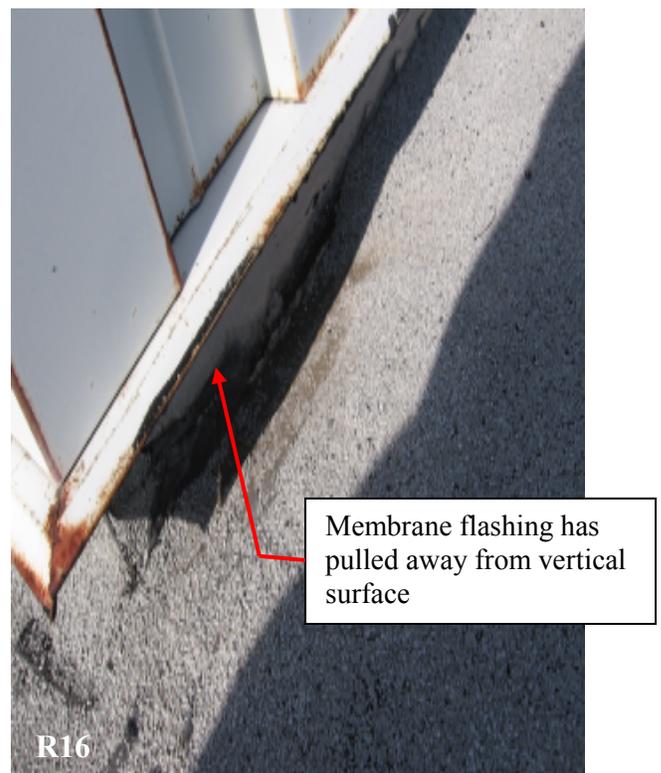
Several roofs have rising wall flashing conditions that do not have the industry's required 8" of flashing height. The purpose of this 8" guideline is to help prevent water from melting ice and snow to leak into the wall system. In one location the membrane flashing has sagged away from the vertical plane allowing water to enter unhindered into the wall assembly. The current roof warranty most likely excludes these low flashing height conditions from the agreement.

Remove the roof in its entirety down to deck and replace with a new 20 year single ply membrane on 1/2" tapered insulation to increase water flow to the drains per Connecticut State law. Install a secondary drainage system per the current plumbing code. Provide 8" flashing heights at all roof to rising wall conditions to insure that the warranty includes all conditions on the job.
