Description:

Existing Conditions Assessment:

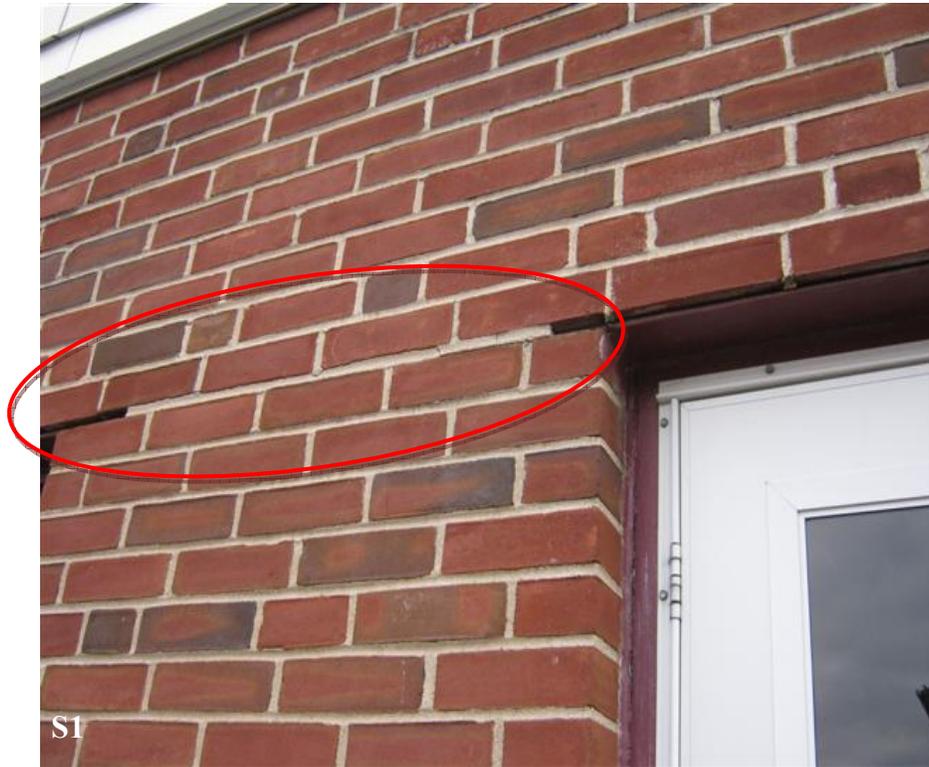
At the original building movement and spalling of the exterior brick and mortar is occurring at various locations on the exterior of the building. The most visible areas are along the south wall of the Cafeteria/Multi Purpose, the exterior wall of the electrical room and the north and east wing walls to the connector that ties the original building to the Central Office.

Spalled Mortar at the Existing Steel Angle Lintels

The brick above and adjacent to the door openings in the original building must be temporarily shored and the steel angles removed and replaced with galvanized angles, proper flashing including end dams and weep holes above the angles to drain the wall. This required at the doors on the south side and door and louver for the electrical room on the original building. The loose bricks especially at the Electrical Room openings could be a safety issue if they began to fall out of the wall.

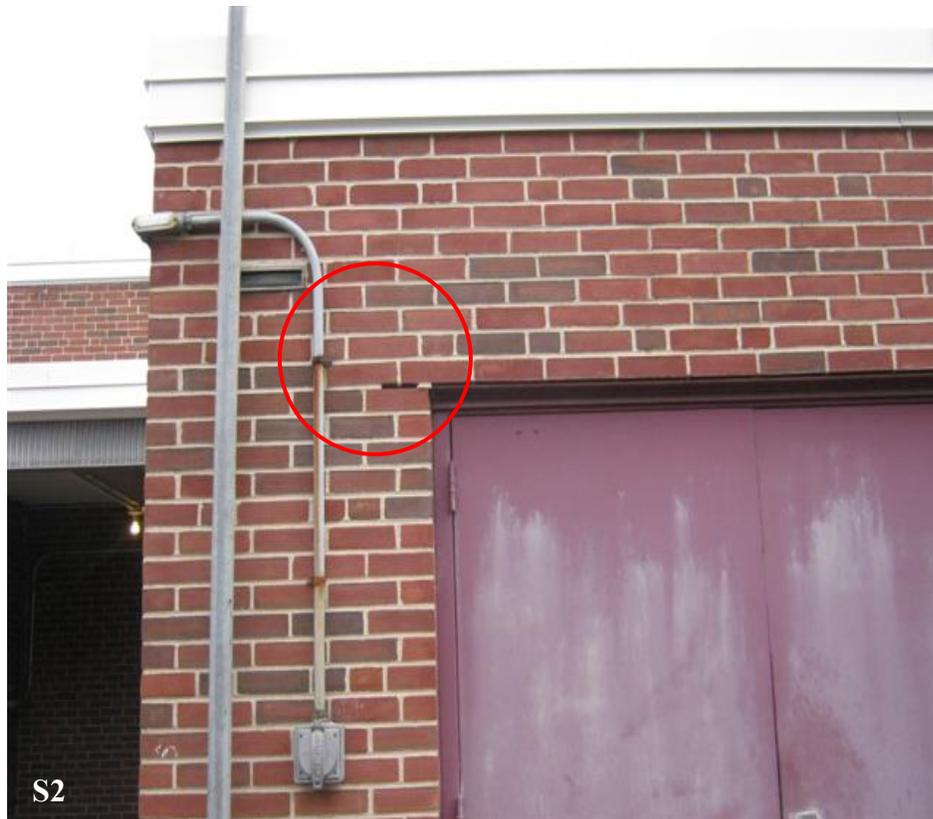
Spalled Mortar at Door Opening

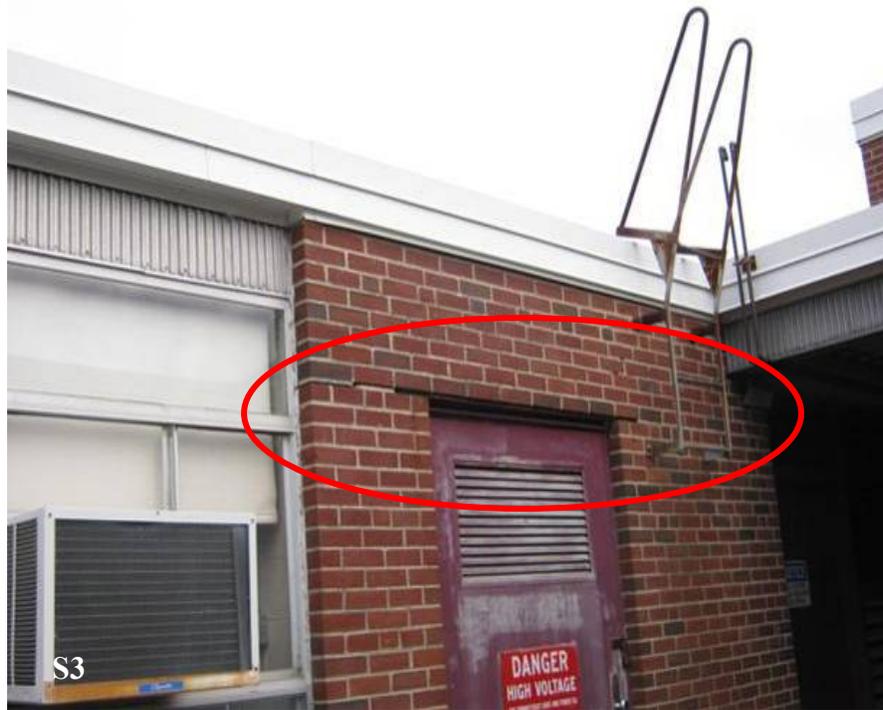
Movement in Brick above the Door

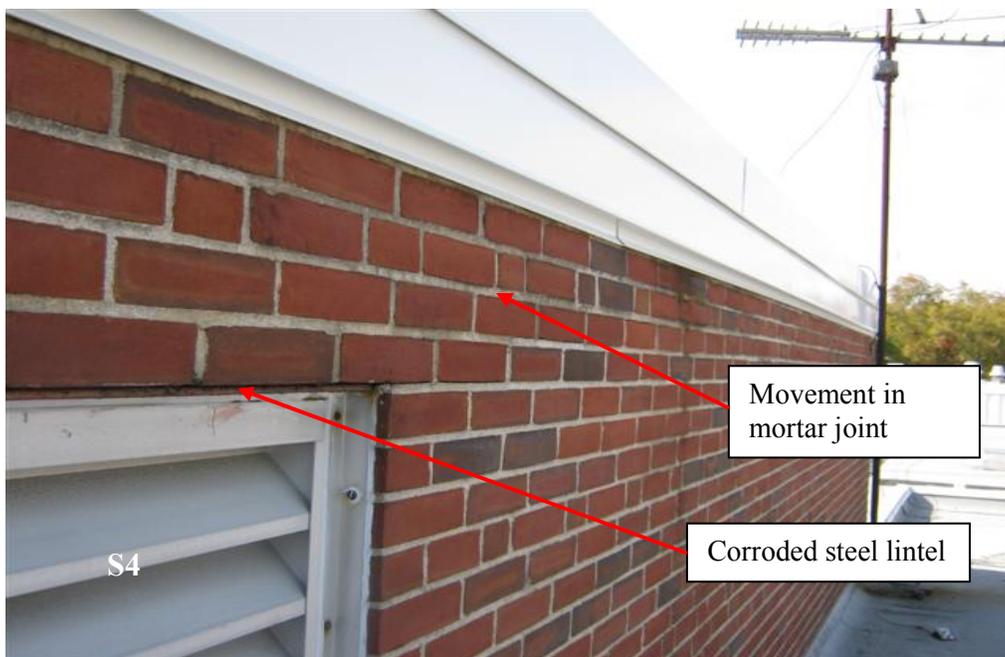
The outer brick wythe on the north side of the exterior wall of the Cafeteria is exhibiting movement and spalling mortar. The movement and spalling are visible at the elevation of the steel lintel and beyond. Where the steel angle lintel bears in the mortar joint, corrosion is occurring to the lintel and the rust combined with the freeze / thaw damage has spalled the mortar and cracked some of the bricks. Weep holes were installed in the walls above the low roof flashing but many of them are clogged with debris and not functioning to drain the wall.

North Face of Cafeteria Wall Looking Southwest

At the Cafeteria, on the north face of the exterior wall above the low roof portions of the brick above and adjacent to the window and louver openings should be removed. This will allow the evaluation of the extent of the corrosion of the steel angle lintels. Recommendations will be provided based on the conditions exposed. The clogged weep holes must be cleaned of the debris so that the water can drain from the cavity.

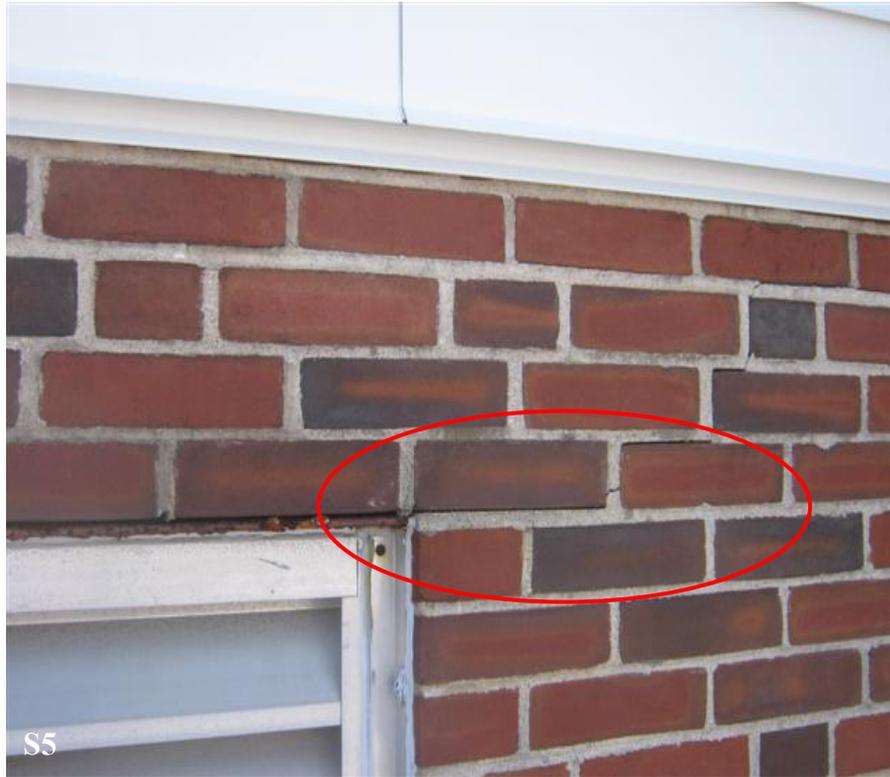
Close up of Cracks and Movement

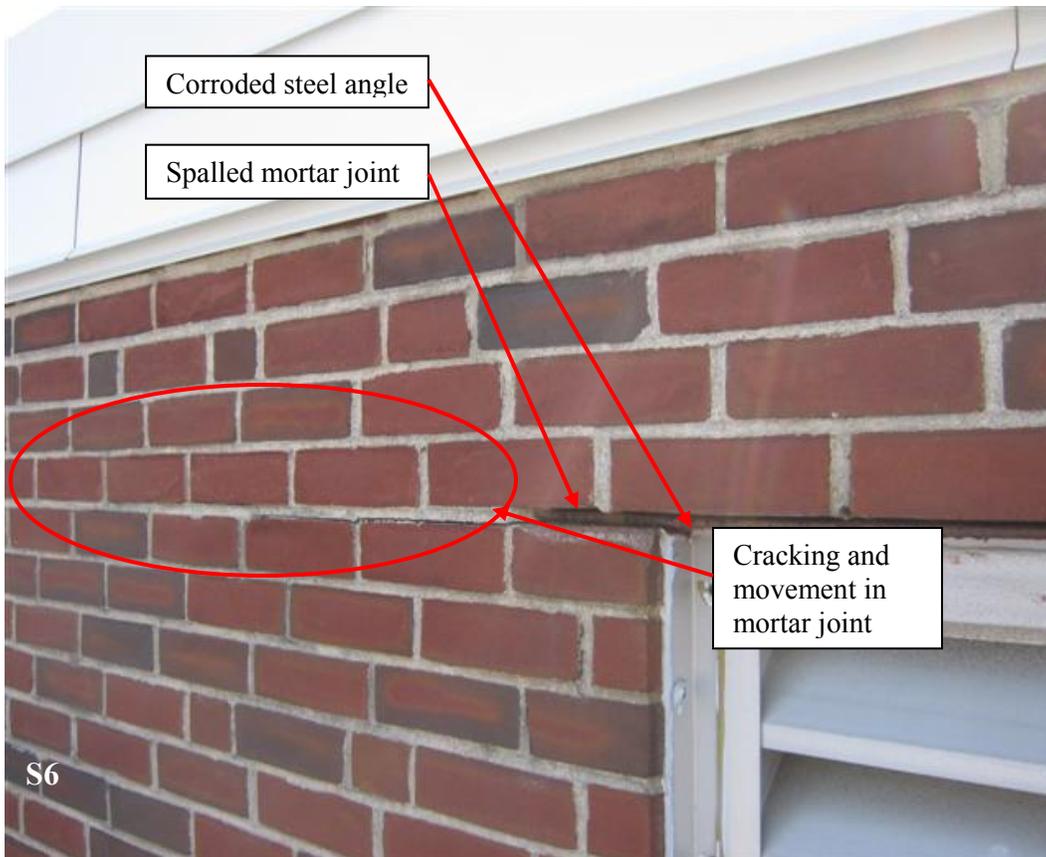
North Face of Cafeteria Wall Looking Southeast

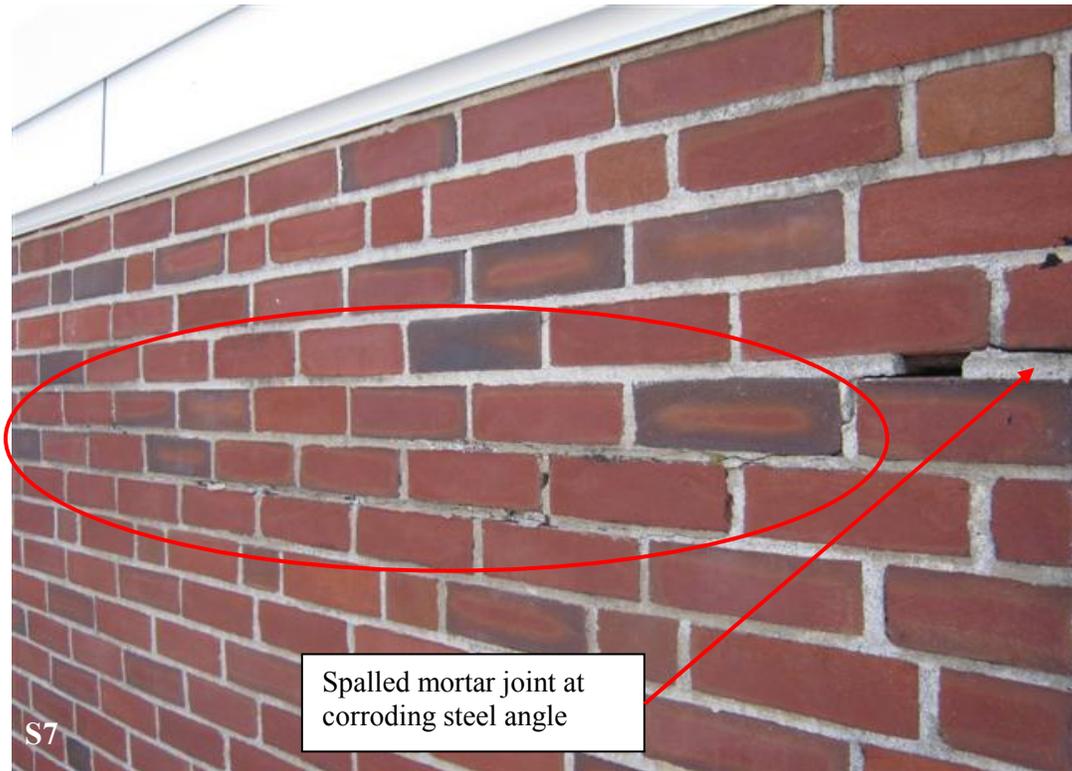
Cracked and Spalled Mortar and Bricks on North Face of Cafeteria

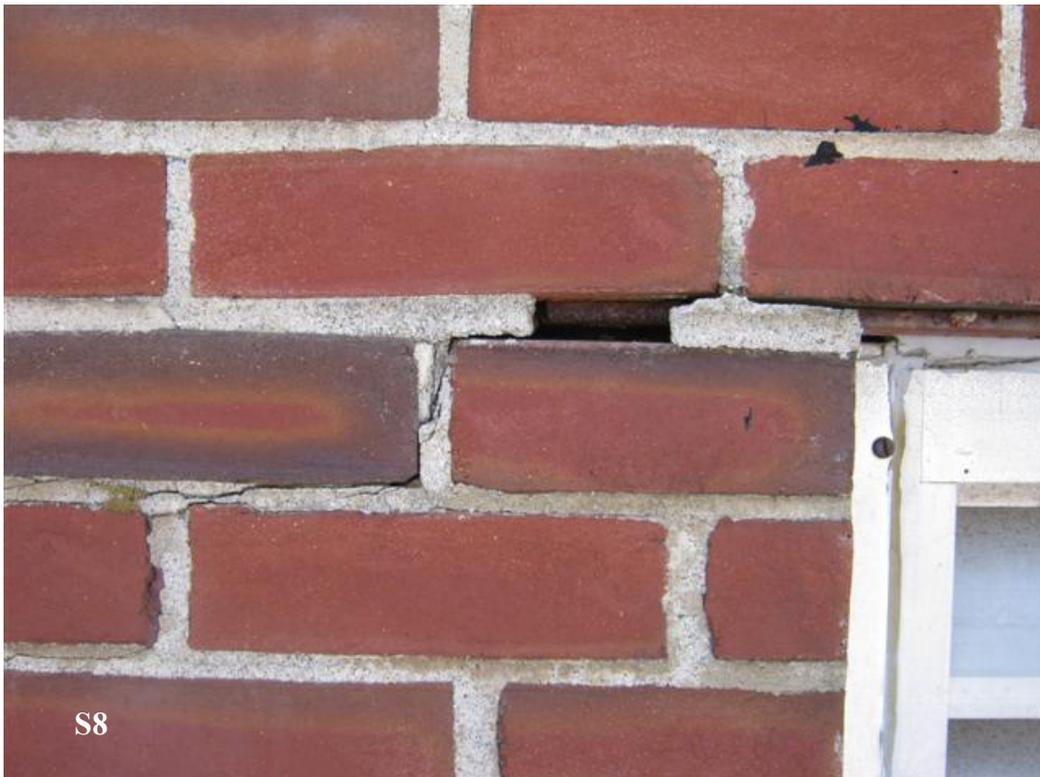
Close up of Spalled and Cracking Mortar

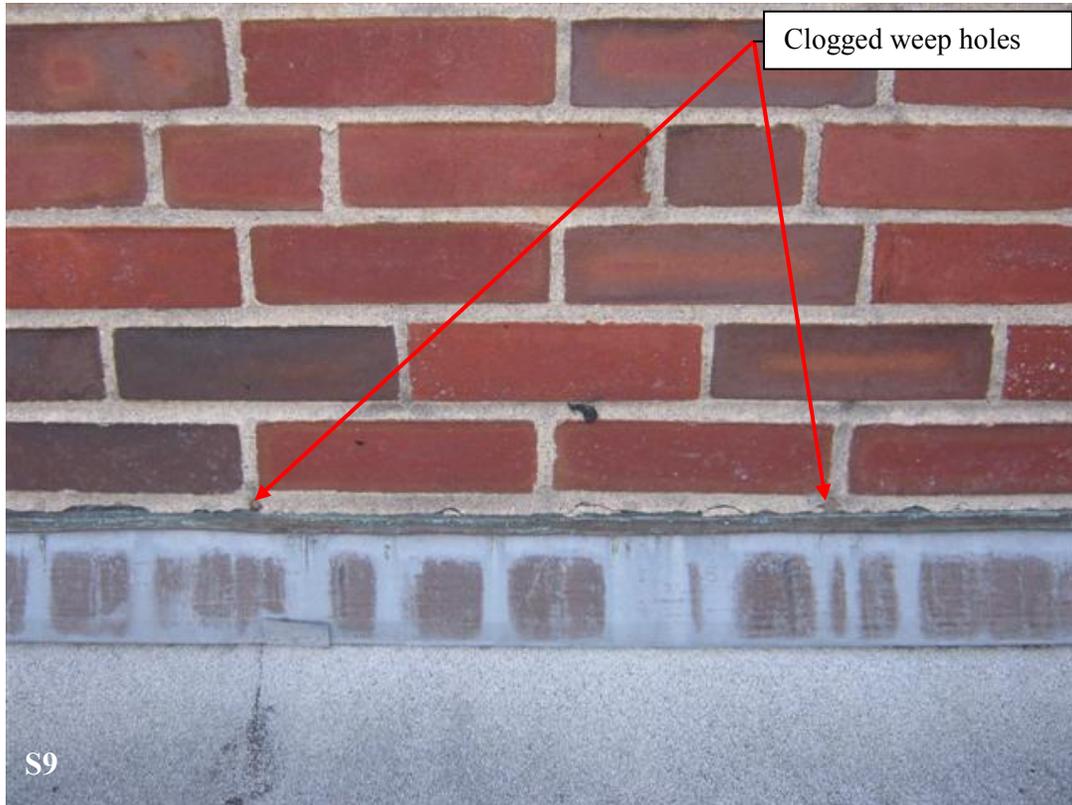
Clogged Weep Holes

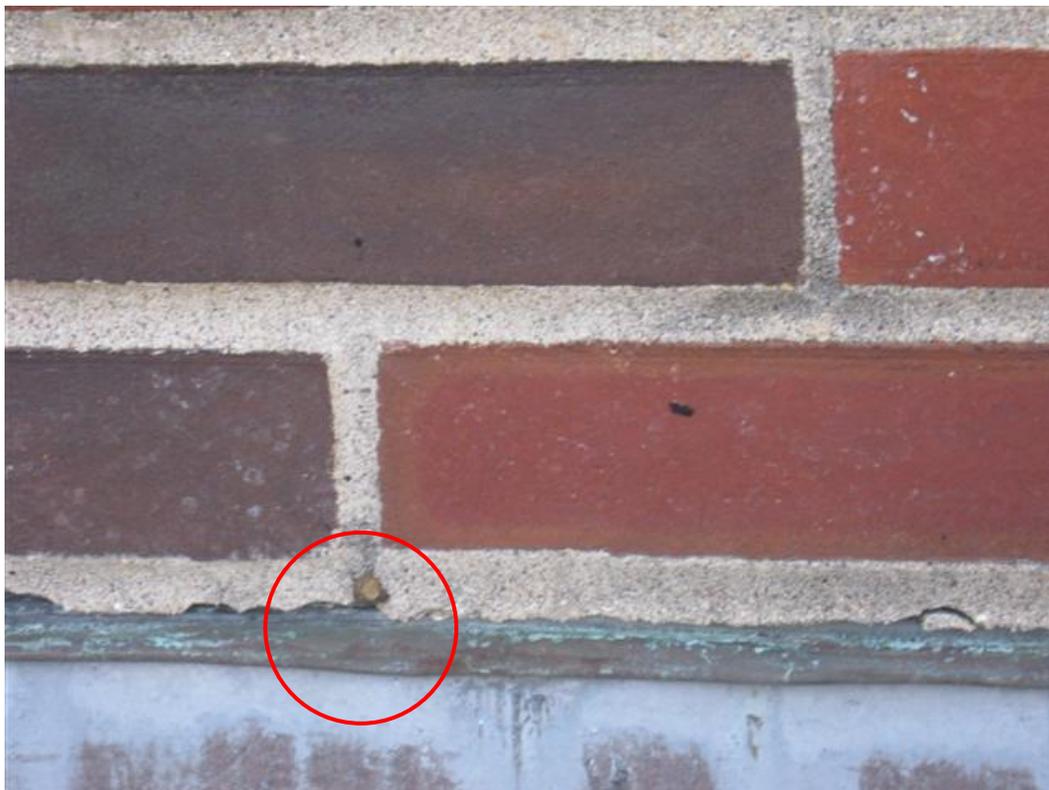
Close up of Clogged Weep Holes

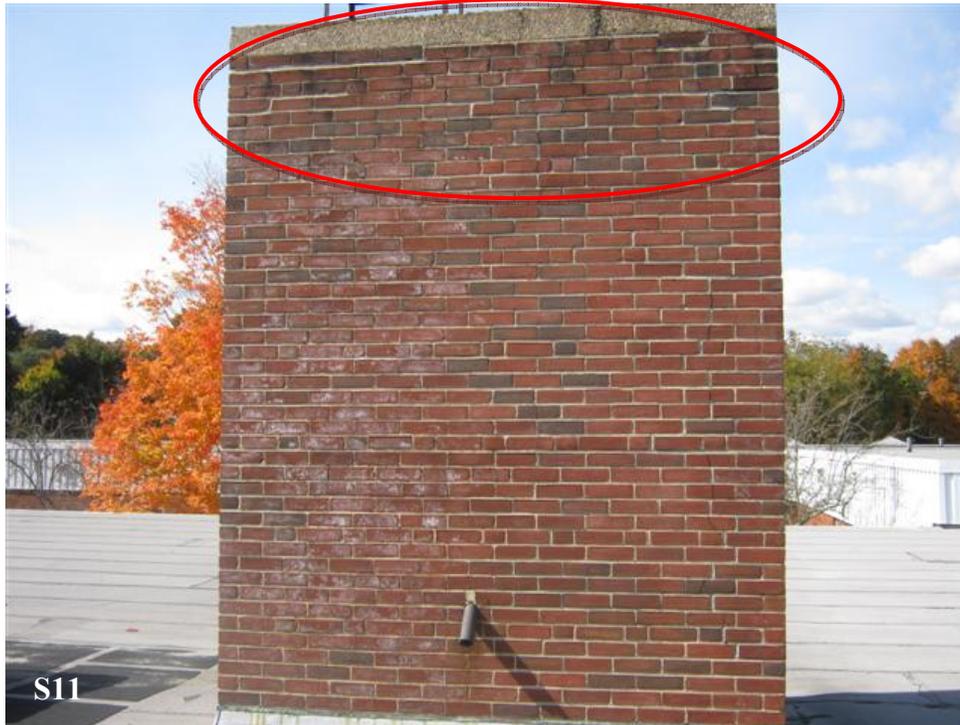
At the chimney there are several vertical cracks and movement is evident. Water is able to enter into the cracks and spalled mortar and cause further deterioration and damage.

Cracking Mortar Joints

Restoration of portions of the chimney should be implemented in the areas where extensive cracking and movement are occurring. This will include removing all damaged bricks and mortar and replacing with new bricks.

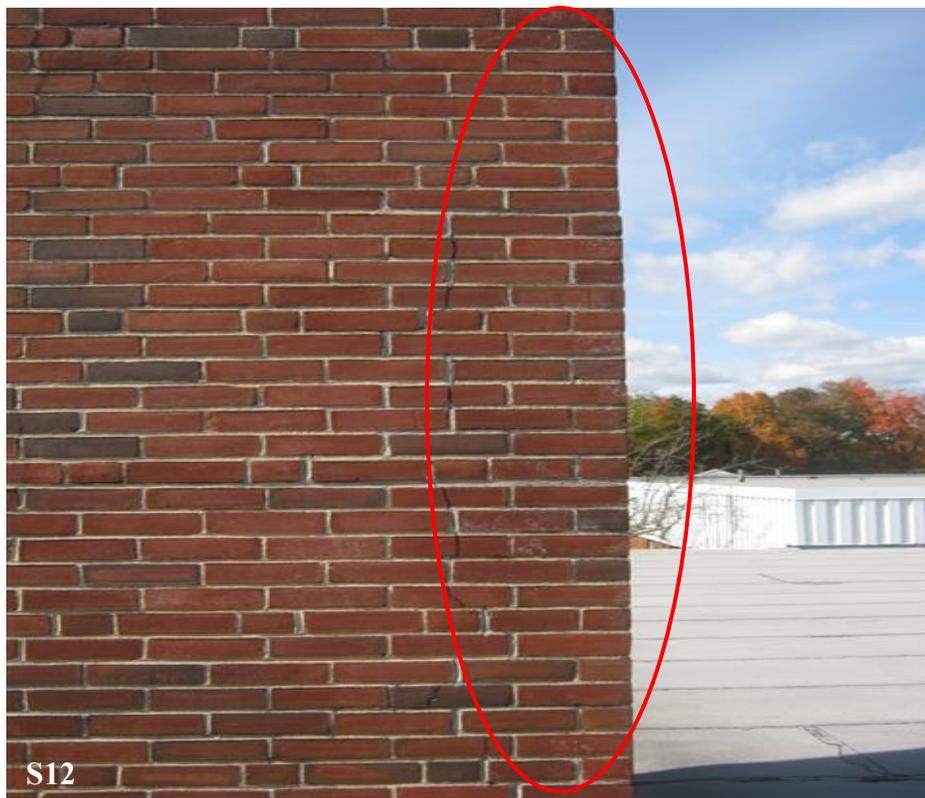
Vertical Crack in North Face of Chimney

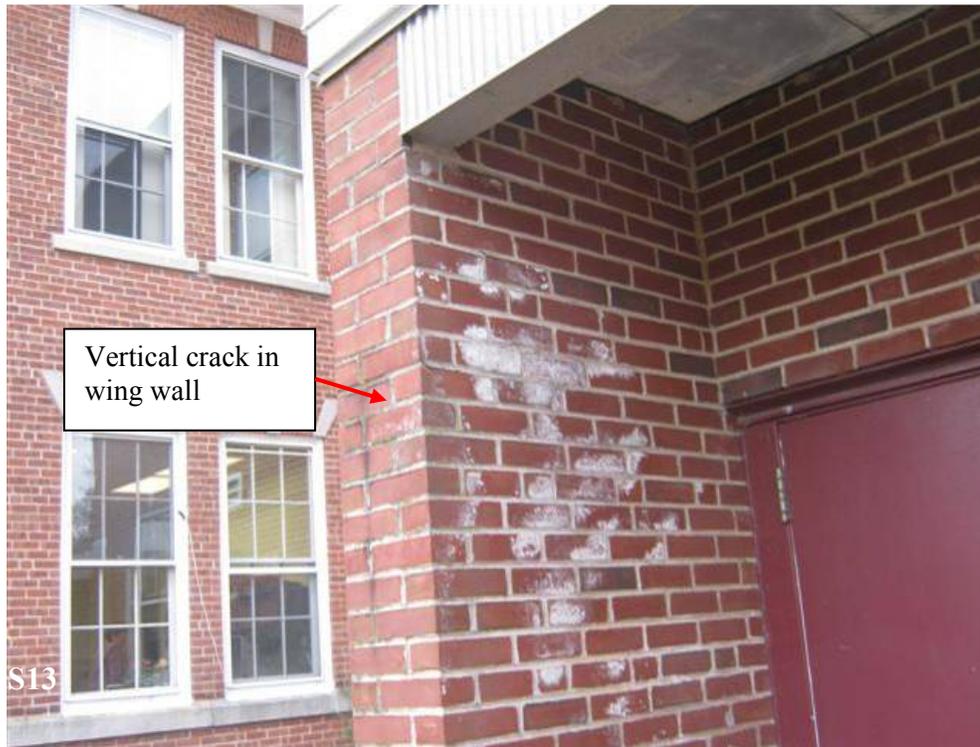
Cracking, movement and efflorescence is present in the wing wall at the connector entrance. The cause of the cracking is not apparent. However, water is entering into the wall as noted by the efflorescence on the face of the brick.

Efflorescence and Cracking in Connector Wing Wall

The cracking, movement and efflorescence in the exterior masonry wing wall will require additional investigation to determine the cause of the movement. The Owner's mason would be required to remove some of the bricks in the area where the movement is most visible to assess the integrity of the anchors.

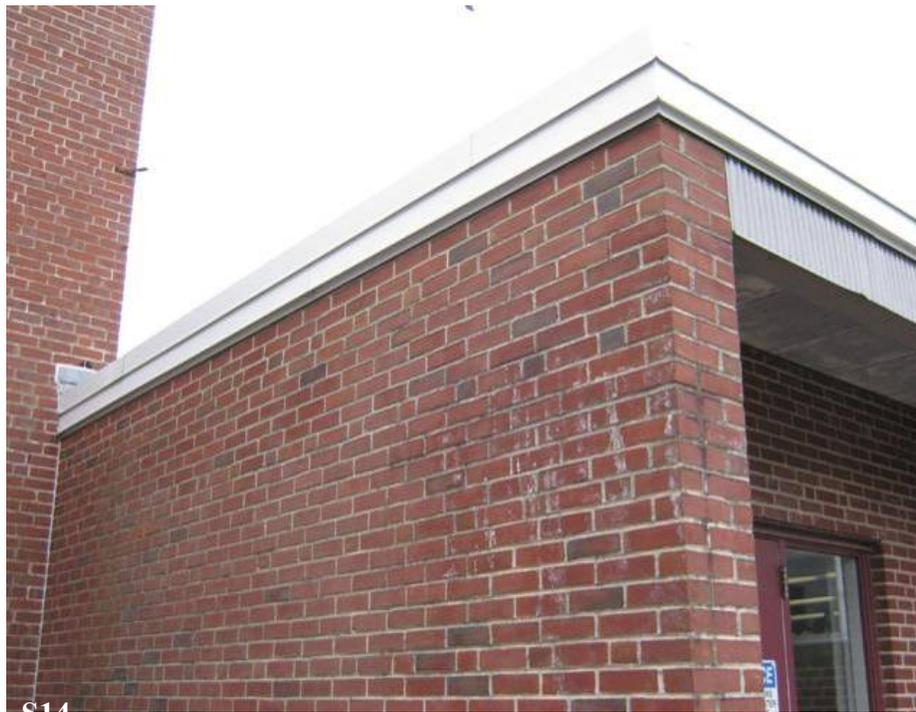
East Face of the Connector Wing Wall with Cracks and Efflorescence

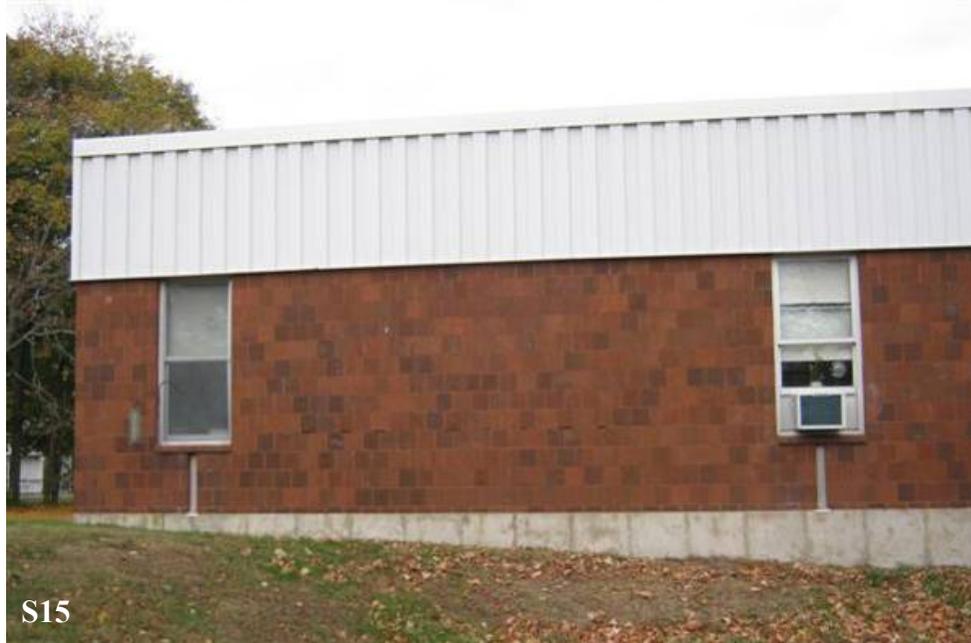
The 1975 additions exhibited freeze / thaw damage to the exterior brick and mortar joints at several locations. Thin layers of the brick surfaces have spalled or are in various degrees of spalling. According to the 1975 Contract Documents, the wall is constructed with 8" concrete block, 2" space for insulation and 4" brick. The ¾" maximum air space is inadequate for proper ventilation of the cavity and is subjecting the brick to wetting from both the exterior and the cavity. In addition, the weep holes are either below grade or many are clogged which will not allow the drainage of the cavity.

Overview of South Wall of 1975 Addition

We are recommending two possible remedial procedures for repairing the spalling mortar and brick on the classroom and Gymnasium additions. A short term solution would involve replacing any spalled bricks, re-pointing the mortar joints and spraying the exposed surface of the brick walls with a waterproof coating to keep water from infiltrating the brick. This procedure would last approximately 5 years depending on the waterproof coating manufacturer's warranty. This would then be an ongoing maintenance issue for the life of the building similar to painting. A long term but considerably more expensive solution would involve the removal of all of the exterior brick and insulation, install a continuous steel angle that is hot dipped galvanized directly on top of the foundation wall and positioned tight to the inner wythe concrete block. The new angle would contain an 8" horizontal leg to support the brick and provide a 4" cavity with 2" thick insulation and 2" air space for proper ventilation and drainage. New air and water barriers, proper flashing, end dams and weep holes would be installed once the new angle is in place. After that work is completed the new brick could be installed and anchored to the inner wythe block with existing anchors or new ones.

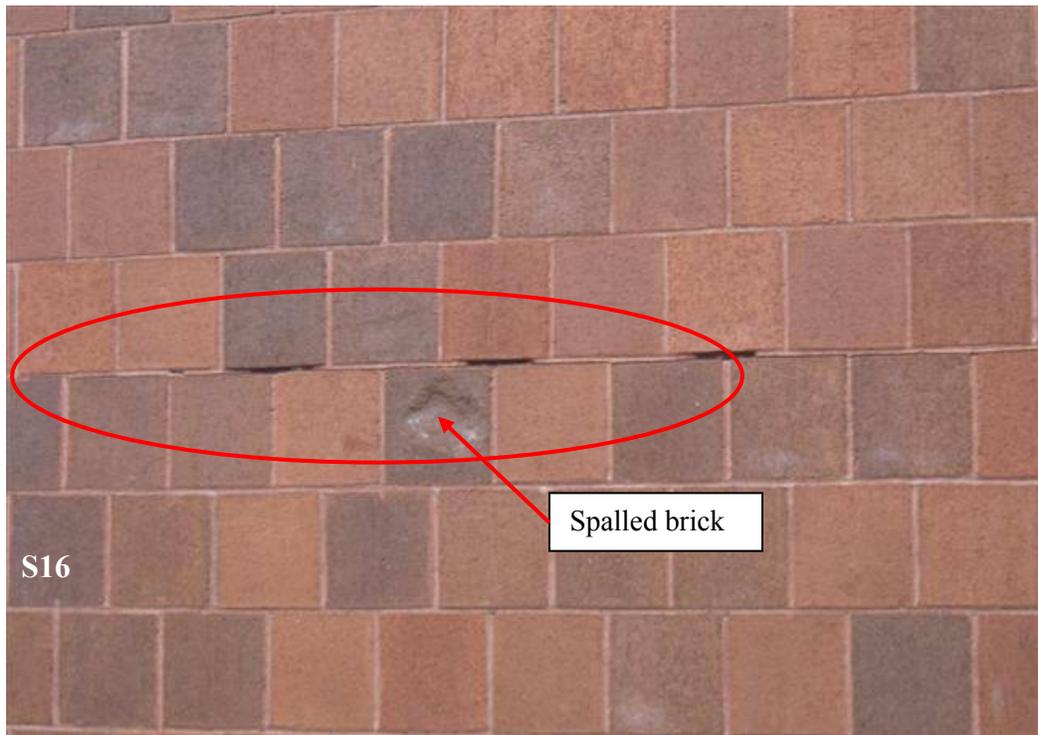
Close up of Spalled Mortar and Bricks on South Wall

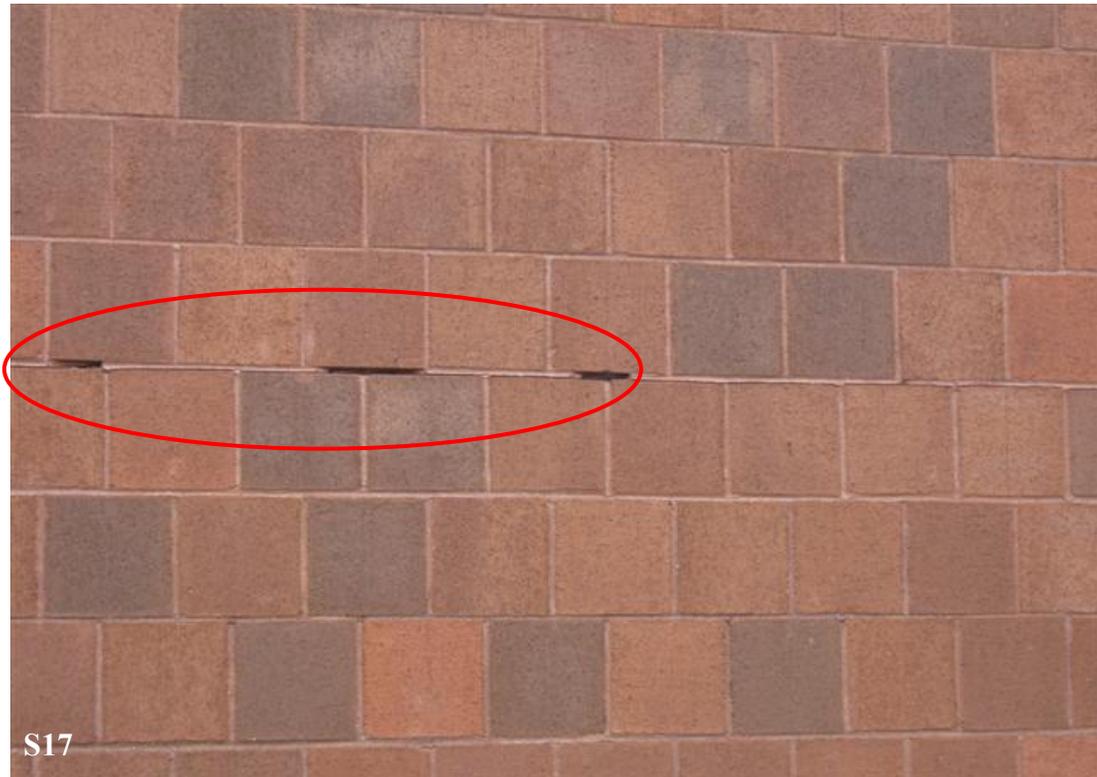
S17

Close up of Spalled Mortar on South Wall

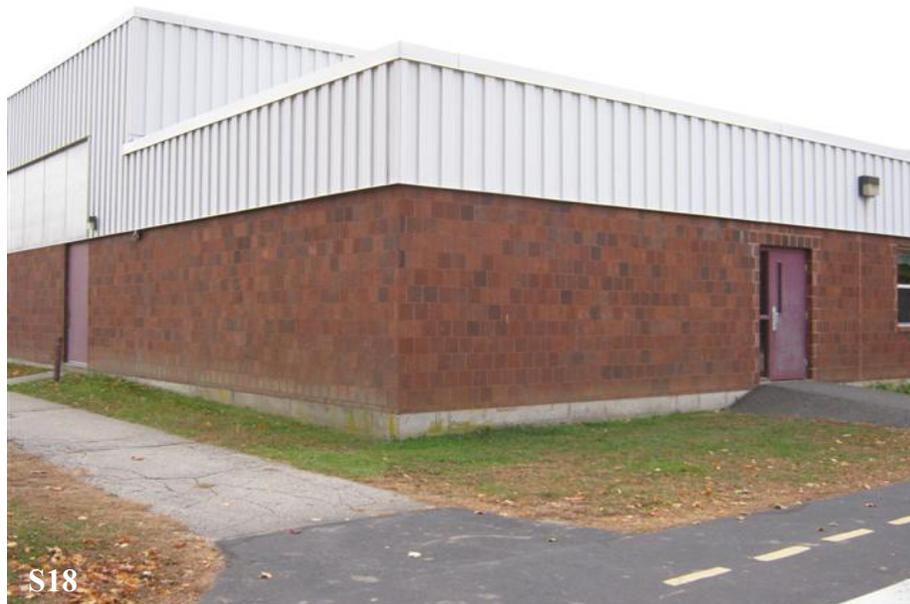
S18

At the 1975 Gymnasium addition similar conditions are occurring with the brick spalling and a vertical crack developed in the brick on the northwest corner. It appears that the spalling and crack is caused by the trapped water in the cavity and the freeze / thaw cycles. The weep holes along a length of the north wall is concealed below a bed of wood chips and soil which further prevents the drainage of water from the masonry cavity.

Overview of Northwest Corner of Gymnasium Addition

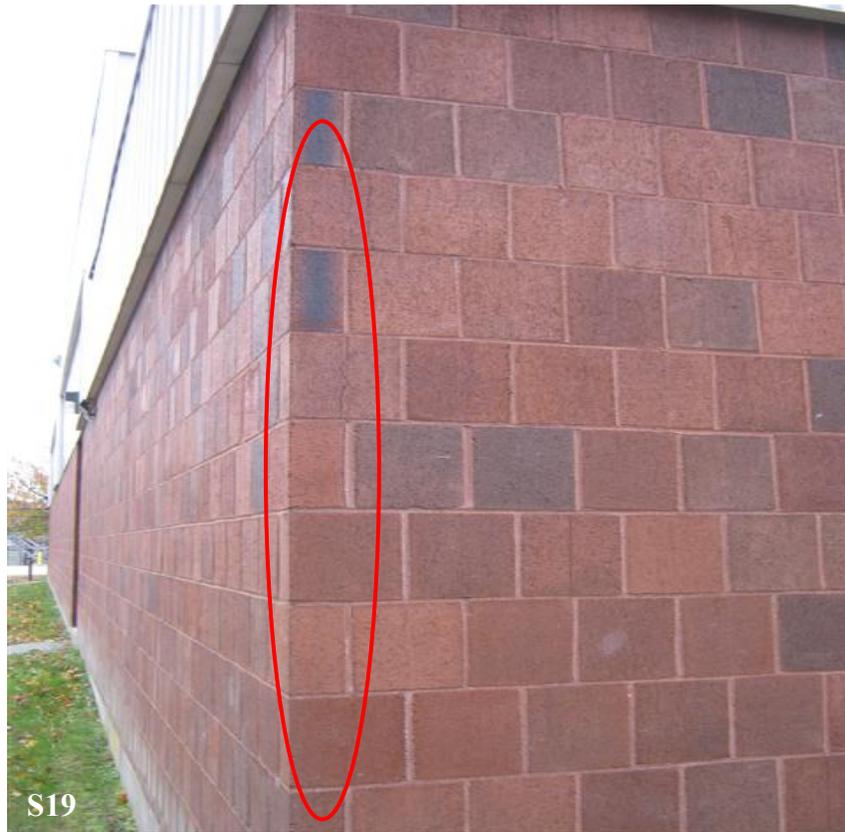
Vertical Crack in Brick at Northwest Corner

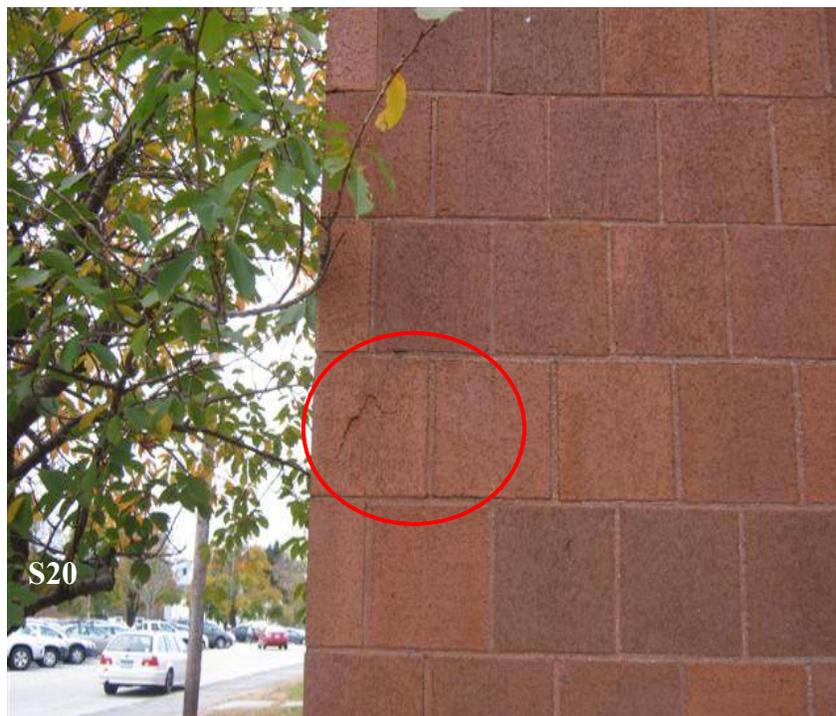
Close up of Spalling Brick

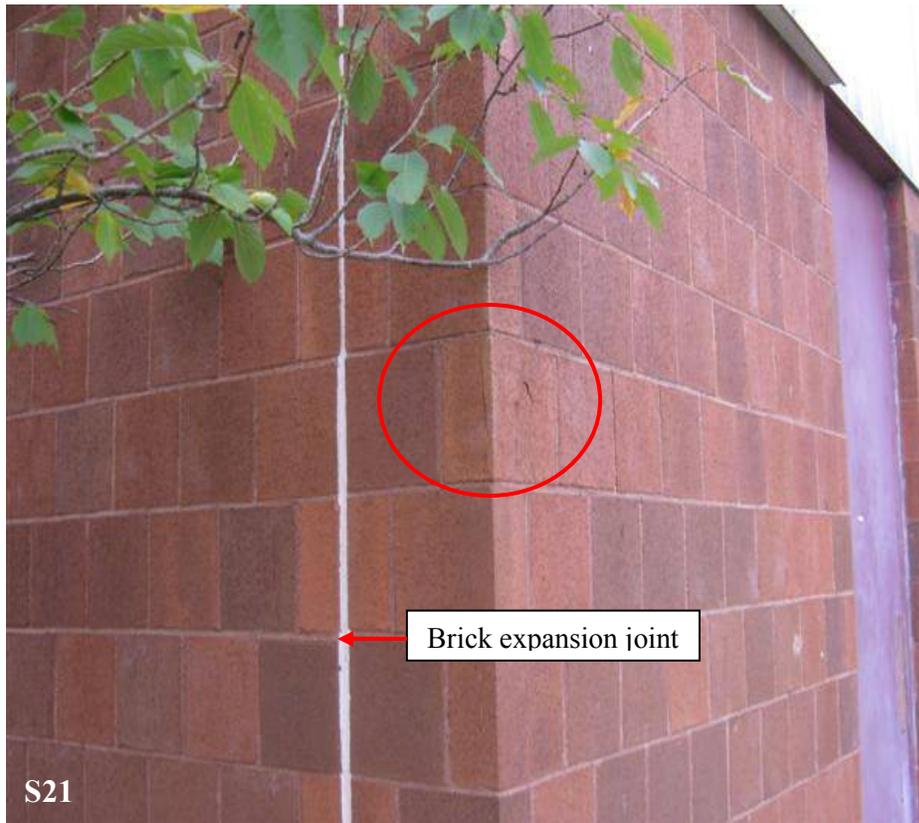
Close up of Spalling Brick

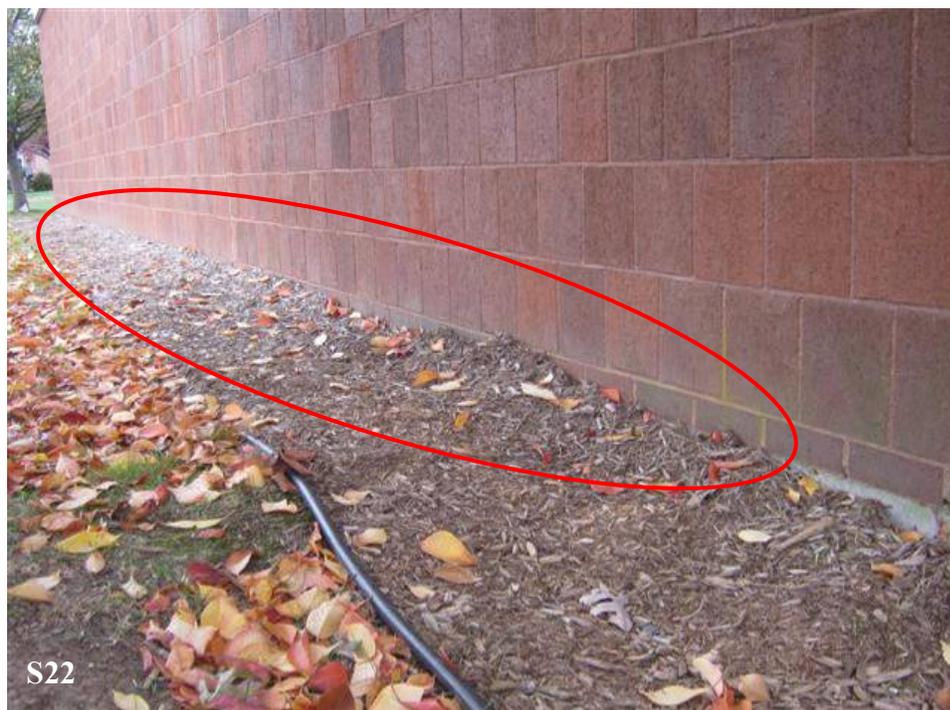
Mulch and Soil above Bottom of Masonry Wall Clogging Weep Holes

Along the front of the original building and on the north side of the 1975 addition the grade is above the weep holes which will restrict any water from draining out of the cavities. The grade should be revised to allow the weep holes to be exposed. All weep holes must be cleaned

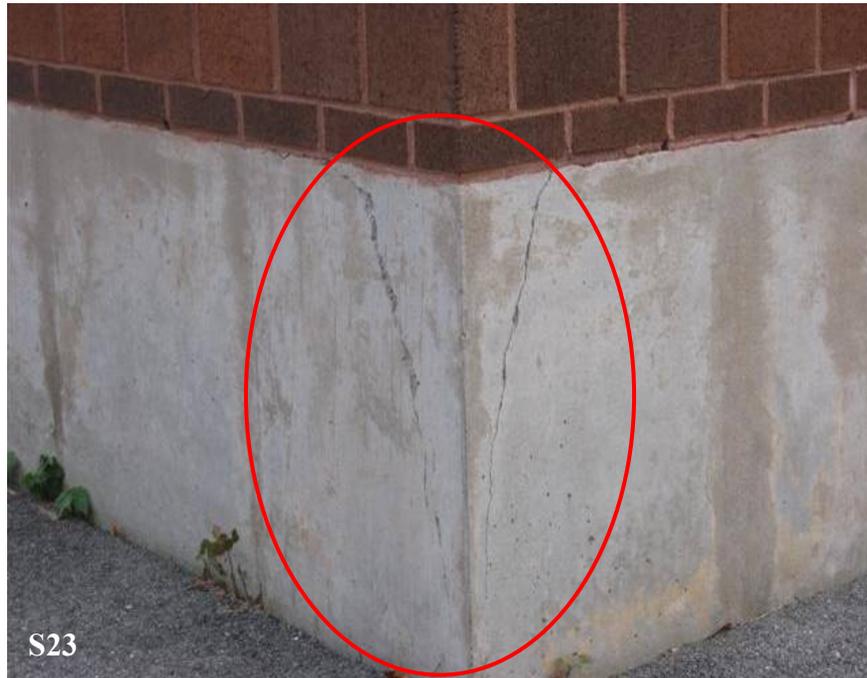
There two items requiring repairs for the foundations in the 1975 addition. One item involves the cracked and spalling corners of the exposed foundation wall. This condition occurs at each of the corners in the addition.

Wedge Shaped Crack in Southeast Corner of Foundation Wall of Classroom Addition

The wedge shaped cracked concrete foundation wall at the corners of the addition and the original building should be removed and replaced. As the existing concrete fails the bricks above will not be supported and movement and cracking in the brick will occur.

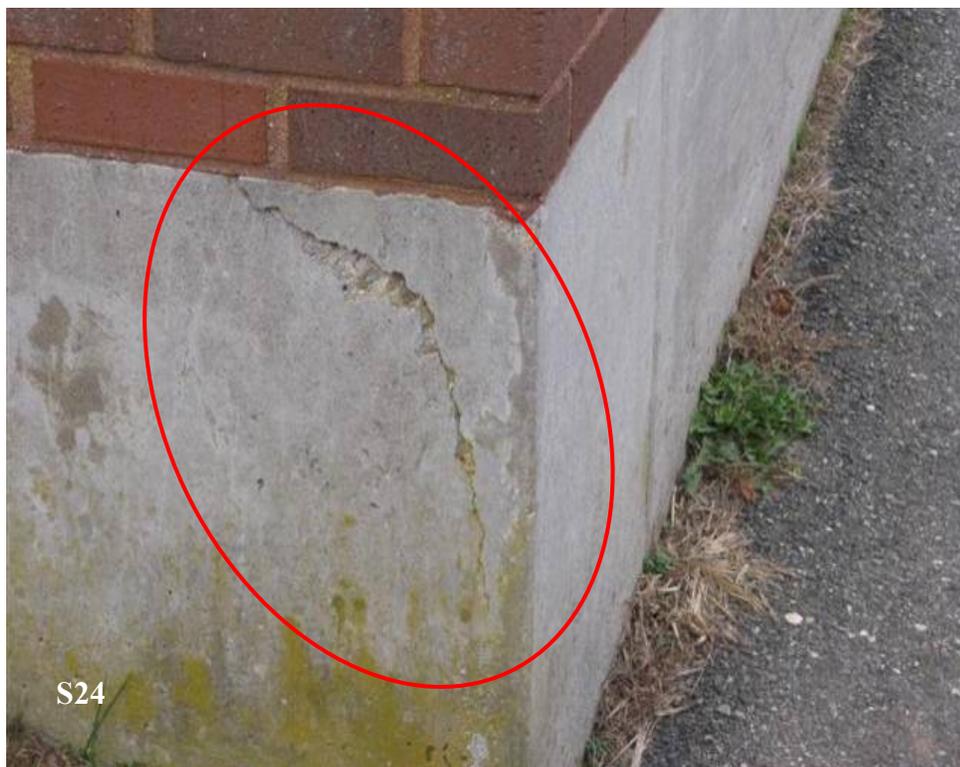
Wedge Shaped Cracking and Spalling at Southwest Corner of Classroom Wing Addition

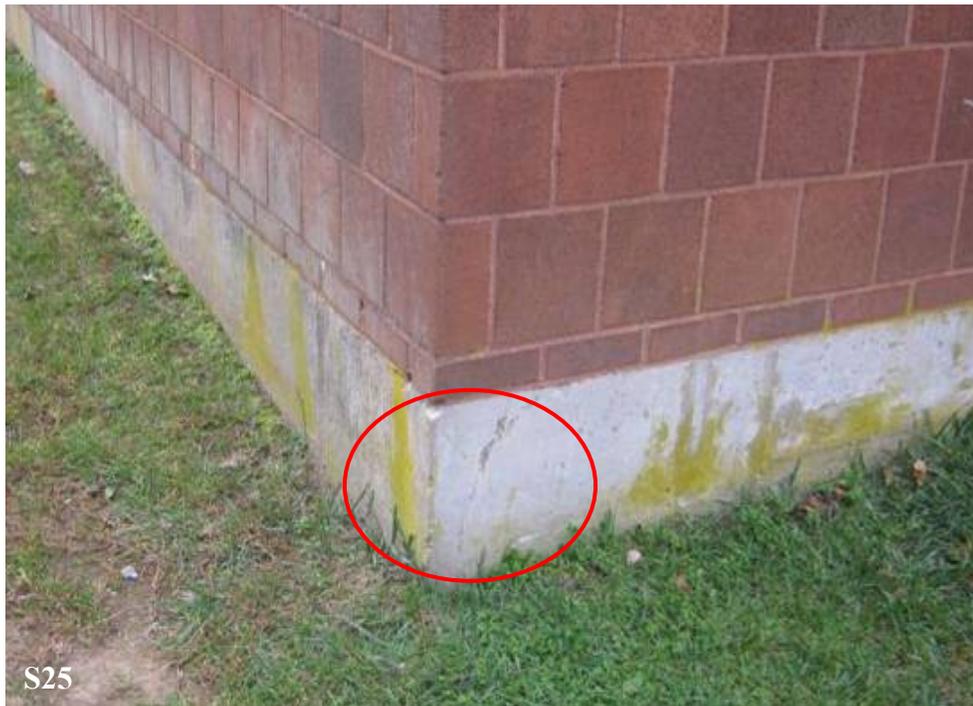
Wedge Shaped Cracking and Spalling at Northwest Corner of Classroom Wing Addition

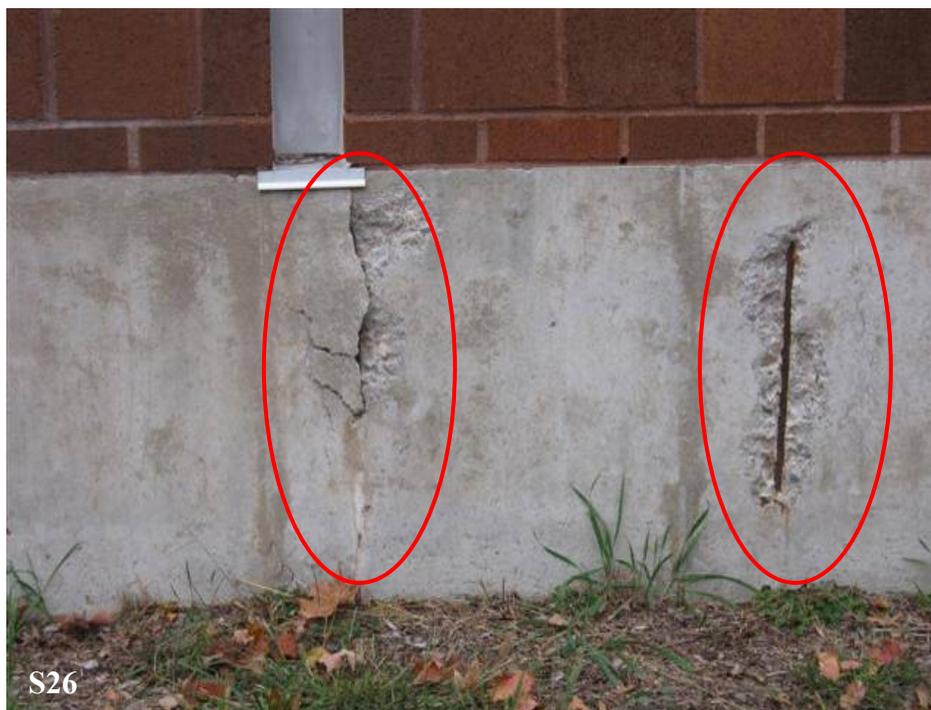
Along the east wall of the classroom addition there are two locations where the wall reinforcing steel was close to the surface. At these locations, the reinforcing steel had corroded and caused the concrete to spall. This has exposed the reinforcing steel to the elements and will expedite the damage.

Spalled and Exposed Foundation Wall Reinforcing on East Face of Classroom Wing Addition

The exposed reinforcing on the face of the foundation wall should be removed and the wall patched.

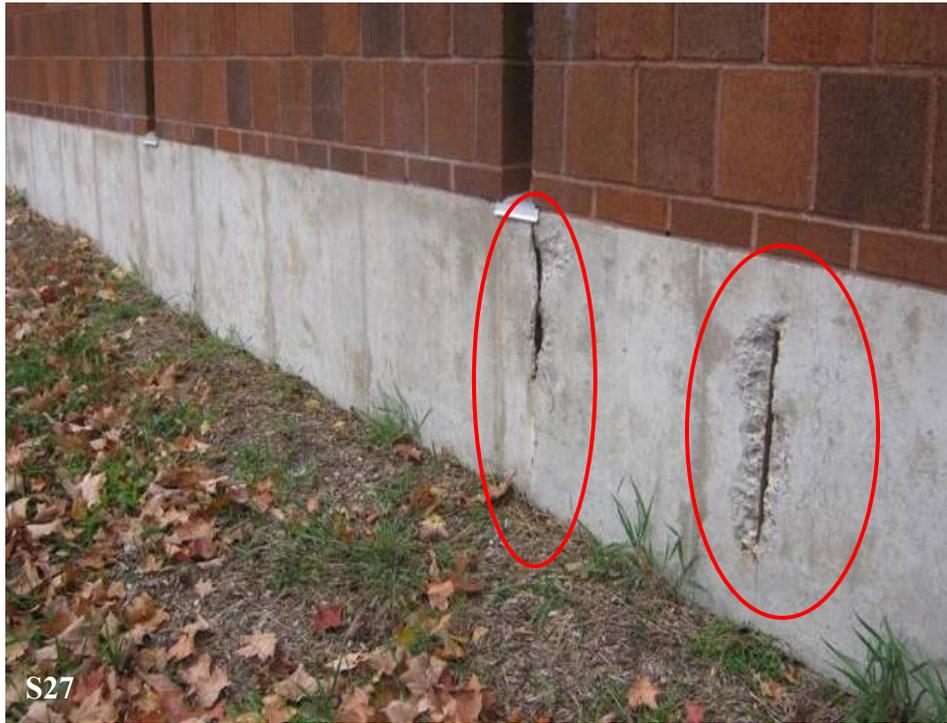
Spalled and Exposed Foundation Wall Reinforcing on East Face of Classroom Wing Addition

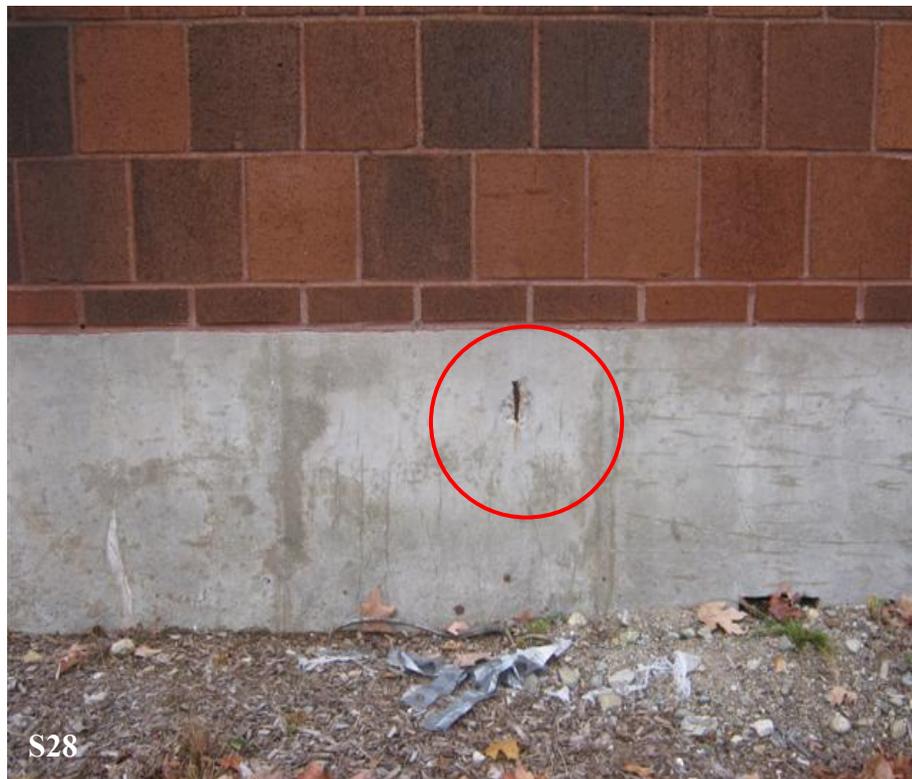
East Face of Classroom Wing Addition
