The East Lyme High School roofs contain two distinct types of membranes as well as areas with standing seam metal roofing. The majority of the school contains low slope roofing surfaces consisting of multi-ply built up asphalt systems with a granulated cap sheet installed less than 10 years ago. The roof on the latest addition, constructed in the 1990's, consists of a fully adhered EPDM rubber membrane. A majority of the membrane roofs have crystalline solar panel arrays which were installed in 2008. The roofing systems appear to be in good condition with a history of only a few leaks which have been addressed as they have occurred.

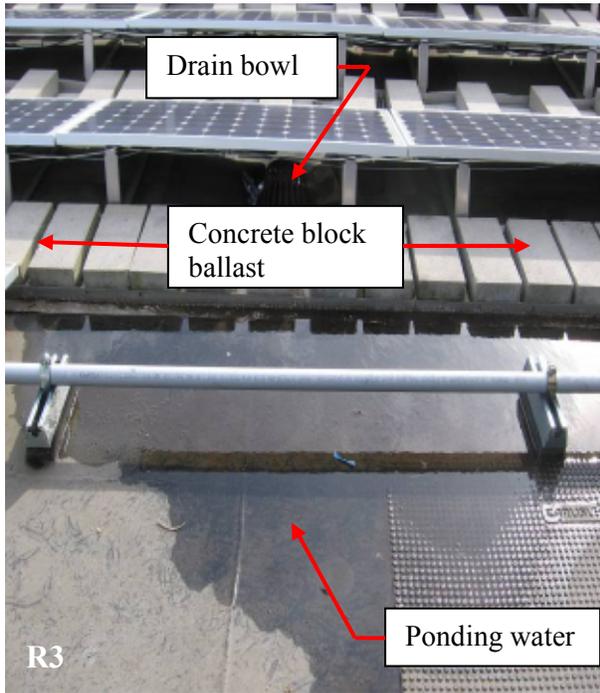
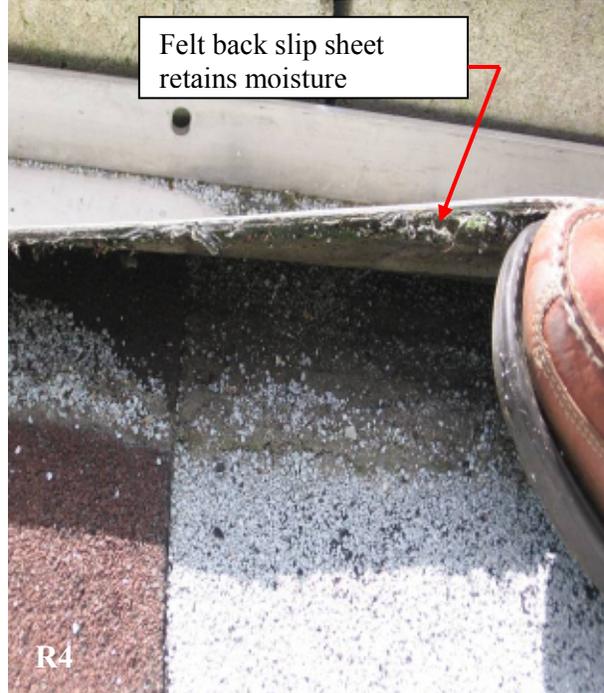
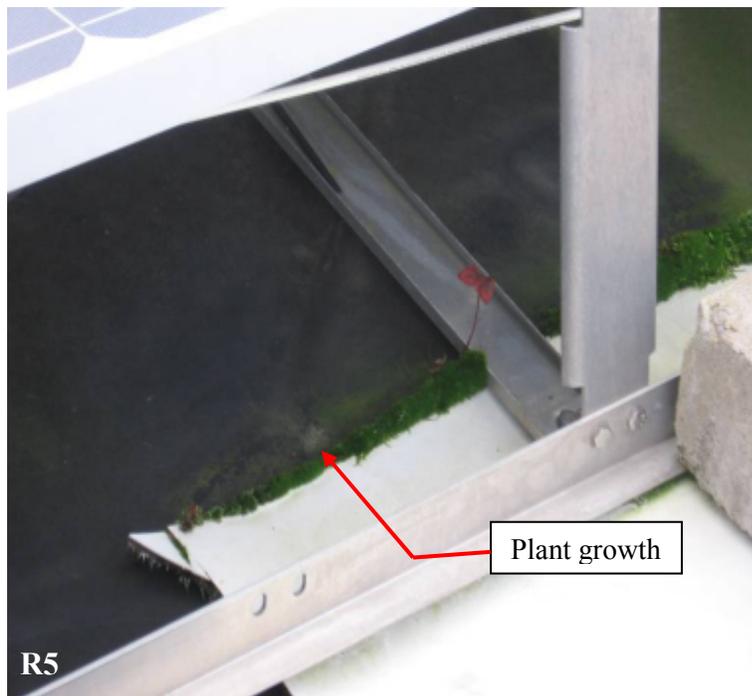
The solar panel arrays are ballasted with concrete blocks in trays that are set onto a felt back slip sheet. The concrete blocks are acting as water dams obstructing the path for the water to the drains. Ponding water is evident, the felt back slip sheets are water saturated promoting mildew and plant growth due to the retention of moisture. The ponding water will over time deteriorate the lap seams, probably decreasing the life expectancy of the roof system.

Install new solar panel array with design that elevates the system to allow better water management and eliminate ponding water.

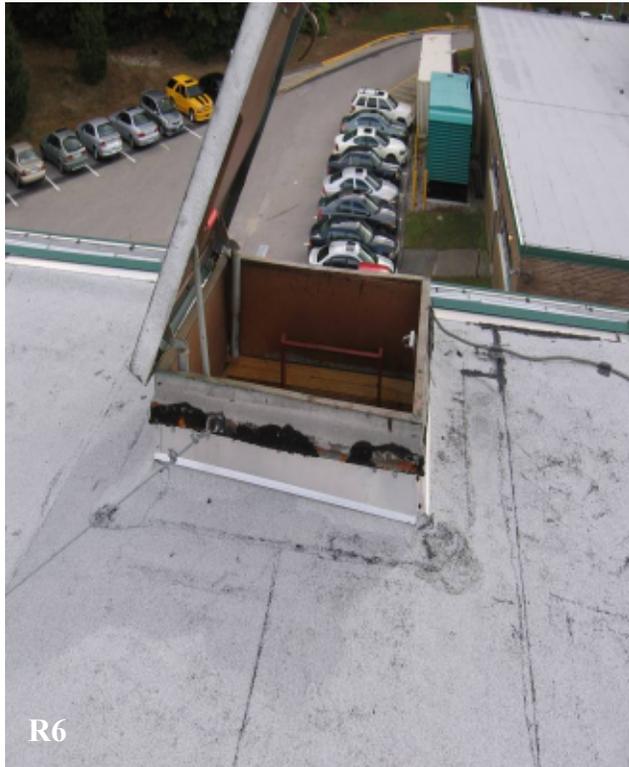
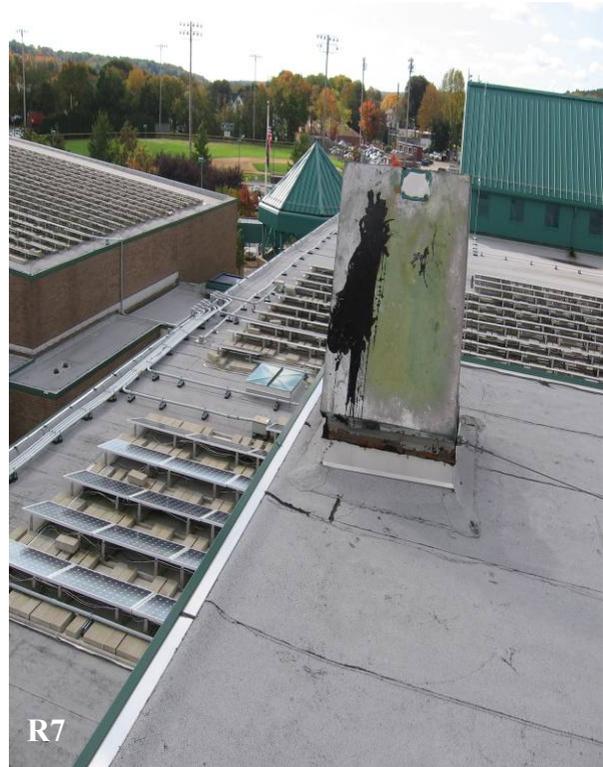
Access hatches are located in very close proximity to the edge of the roof at several locations creating a very dangerous condition.

Install guard rails secured to the structural steel at access hatch and roof top mechanical equipment located within 10 ft. of the roof edge

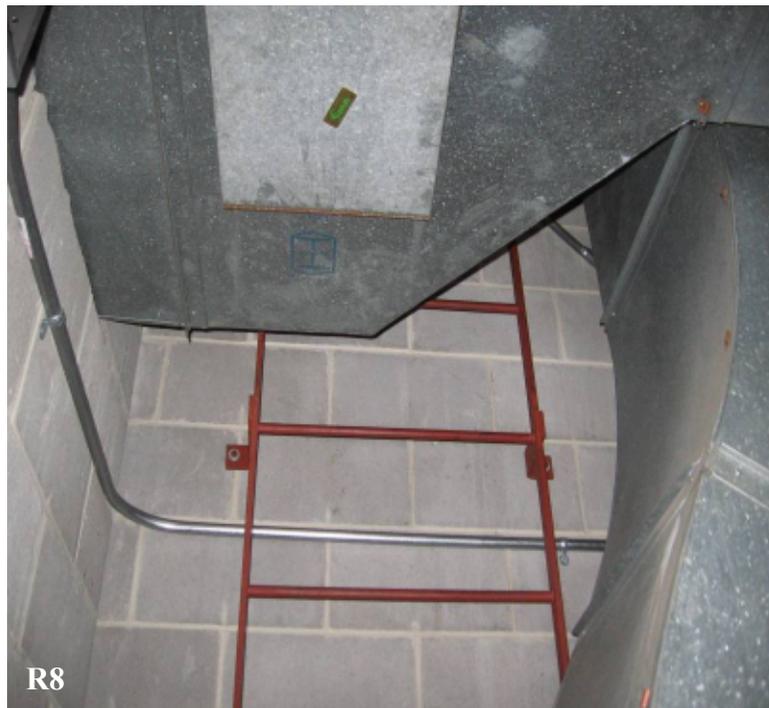
The ladder to access to the gymnasium roof is totally blocked by ductwork.

Install wall mounted ladders to provide safe and easy access to the roofs.

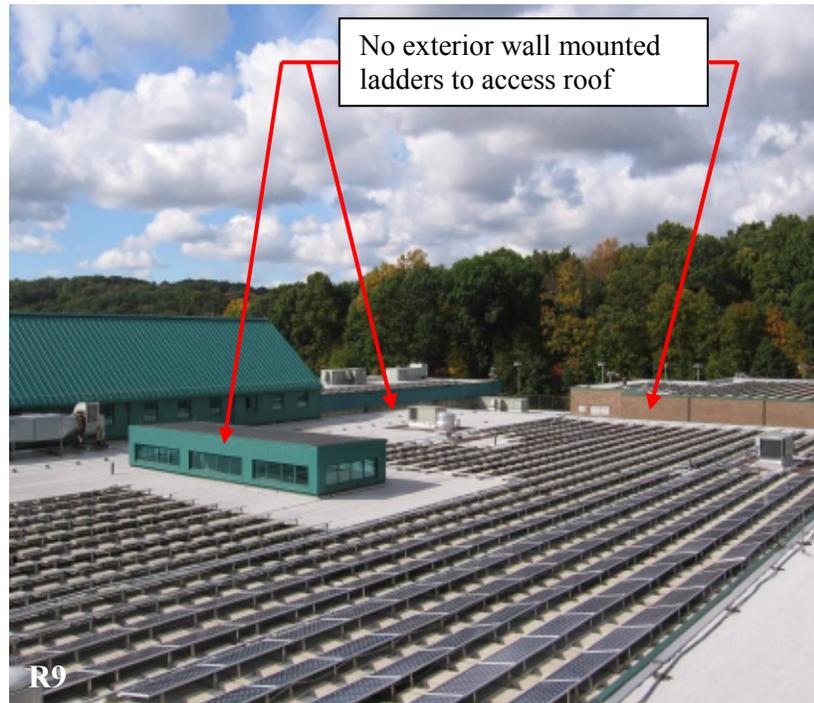
There are no exterior wall mounted ladders to access several roofs including the gymnasium due to the previously mentioned condition.

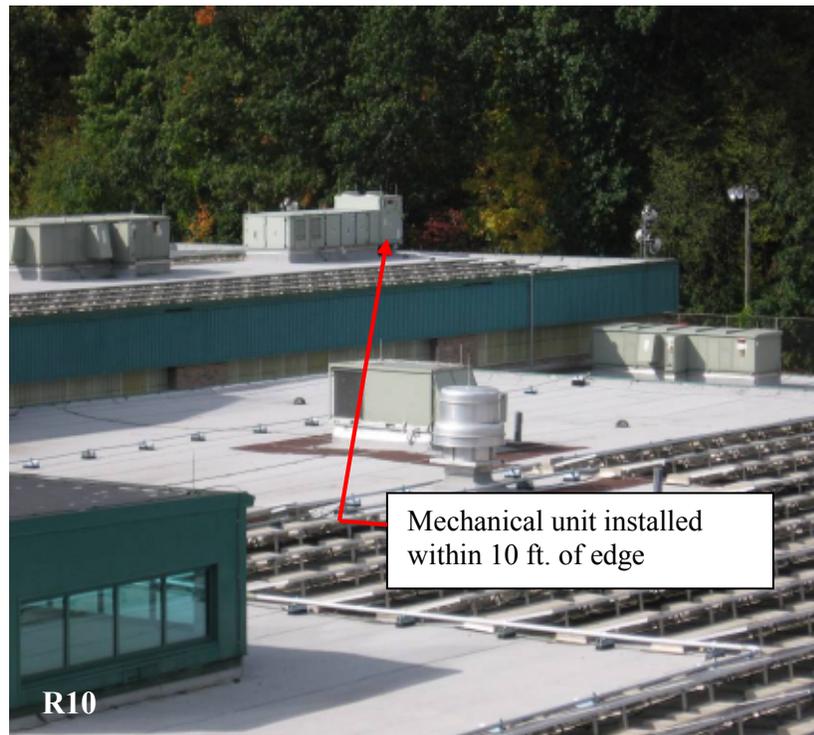
Guard rails were not provided where several mechanical units were install within 10 ft. of the roof edge which is a code violation.

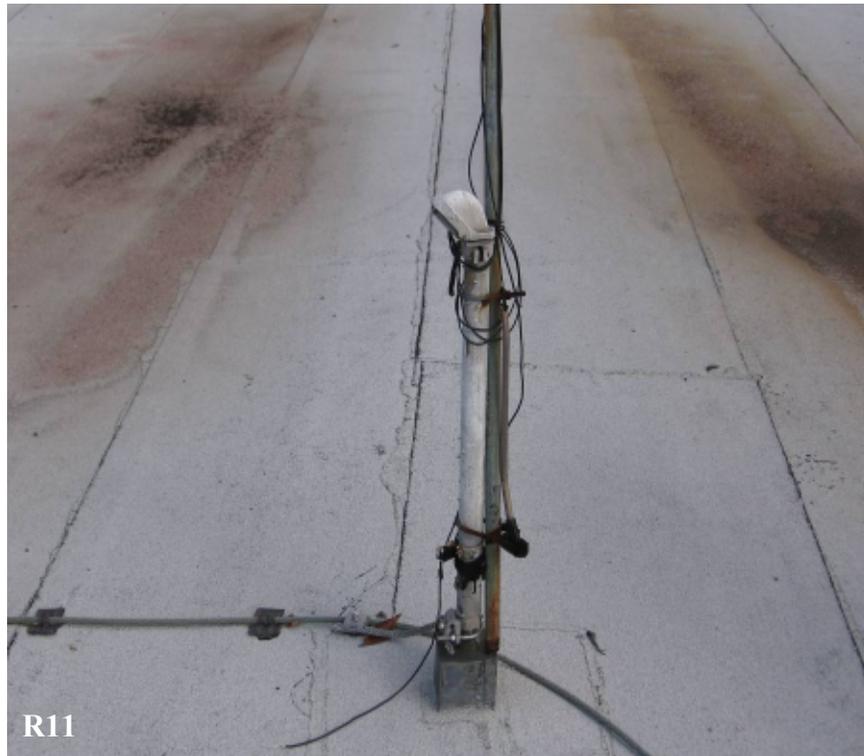
Several abandoned pitch pocket penetrations are a future source of leaks.

Remove and patch all abandoned roof top penetrations to eliminate potential leaks.

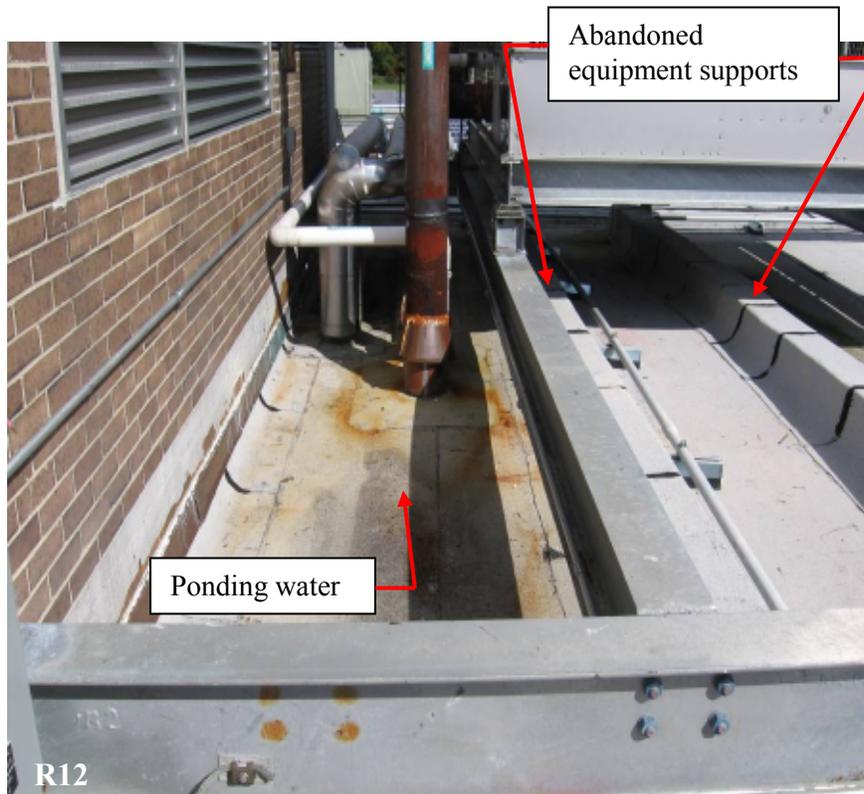
Above the boiler room 2 abandoned equipment supports act as dams impeding the flow of water to the drain.

Remove the 2 large abandoned equipment supports above the boiler room to allow water to flow directly to the drain.

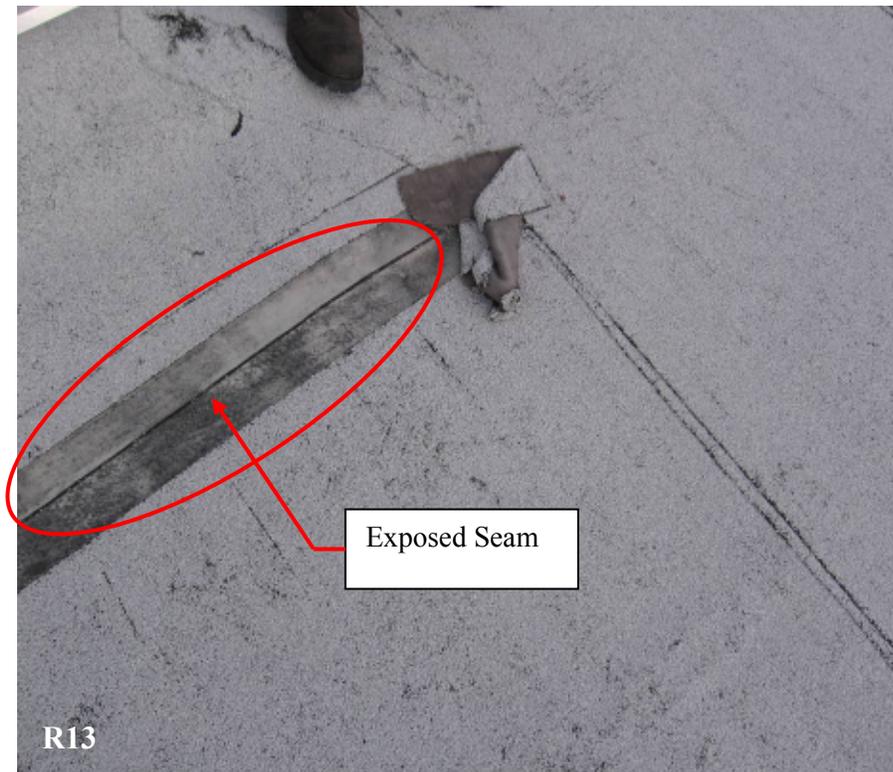
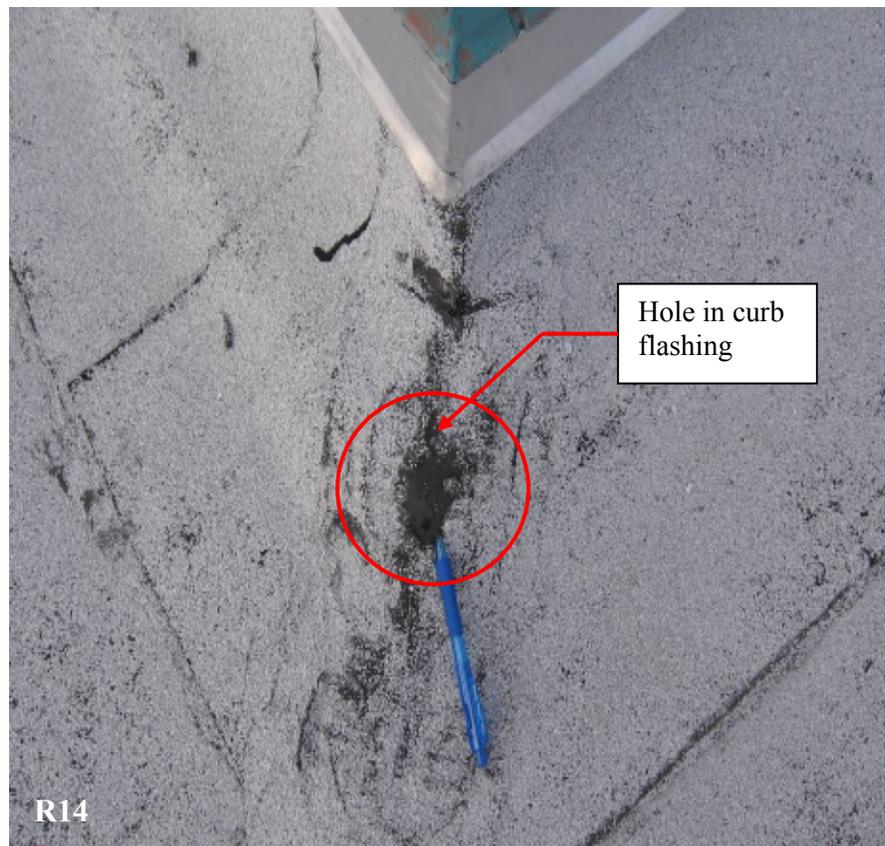
Damaged membrane flashing was observed on the auditorium roof.

Patch damaged membrane flashings on the auditorium roof.

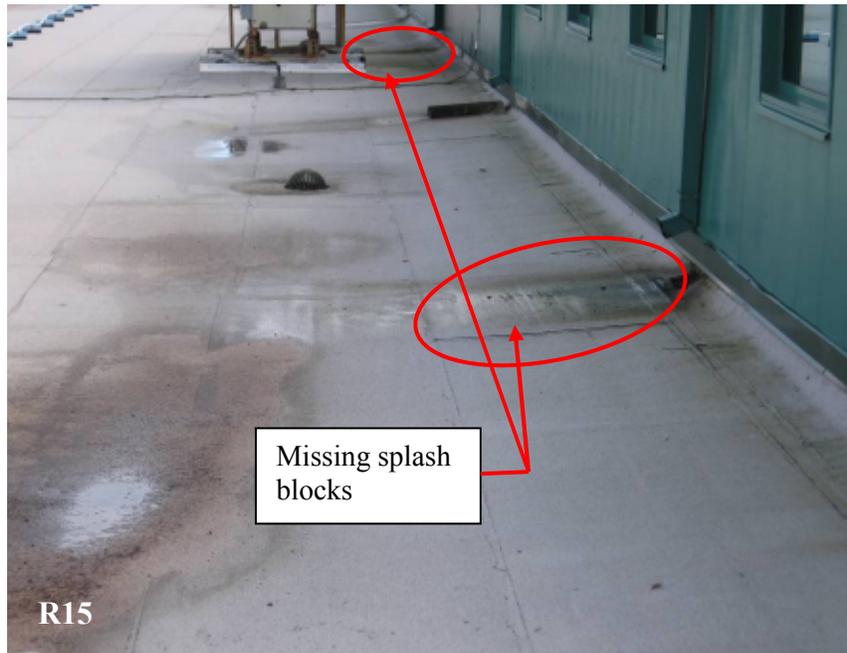
Splash blocks which help prevent damage to the surface of the granulated cap sheet were missing at several locations.

Install missing splash blocks at bottom of downspouts to protect granulated cap sheet.

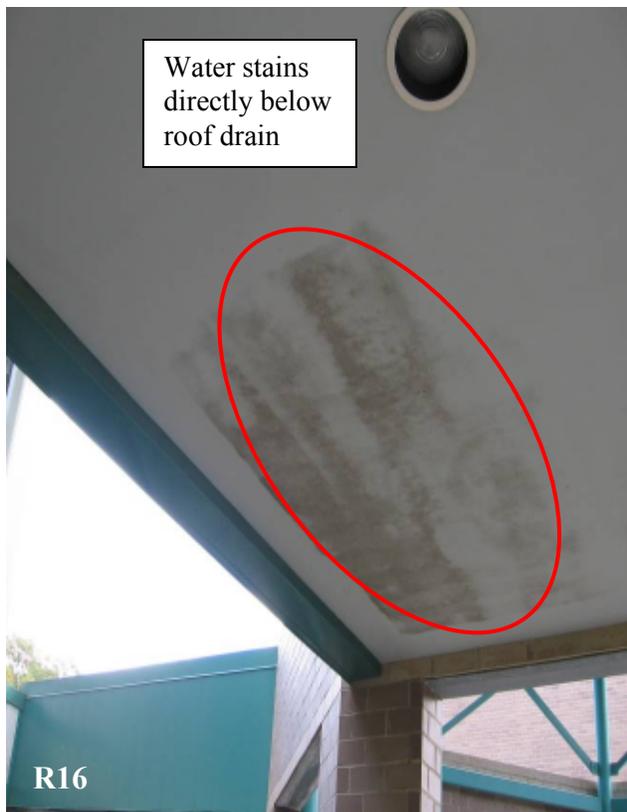
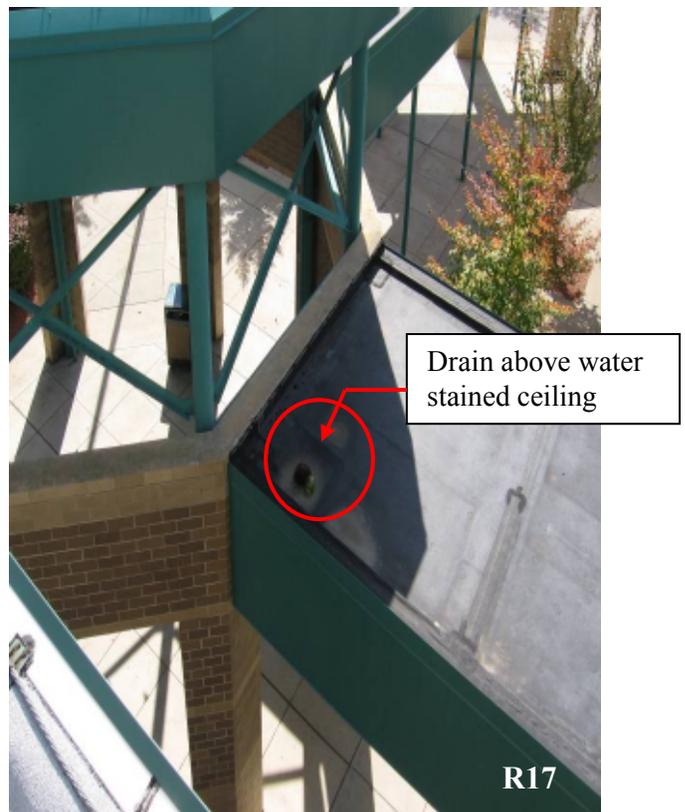
Water stains were observed on the underside of the entry canopy directly below a roof drain.

Investigate and fix leak under drain at main entry canopy.

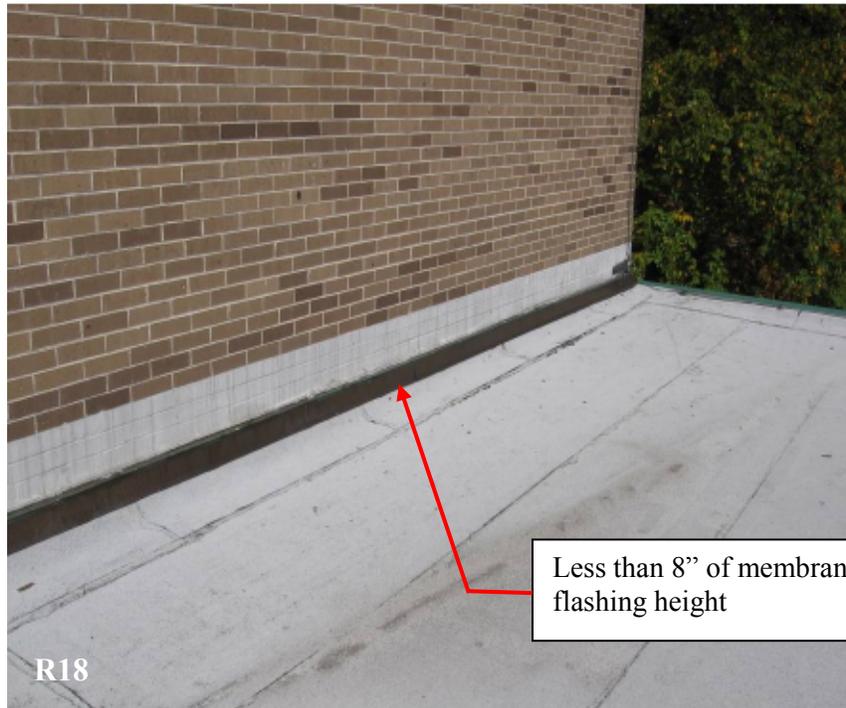
A section of membrane flashing at a transition onto a rising wall does not have the required 8" of flashing height which probably means that this area of roof is not under warranty.

Raise the height of the thru wall flashing where it does not provide the required 8" of flashing height.

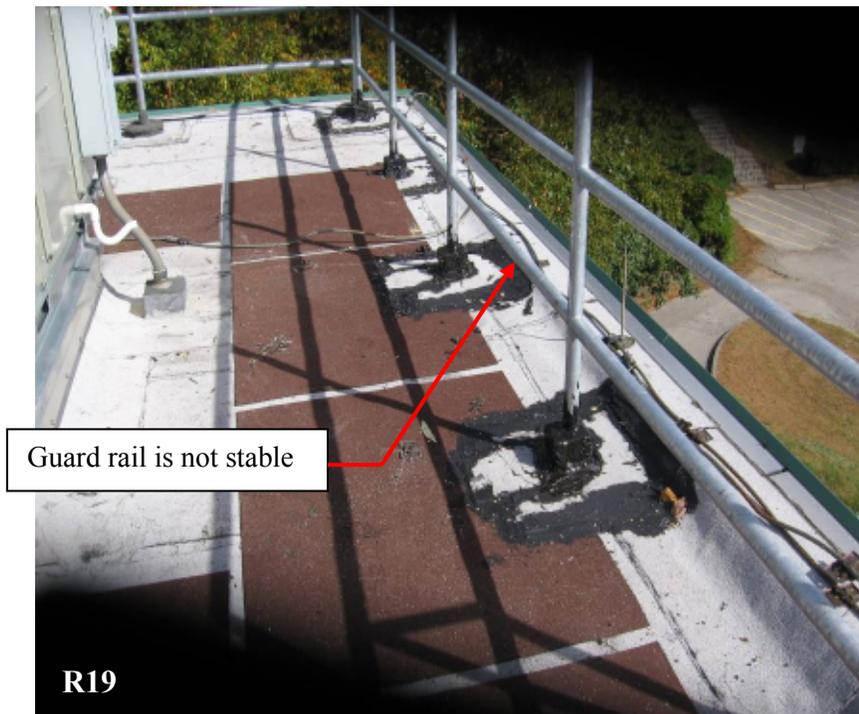
The guard rails recently installed on the mechanical room roof do not appear to be fastened to the structural steel. The railings easily move back and forth when touched and most likely would not be able to withstand the 200 lbs. of horizontal force required by code.

Remove and re-install new guard rail in order to withstand horizontal force of 200 lbs.

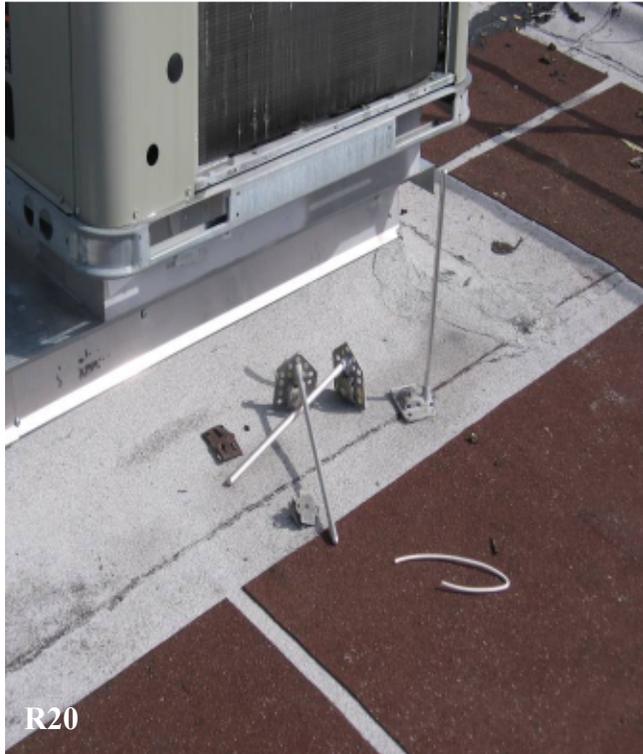
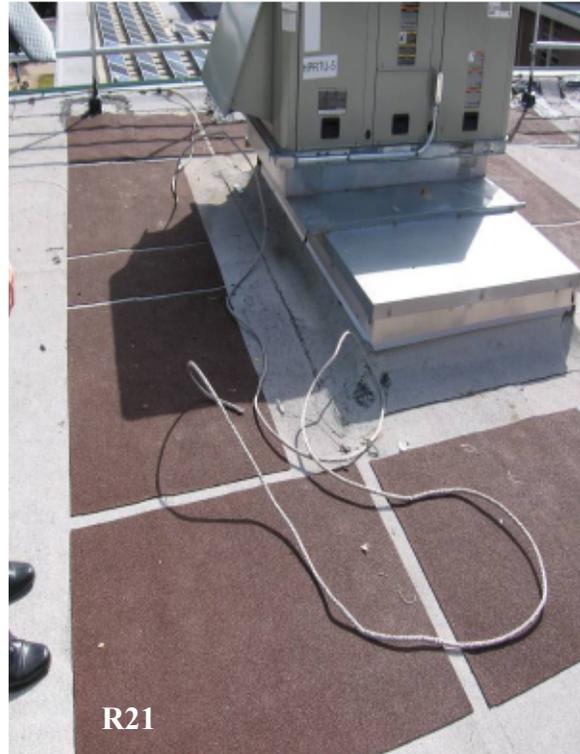
Construction debris remains on the mechanical room roof including a cable which could be a tripping hazard.

Remove all construction debris and tripping hazard from the roof.

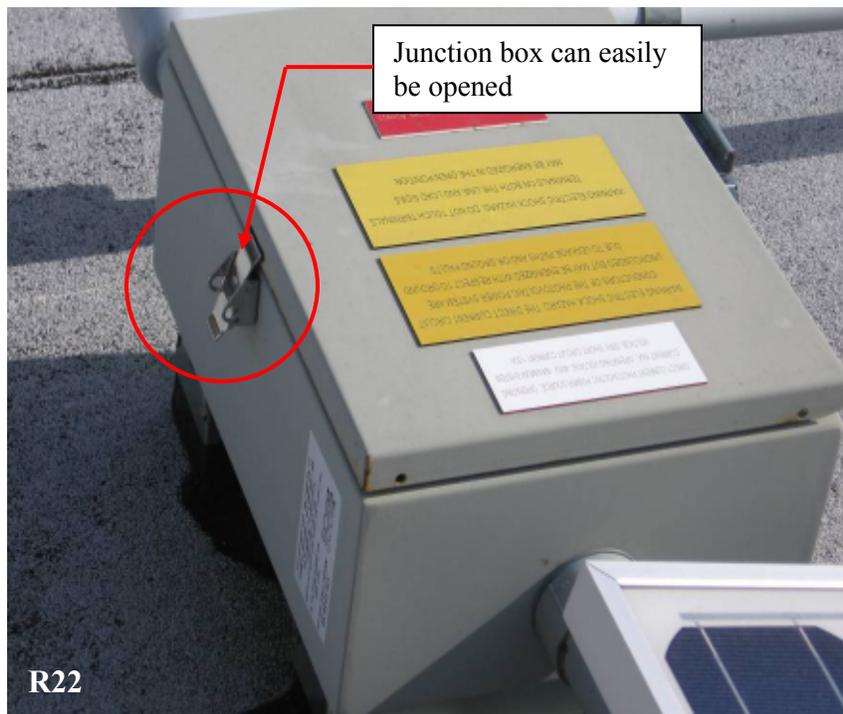
The junction boxes for the solar panel system do not have locks and can easily be tampered with which presents a danger to the system as well as the individual.

Provide locks to secure the solar panel electrical junction boxes.

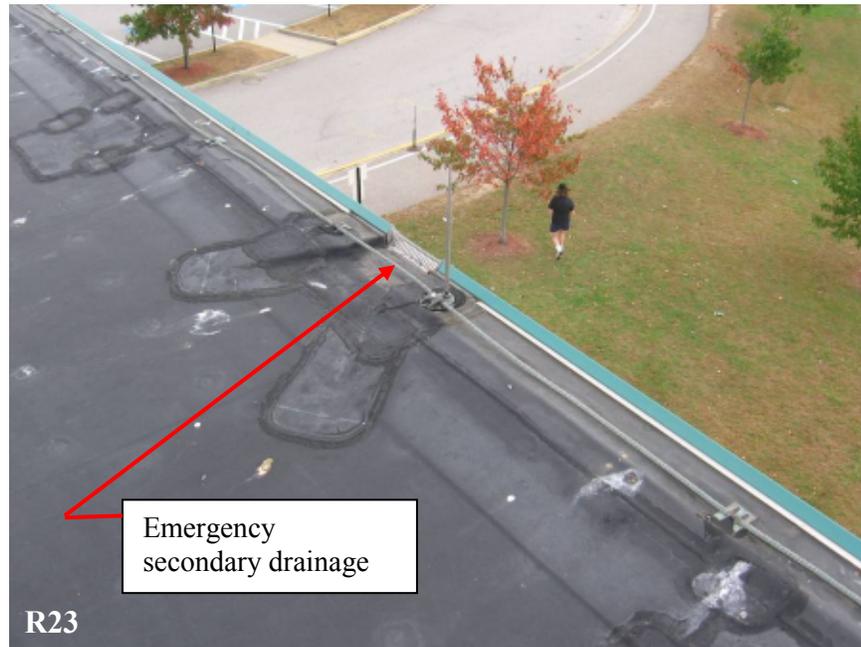
Emergency secondary drainage system (scuppers) were only observed on the EPDM rubber roof installation.

Provide emergency secondary drainage on all roofs per code requirements.

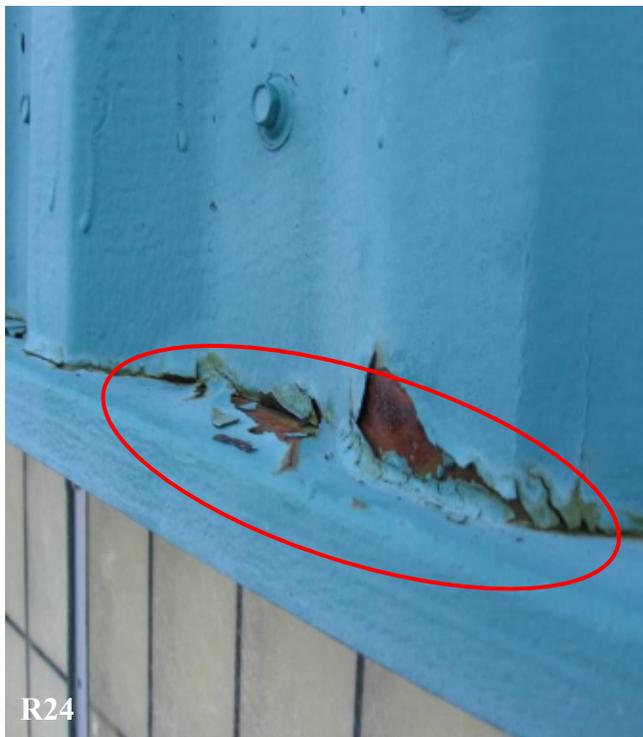
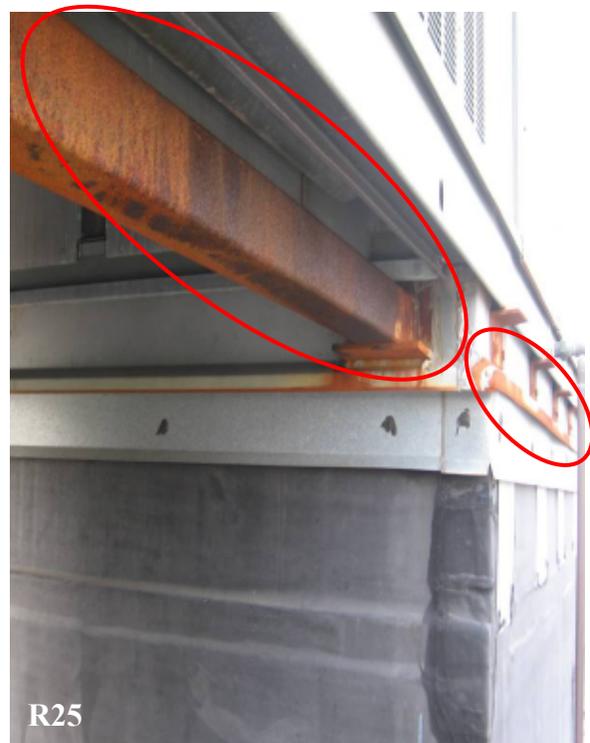
Rust was observed on the metal fascia panels around the standing seam roof and on RTU dunnage support.

Sand prime and paint all rusting metals to prevent further deterioration.
