**Overview:**

**Existing Conditions Assessment:**

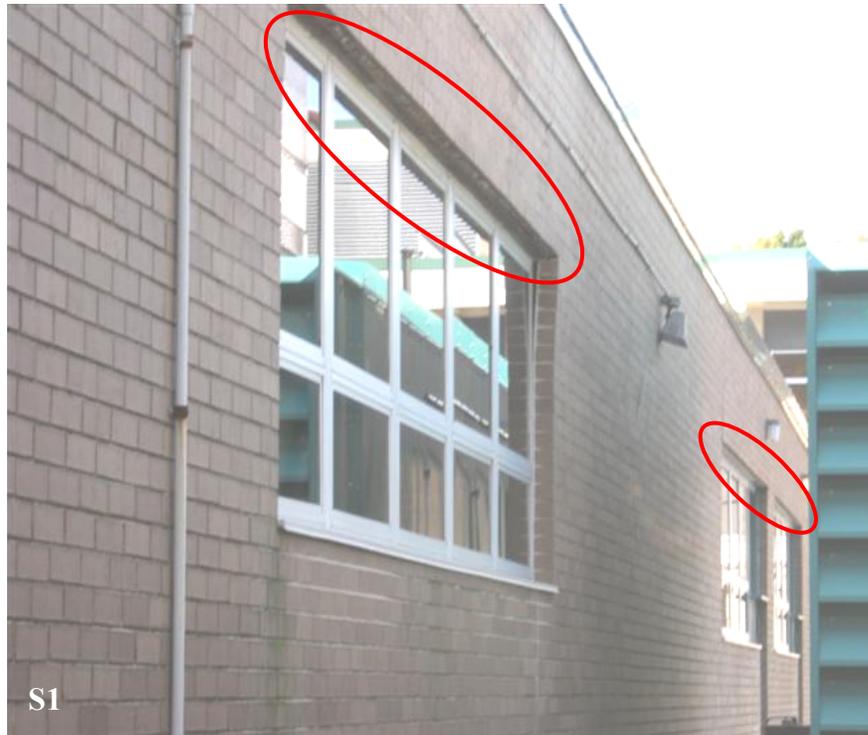
Movement has been observed in the exterior brick on the north side of the Music Rooms adjacent to the Auditorium and above the mechanical louver on the south side of the north Gymnasium as well as above the three window openings on the north side of the same Gymnasium. The exterior brick wythe is moving outward away from the face of the building. The movement is greatest directly below the roof's gravel stop and ends approximately half the distance down the window height. The cause of the movement is not known at this time and additional exploration of the wall will be required.

**North Wall of the Music Suite Adjacent to the Auditorium**

The cause of the movement in the north exterior wall of the Music Suite is not known. We would recommend that the Owner hire a mason to remove small areas of the brick in a number of locations so that a further investigation of the type, condition and spacing of the masonry anchors can be documented. At this time, our recommendation for permanent repairs would be to remove all of the brick and anchors projecting from the inner wythe concrete block down to the top of the foundation wall. An air and vapor barrier should be applied to the exterior surface of the concrete block, new expansion anchors installed along with insulation, flashing and weep holes as part of rebuilding the brick wythe. The rebuilt wall would continue to new vertical expansion joints constructed where the new wall meets the remaining existing wall. The additional investigation will confirm our preliminary findings prior to preparing construction documents.

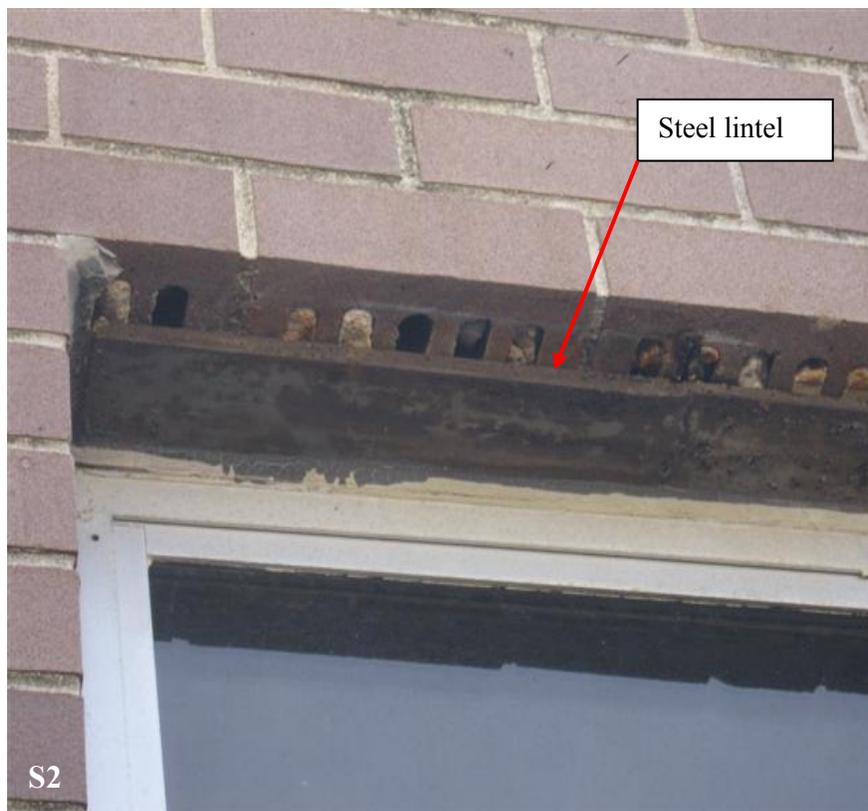
**Close up of Movement in the Exterior Brick Wall at the Music Suite**

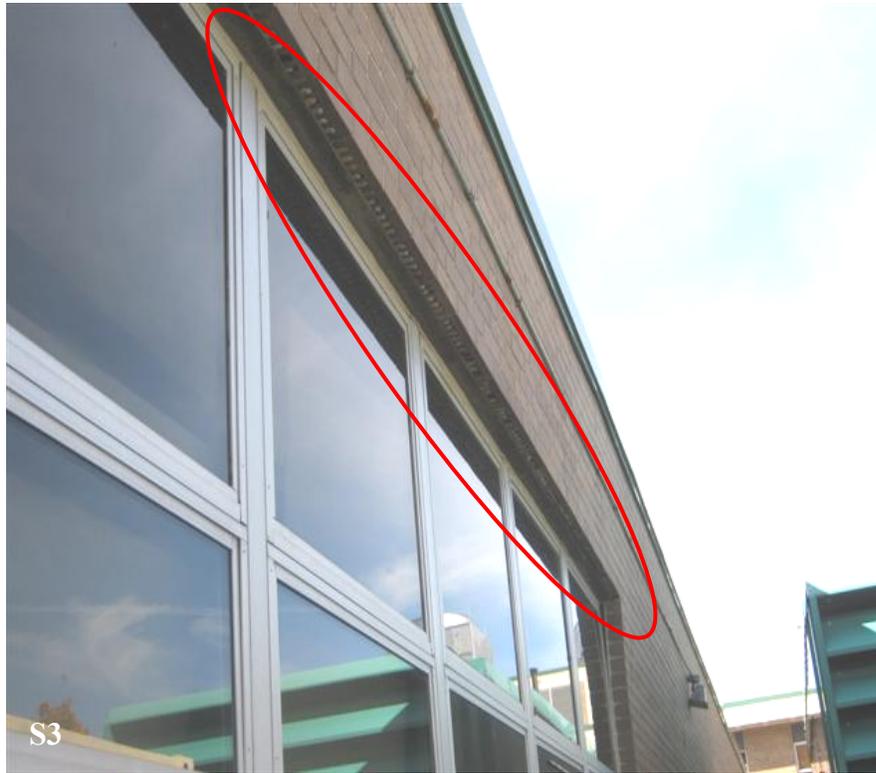
**Outward Displacement of the Exterior Brick**

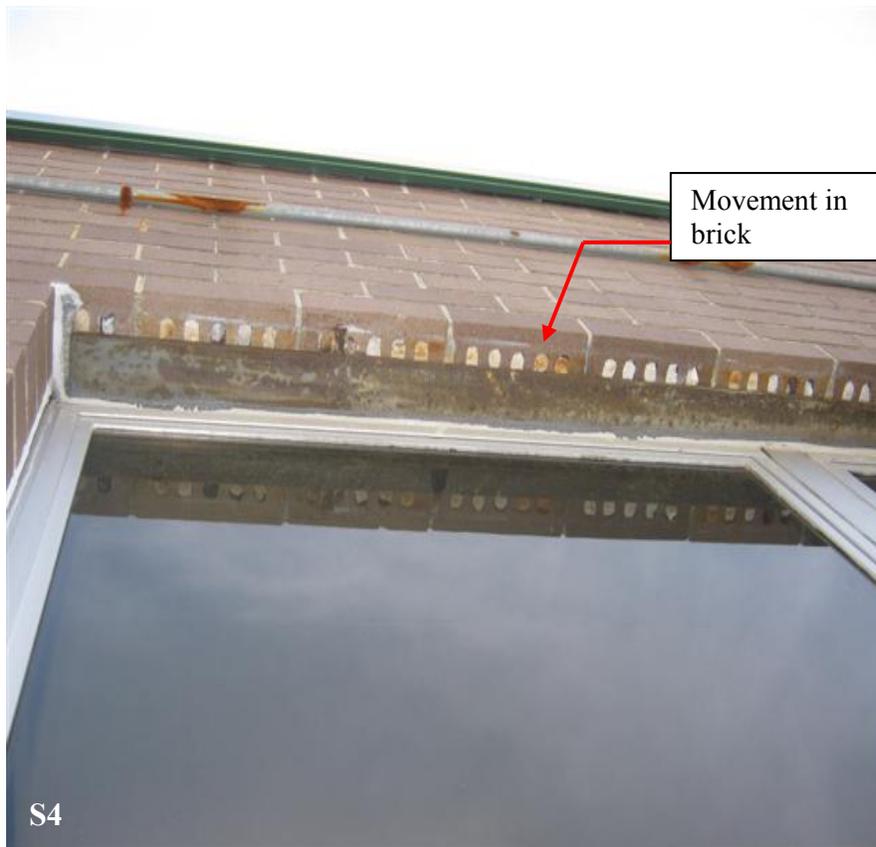
**Looking Upward at the Brick Displacement**

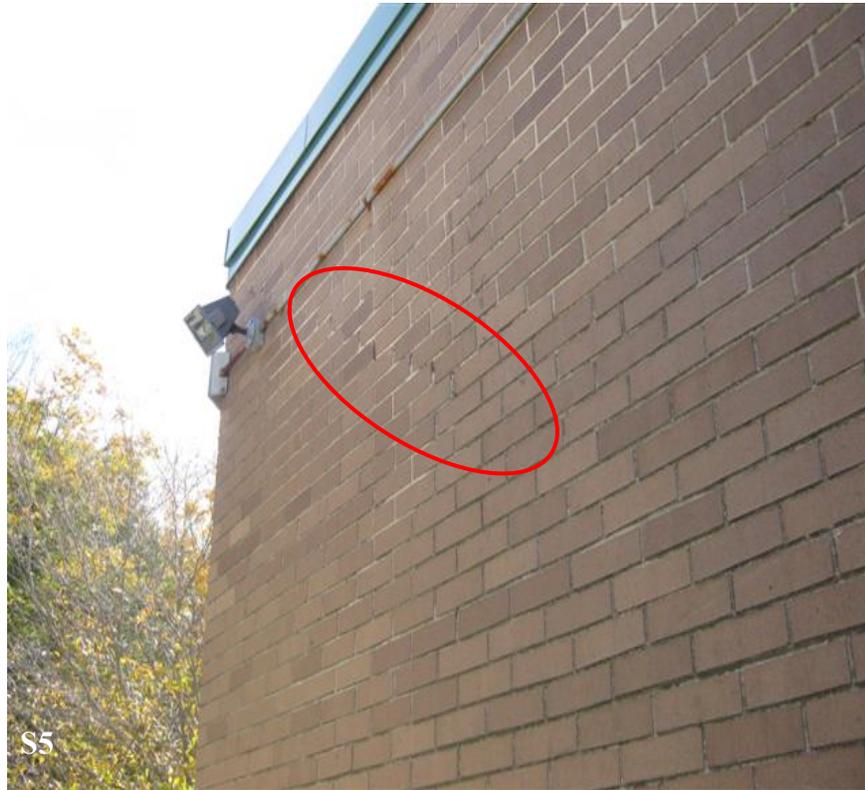
**Diagonal Cracking and Movement in the Exterior Brick**

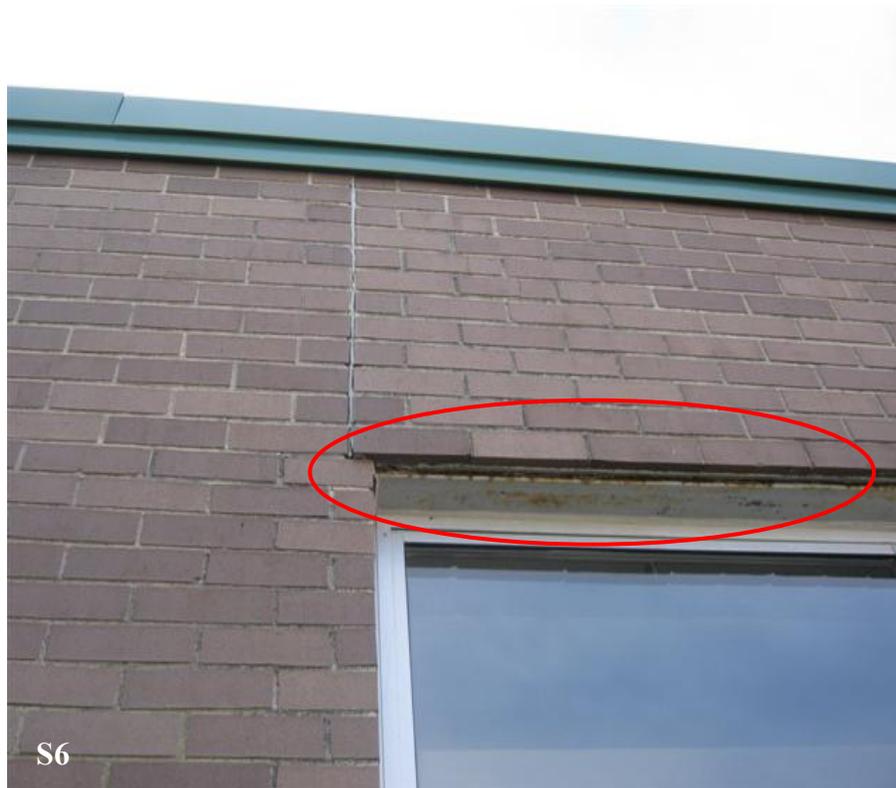
**Brick Shifting Outward above Window Opening**

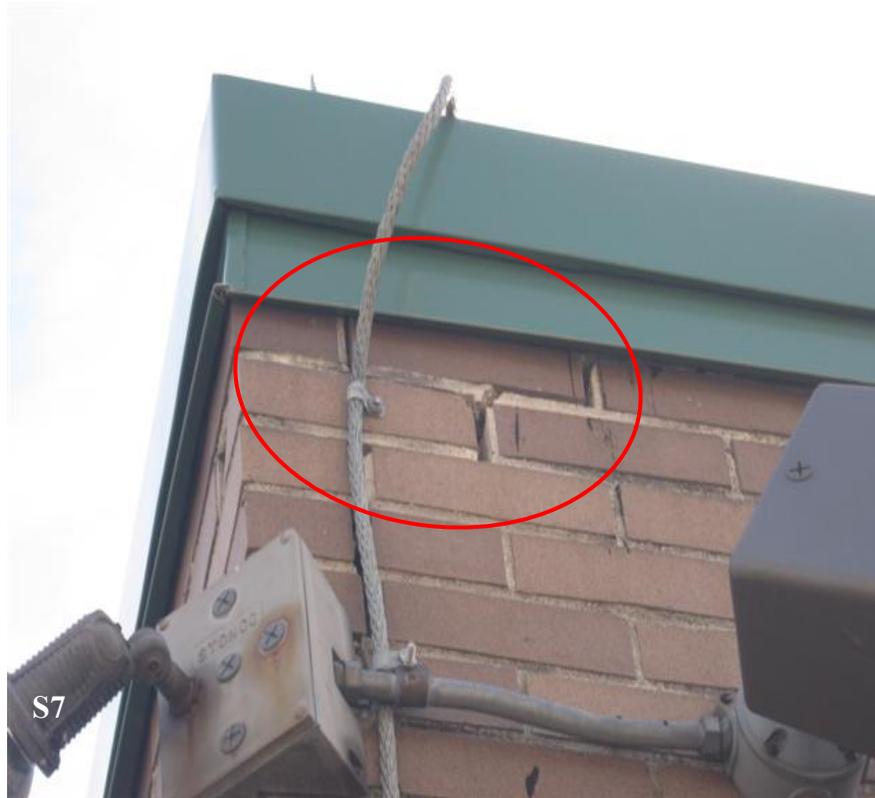
**Movement in the Exterior Brick at Northwest Corner of Music Suite**

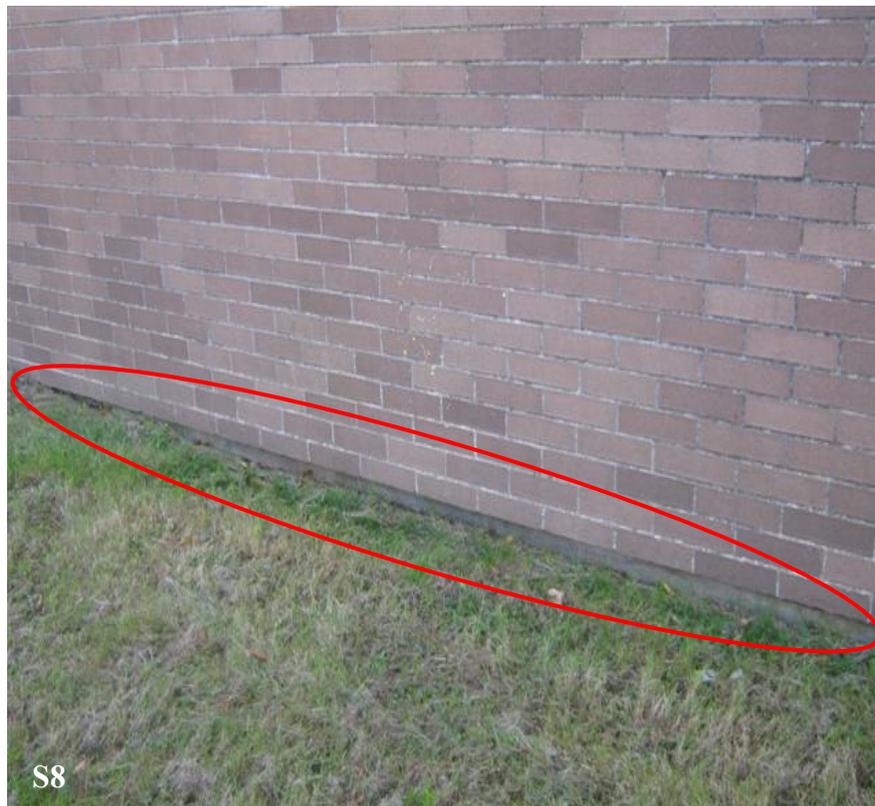
**Omitted Weep Holes at Base of Exterior Brick at Music Suite**

Where weep holes are concealed below grade, the ground must be regarded such that the weeps are exposed. Any debris clogging the weep holes must be removed to create positive drainage.

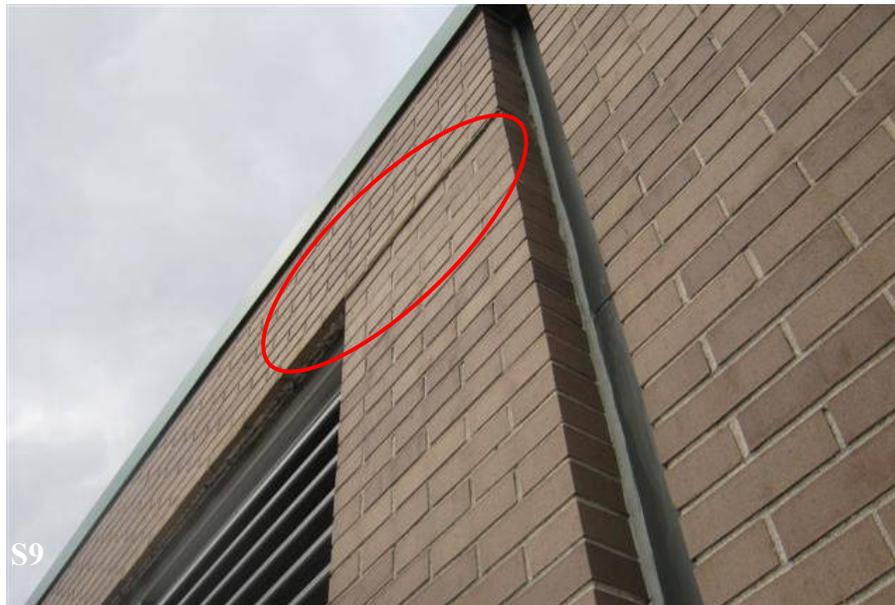
The brick supported by the steel angle lintel that spans the large louver opening on the south wall of the north Gymnasium has shifted outward  $\frac{3}{4}$ " minimum. Approximately 2" of the  $3 \frac{5}{8}$ " width is suspended beyond the support of the angle. Water is able to enter into the enlarged cavity caused by the movement. Any water trapped in the wall may cause mold to grow in the wall undetected. The wet condition will also create the proper atmosphere for corrosion to the steel angle and possible freeze / thaw damage. A similar condition is beginning to occur to brick above the window openings on the north wall of the north Gymnasium. The movement is not as extensive at this time but the brick will continue to shift until it fails.

**Outward Movement in Exterior Brick above Lintel at North Gym Mechanical Room**

At the louver and windows in the exterior walls of the North Gymnasium, a similar investigation should be performed to confirm that the movement at these locations is caused by the same issue as the wall at the Music Suite.

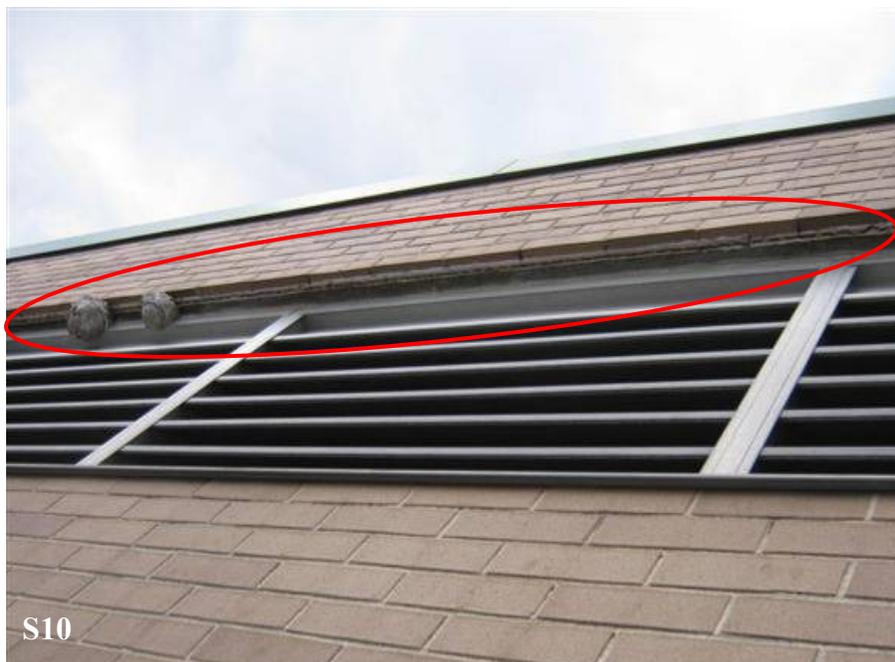
**View Looking Upward at the Brick Displacement**

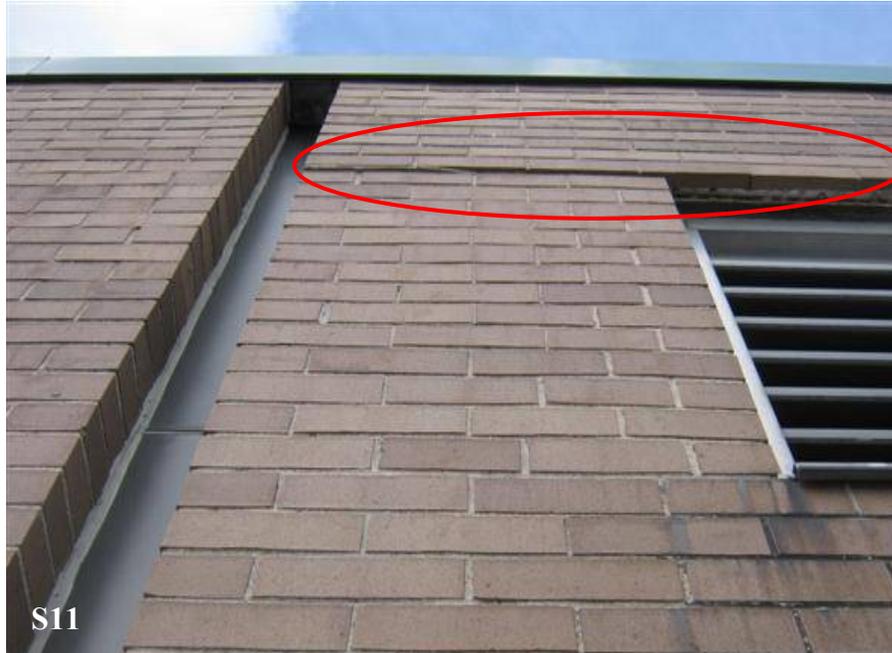
**Movement in the Brick at West Pilaster of Louver Opening in South Face of North Gym**

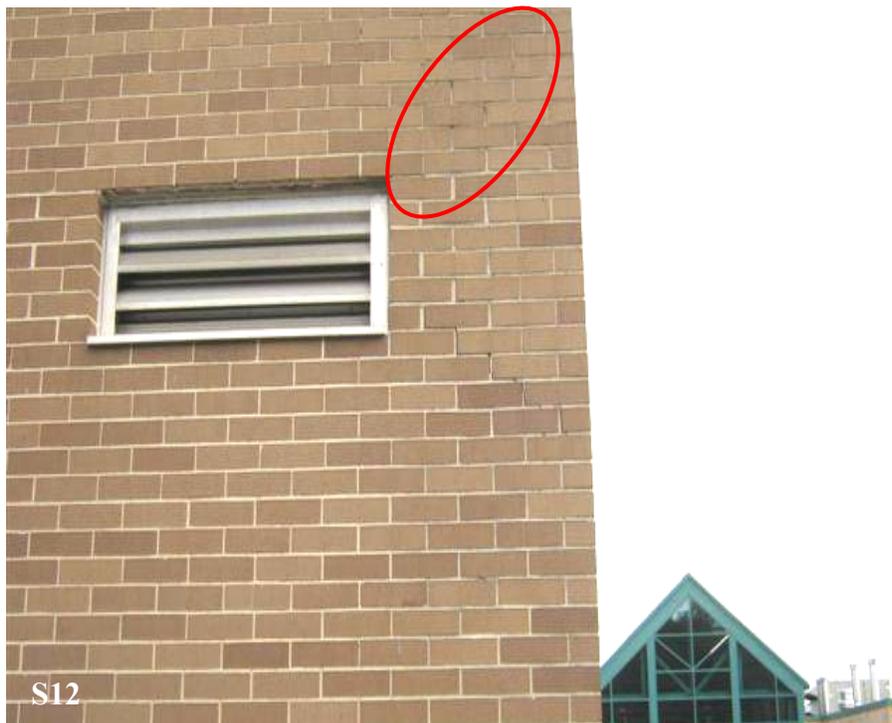
Movement in the exterior brick is visible at the southwest corner of the Mechanical Mezzanine above the Locker Rooms that are attached to the north Gymnasium. The crack begins at the corner of a louver which is cut into the west wall and continues diagonally toward the corner of the building. Differential movement is not noticeable on the corner of the building.

**Cracking and Spalling in South Wall of North Gym Mechanical Room**

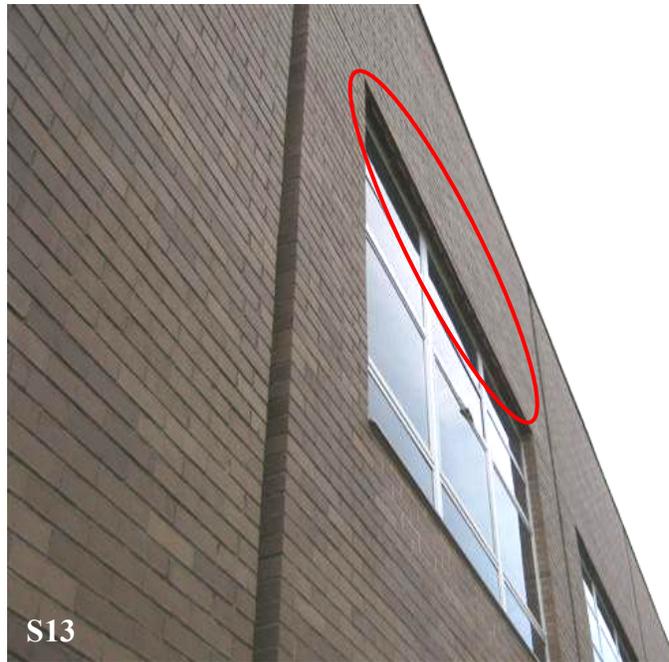
A similar condition is beginning to occur to brick above the window openings on the north wall of the north Gymnasium. The movement is not as extensive at this time but the brick will continue to shift until it fails.

**Outward Movement in Exterior Brick above Window Openings in North Wall of North Gym**

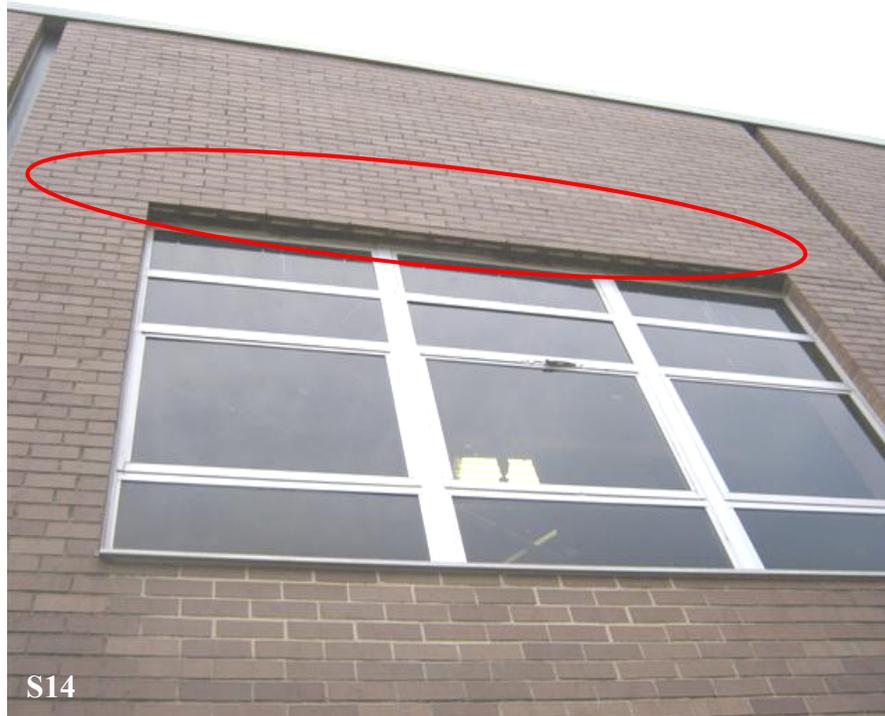
**Movement in Brick above Center Window of North Gym**

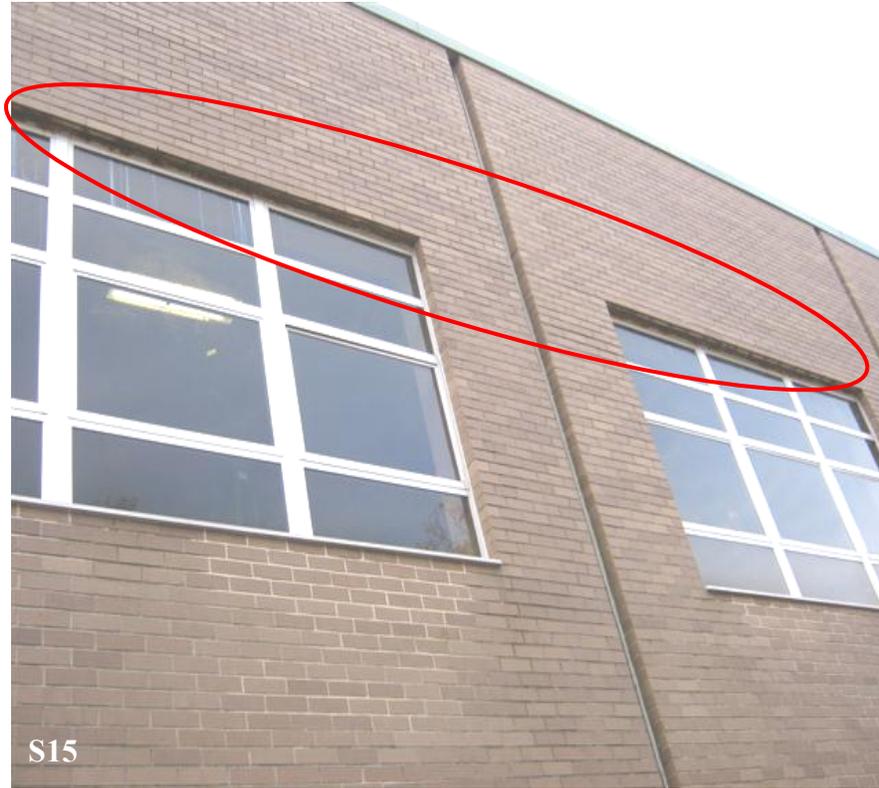
**Movement in Brick above the Center and West Window Openings in North Gym**

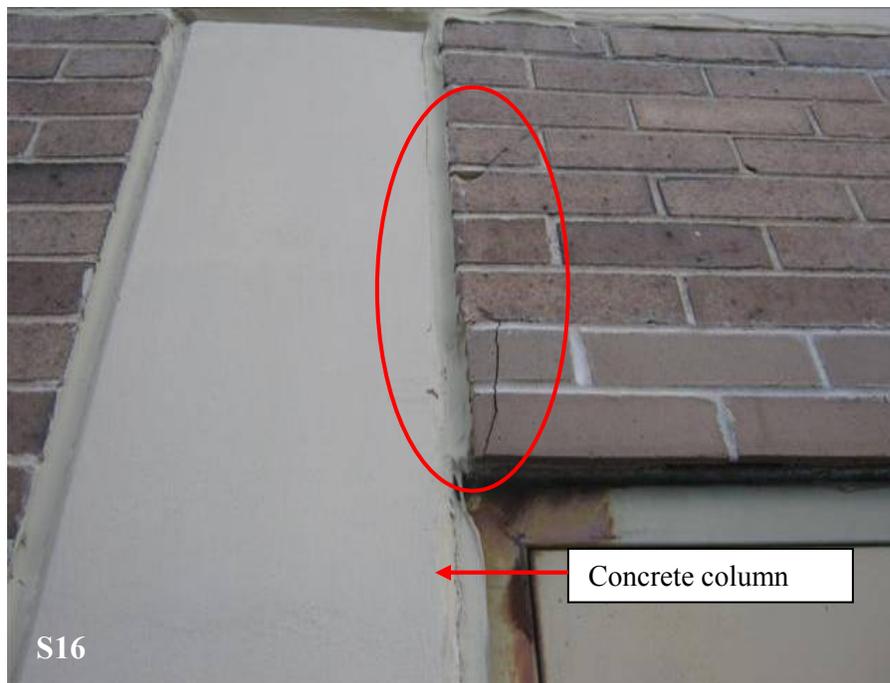
Vertical cracks were observed in the exterior bricks at various locations throughout the exterior of the building. Some of the cracks were due to natural movement due to the omission of brick expansion joints. At other locations, the reason for the movement is not apparent.

**Cracking in Exterior Brick Adjacent to Concrete Column on West Face**

Locations where vertical cracks have occurred in the exterior brick should be repaired to prevent water damage. The damaged bricks will be removed and replaced and anchored to the inner wythe concrete block. Flashing, backer rods and caulking would also be installed locally at the area to be repaired.

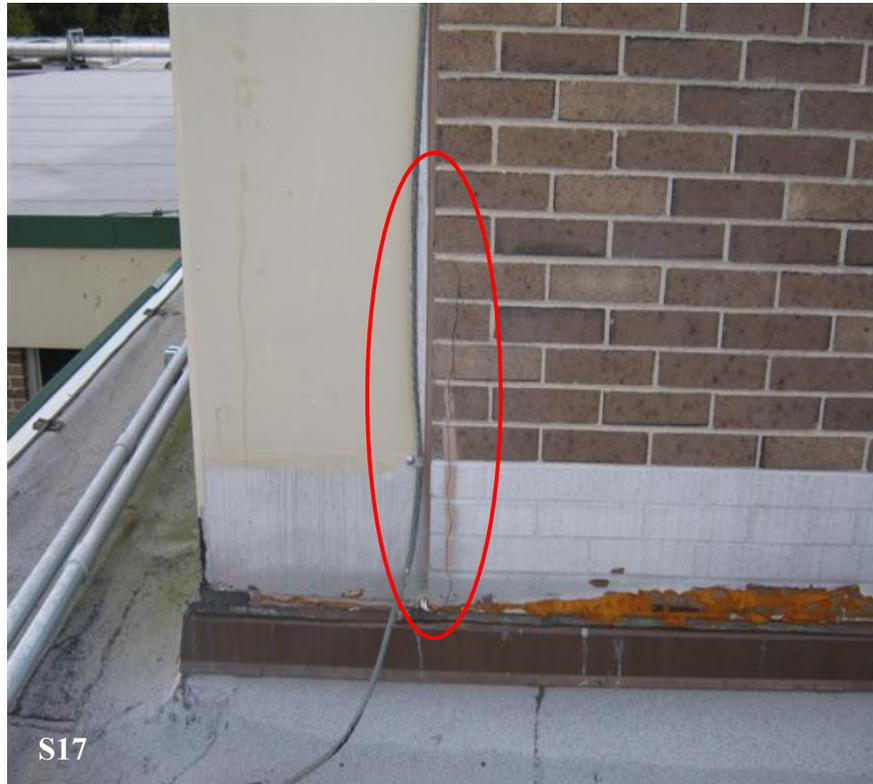
S17

**Cracking in Exterior Brick adjacent to Concrete Column above low Roof at Mechanical Room**

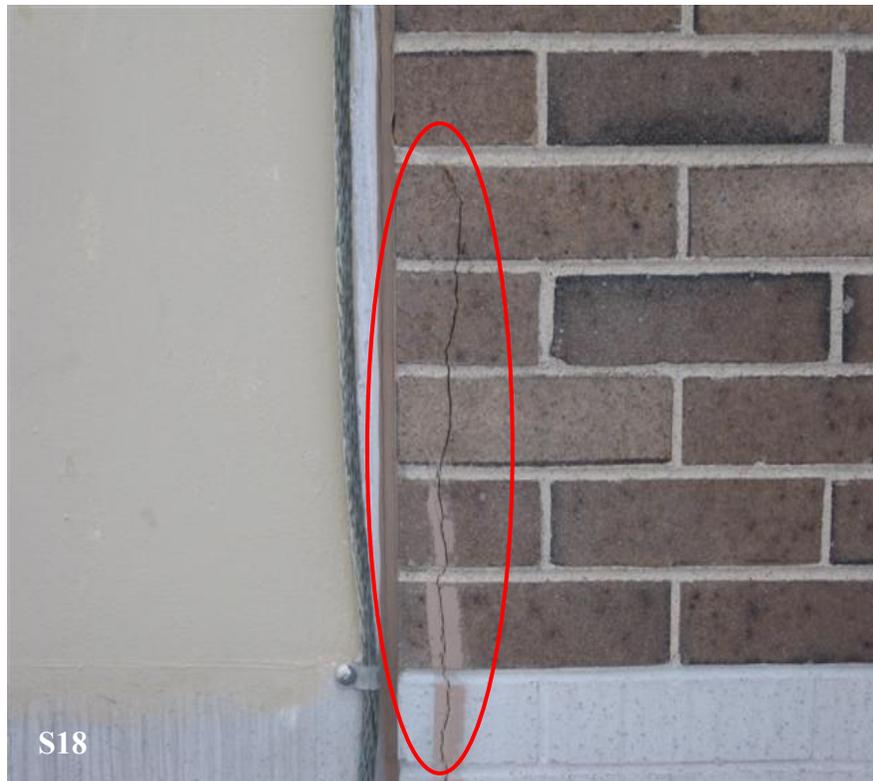
S18

**Close up of Vertical Crack.**

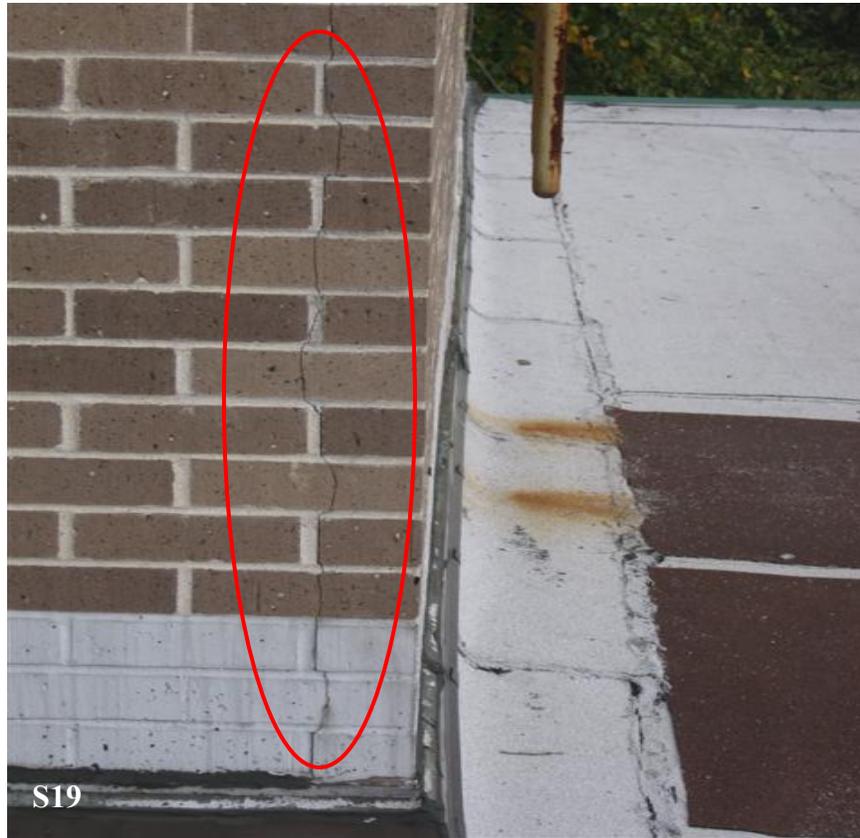
**Vertical Crack in Exterior Wall above Low Roof**

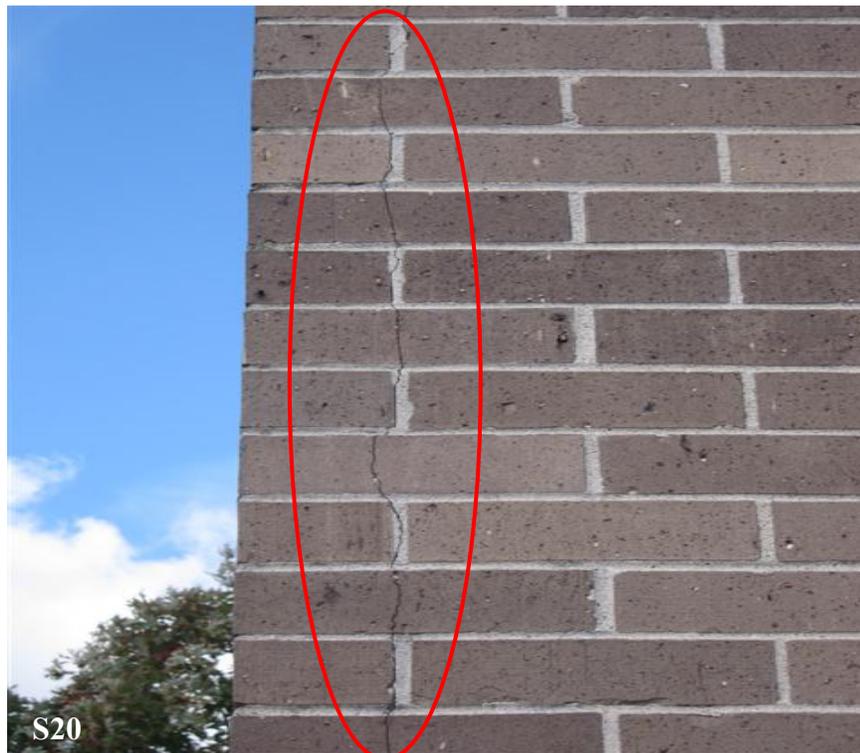
**Vertical Crack at Southeast Corner of the Auditorium above Low Roof**

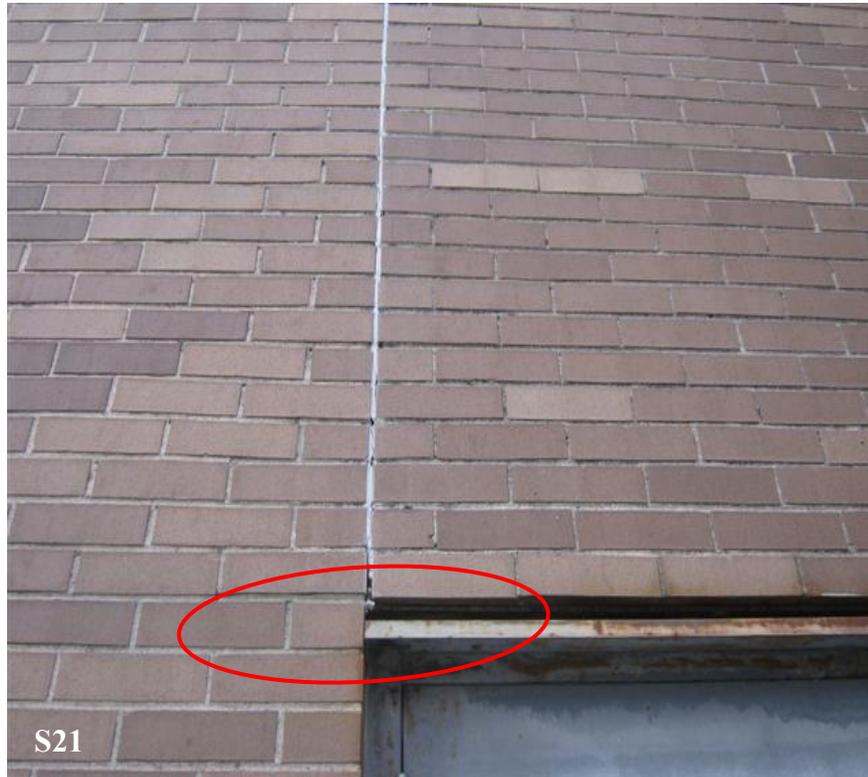
**Movement in Exterior Brick at Steel Lintel for Door Opening**

At door, louver or window openings where the steel angle lintels are in various degrees of corrosion that is causing the mortar and brick to crack and spall, Owner's mason should remove a few bricks at these locations so that we can evaluate the extent of the corrosion occurring to the steel lintels. Recommendations for repairing the condition will be developed based on the information gathered.

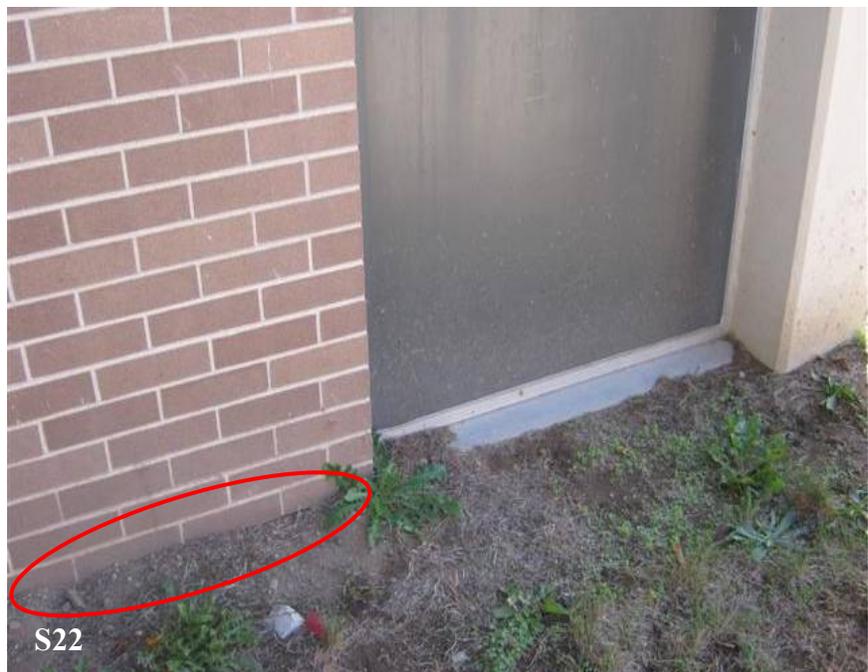
Along the south and west sides of the original school building the grade is such that the weep holes located at the base of the masonry walls was buried below the grade. This has and will continue to trap water behind the brick and allow freeze / thaw damage to occur over a period of time. At other walls there are no weep holes present on the exterior face of the brick walls

**Weep Holes below Grade**

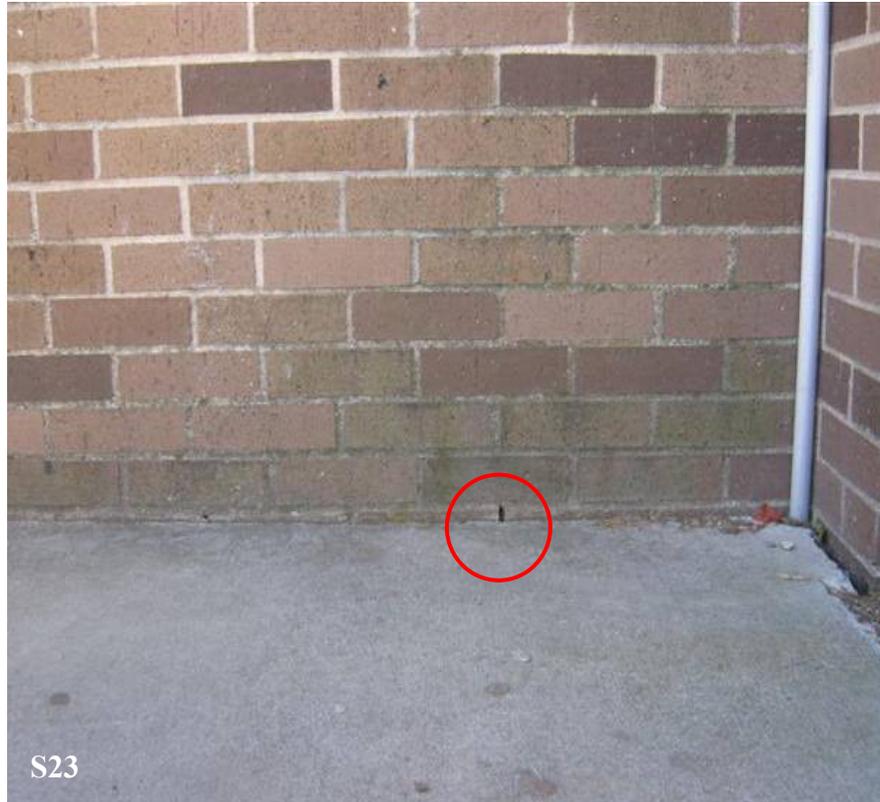
**Partially Concealed Weep Holes at Sidewalk**

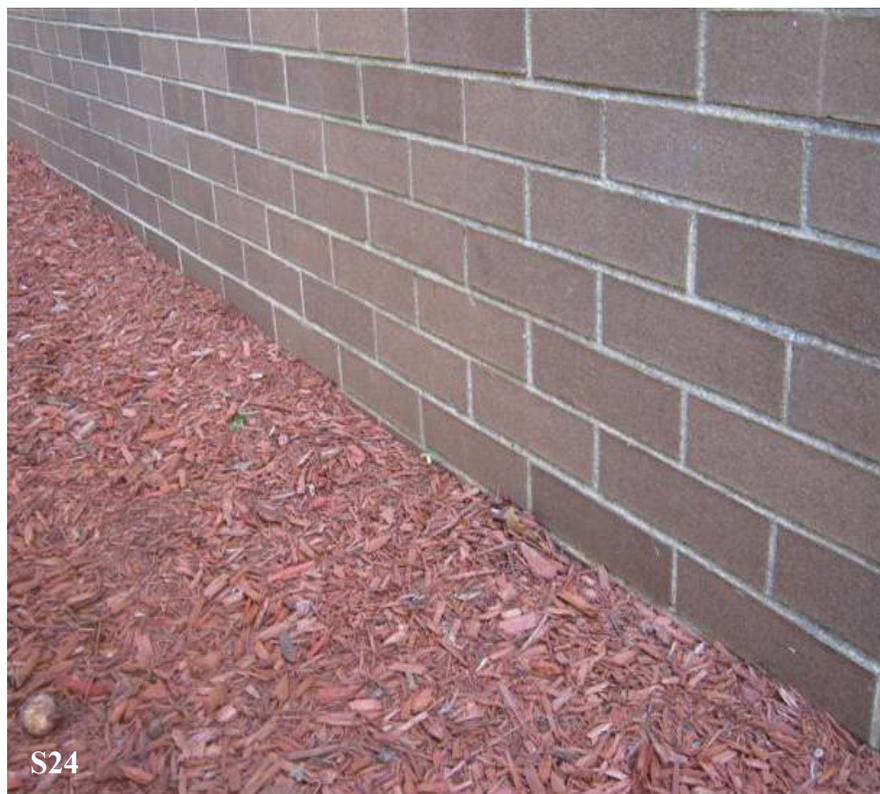
**Concealed Weep Holes below Mulch**

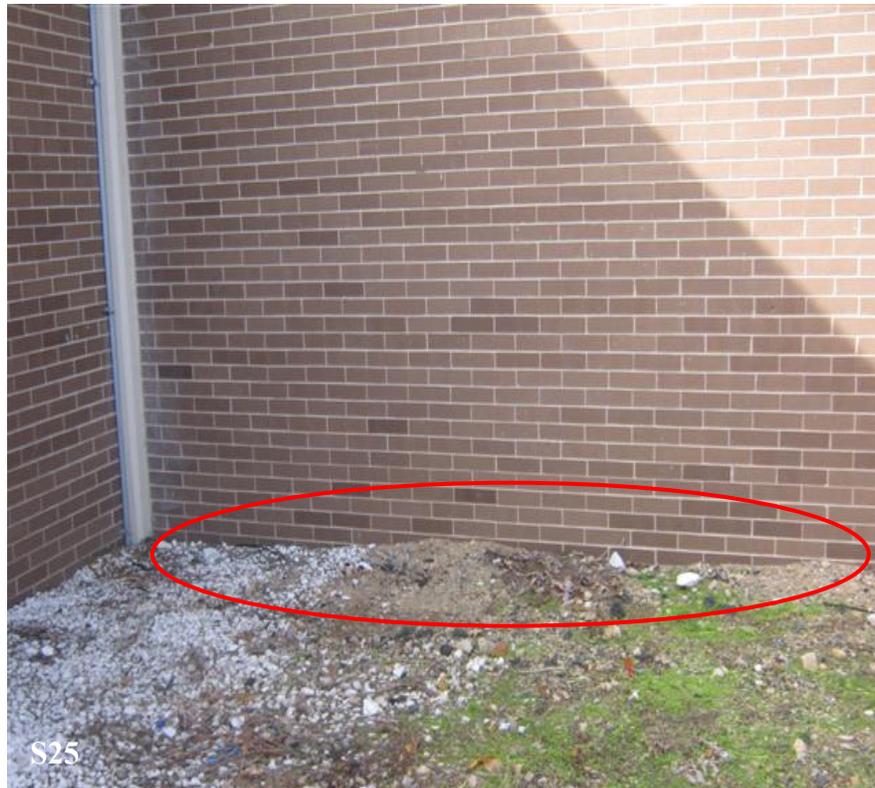
**Concealed Weep Holes below Grade**

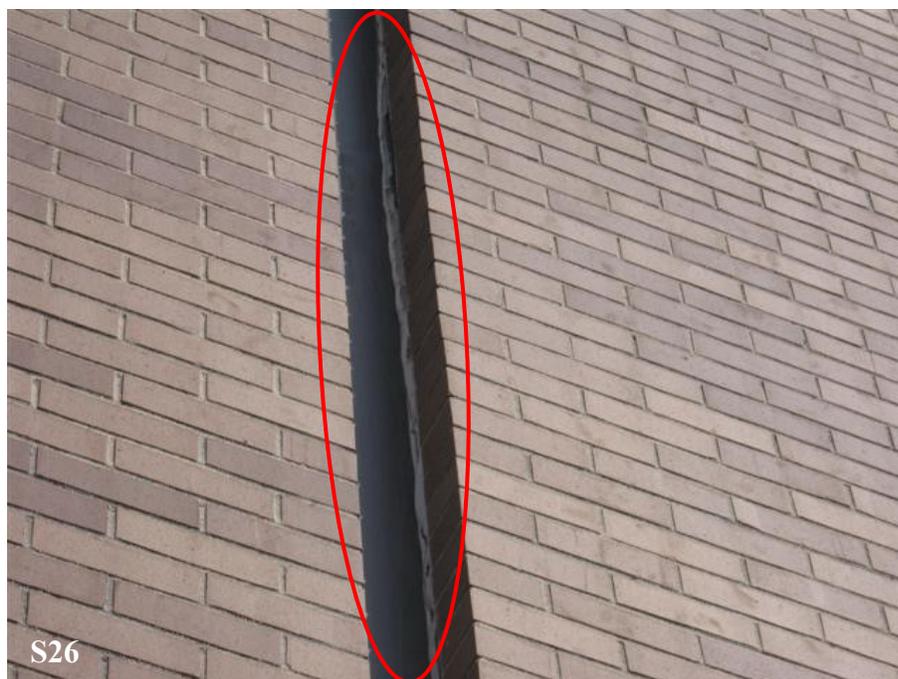
Several of the caulk joints at the brick expansion joints and column covers are failing. The failed caulking is dry and brittle and cracking open which may allow water into the cavity behind the brick or into the building.

**Brittle and Open Caulk Joint at Column Cover**

Caulk must be removed from all caulk joints and reinstalled with the proper backer rods and caulking.

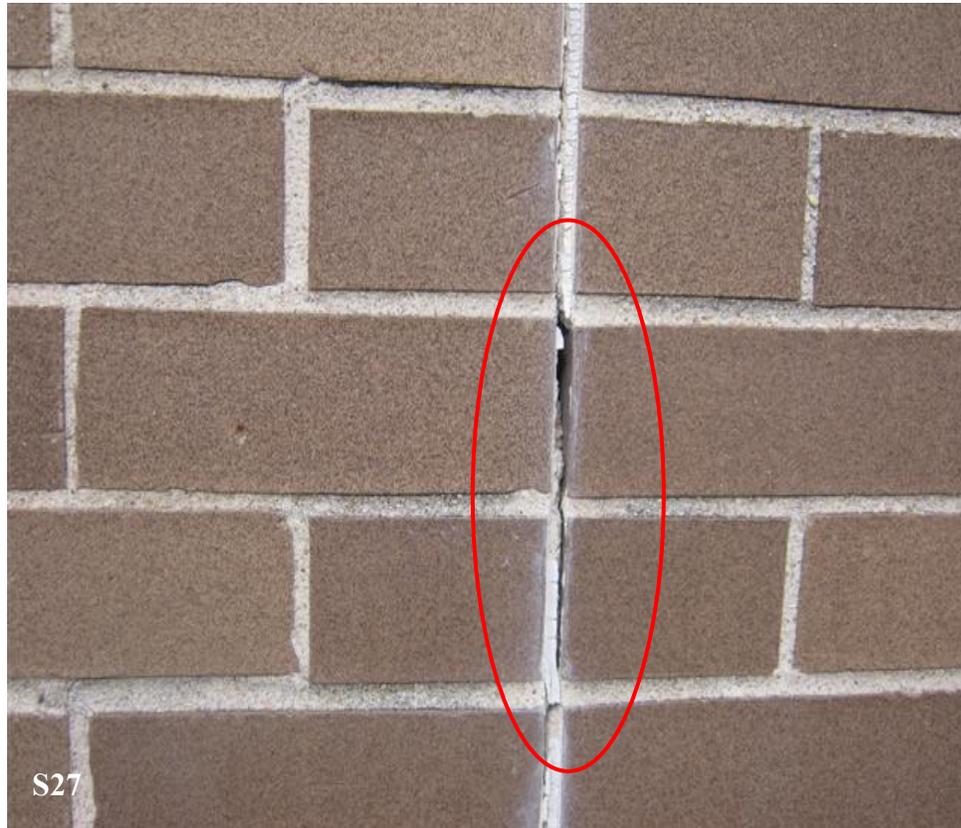
**Dried and Spalled Caulking at Vertical Joint in Brick**

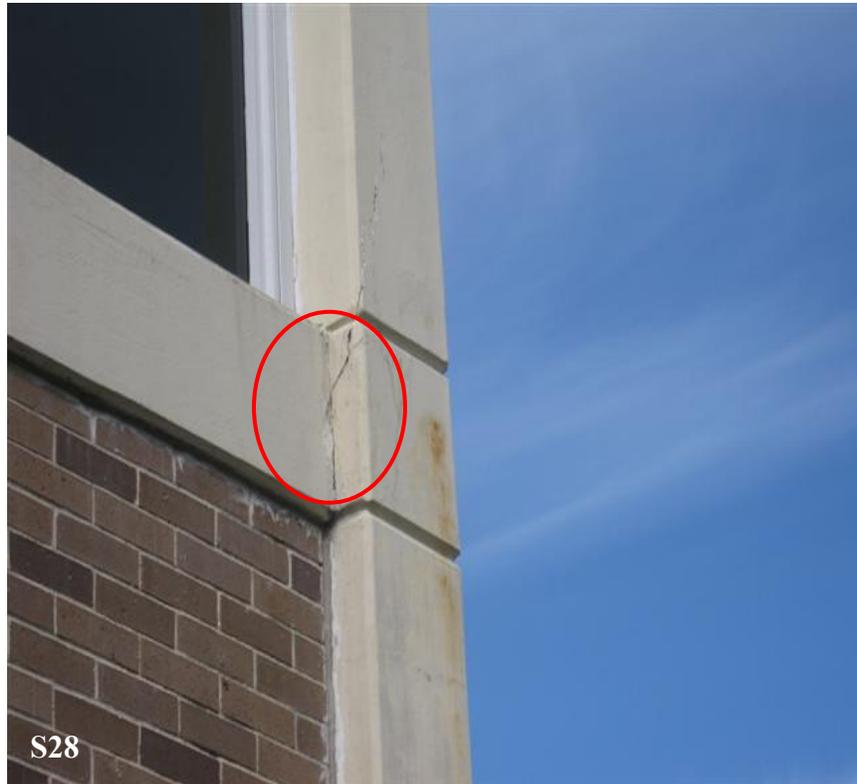
The two story classroom addition to the north side of the original building exhibited issues involving the movement and spalling of the exterior concrete spandrel beams especially on the north and east faces of the addition and the east, south and west faces in the courtyard. The damage varied from hairline cracks (typically vertical) to major spalling of the face of the concrete beams and columns. The most extensive movement is visible on the northeast corner of the building where chunks of the concrete are in various stages of spalling. The reinforcing steel in these areas is beginning to be exposed as the concrete breaks off the beams and column. Spalling is also present in the concrete spandrel beams that support the roof deck on the south face of the addition in the courtyard. Spalling is also present on the face of the roof spandrel beams on the west side of the addition.

**Spalling Concrete and Rust Stains at Concrete Column**

A further investigation of the damage occurring at the concrete columns and beams is required. The investigation would include the Owner's mason removing small areas of the loose concrete so that we can evaluate the depth of the cracks and the condition of the concrete and reinforcing steel. We would also model the structure of the building to determine the possible drift of the building. The drift is a critical issue because of the cracking in concrete and also the spalling of the mortar, caulk and masonry in the brick panels which were constructed between the concrete columns and beams. We will provide recommendations based on the analysis of the building and investigation of the concrete and reinforcing.

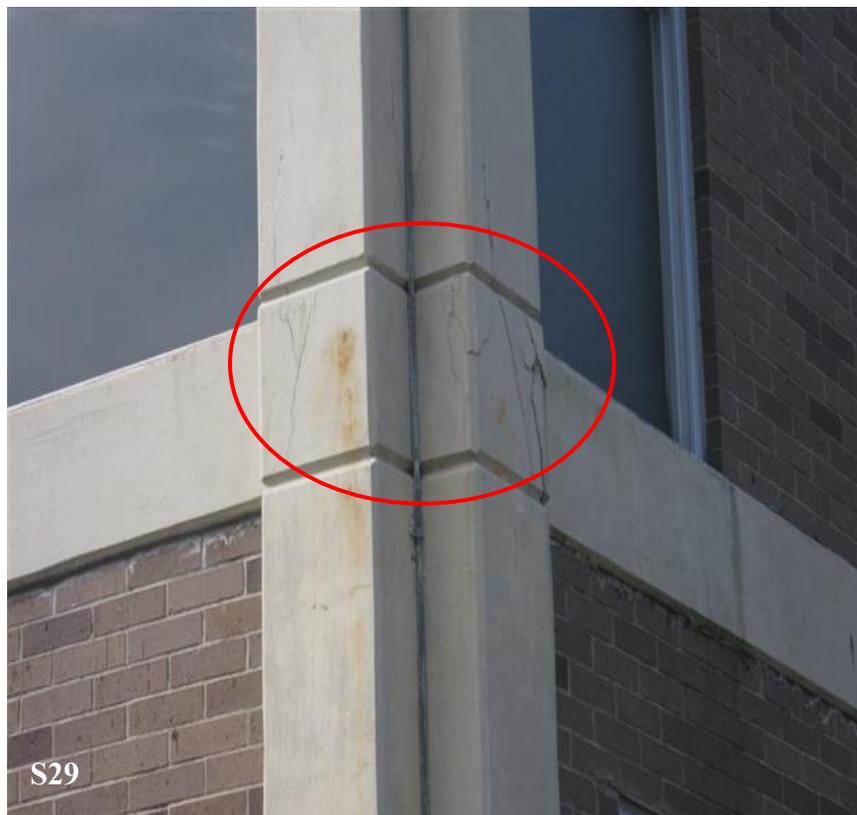
**Spalling Concrete and Rust Stains at Concrete Column looking Southwest**

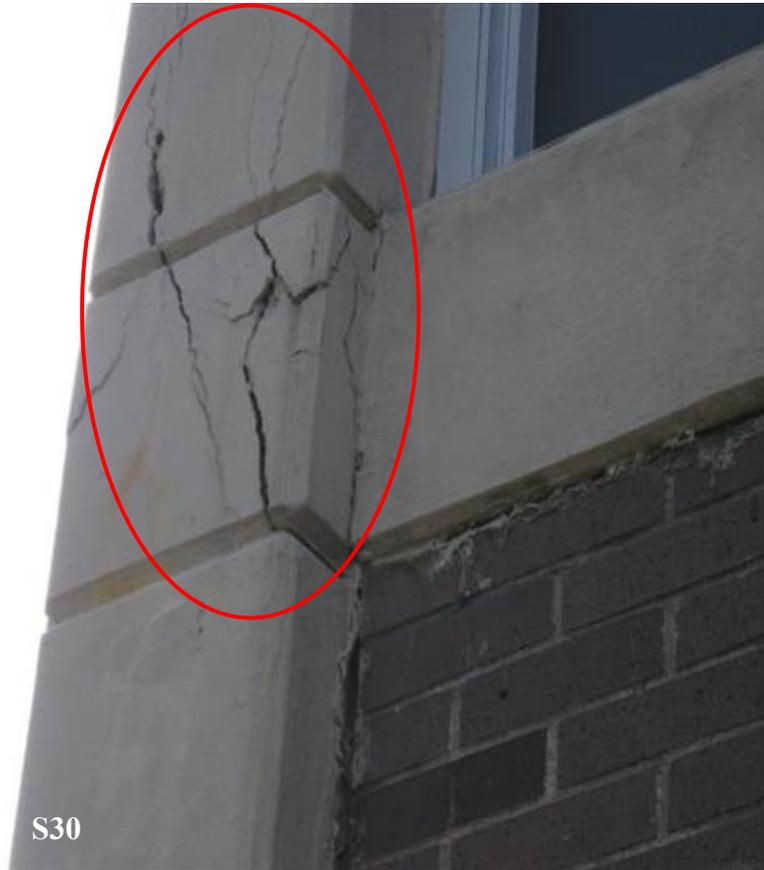
**Close up of Spalled Concrete Beam and Column**

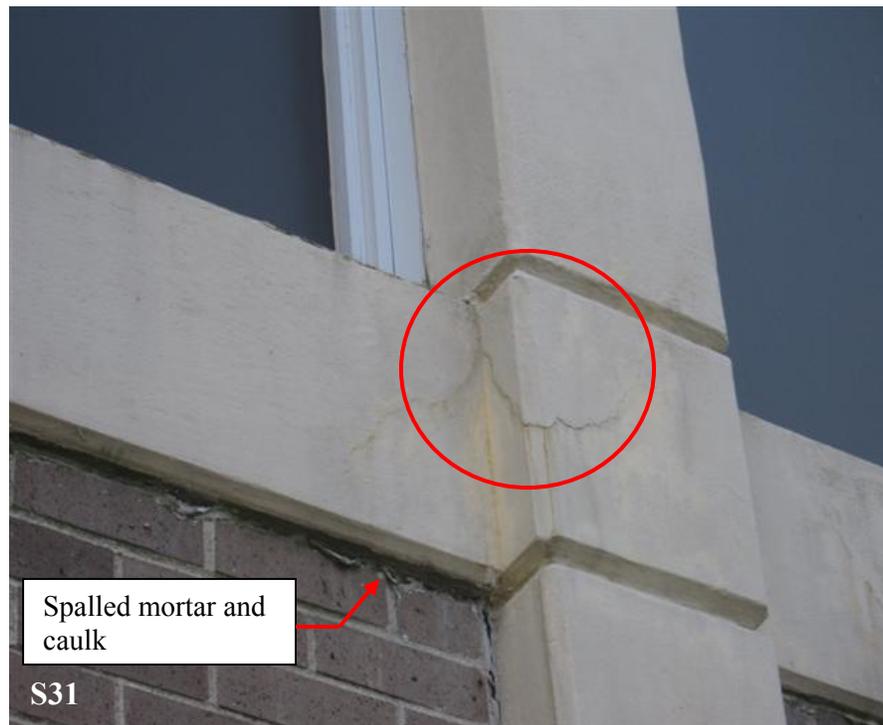
**Cracks and Spalling beginning in Concrete Column and Beam**
