**Overview:**

**Existing Conditions Assessment:**

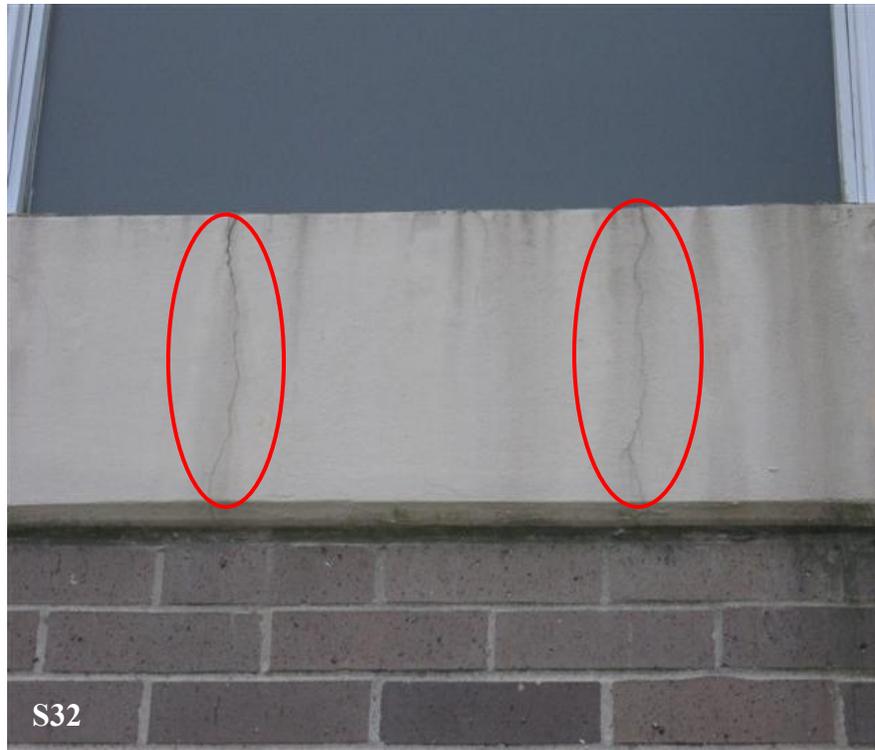
**Cracks in Concrete Spandrel Beam at Upper Level floor**

A further investigation of the damage occurring at the concrete columns and beams is required. The investigation would include the Owner's mason removing small areas of the loose concrete so that we can evaluate the depth of the cracks and the condition of the concrete and reinforcing steel. We would also model the structure of the building to determine the possible drift of the building. The drift is a critical issue because of the cracking in concrete and also the spalling of the mortar, caulk and masonry in the brick panels which were constructed between the concrete columns and beams. We will provide recommendations based on the analysis of the building and investigation of the concrete and reinforcing.

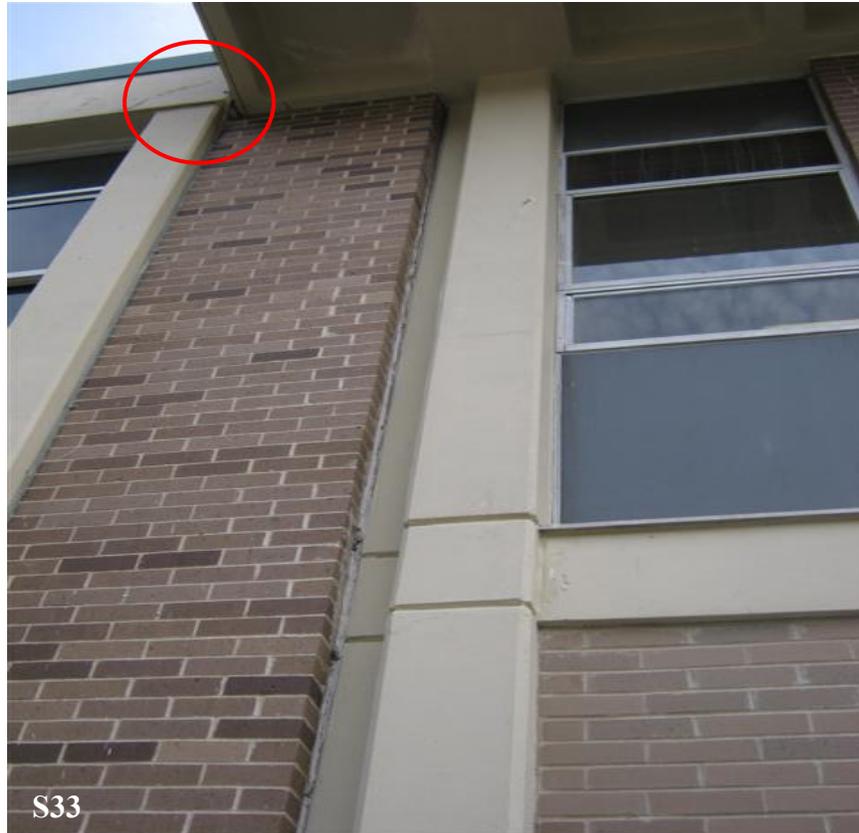
**Crack and Spalling in Face of Concrete Spandrel Beam**

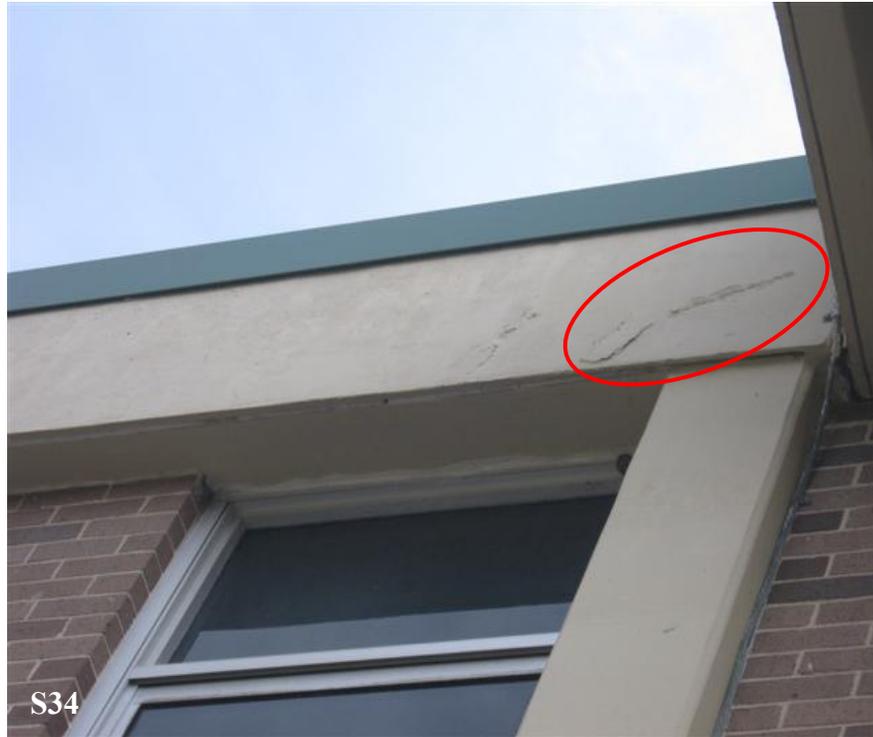
**Close up of Spalling and Cracking in Beam**

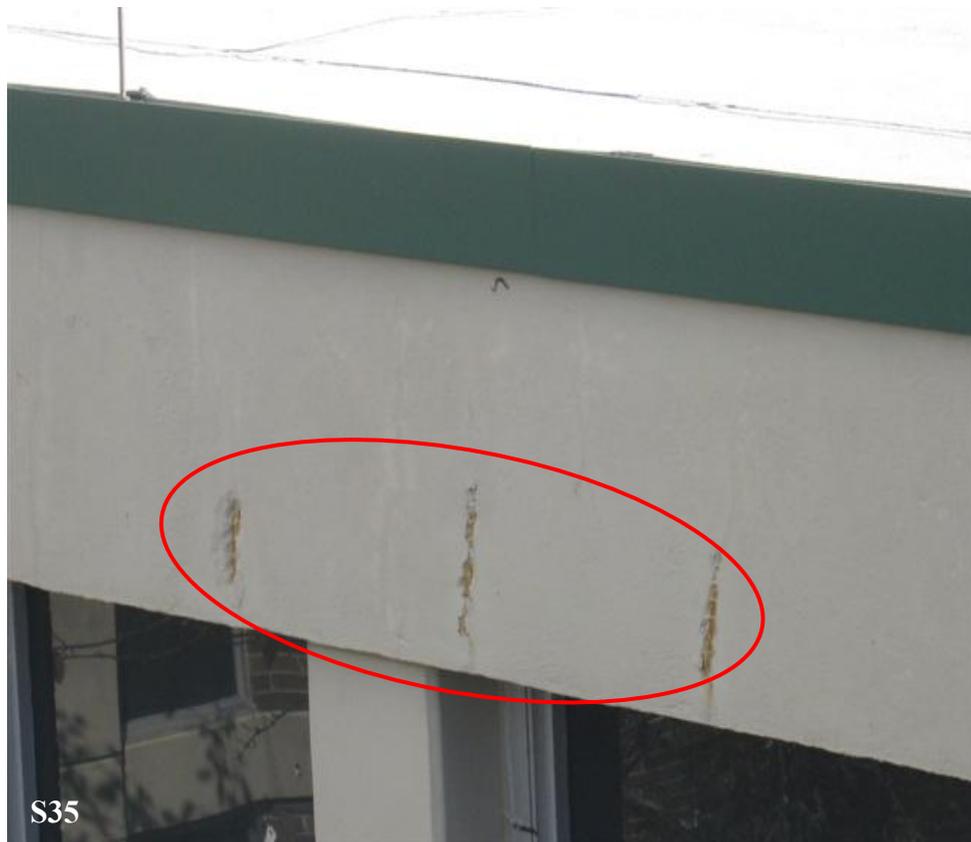
**Spalling Concrete at Beam Stirrups**

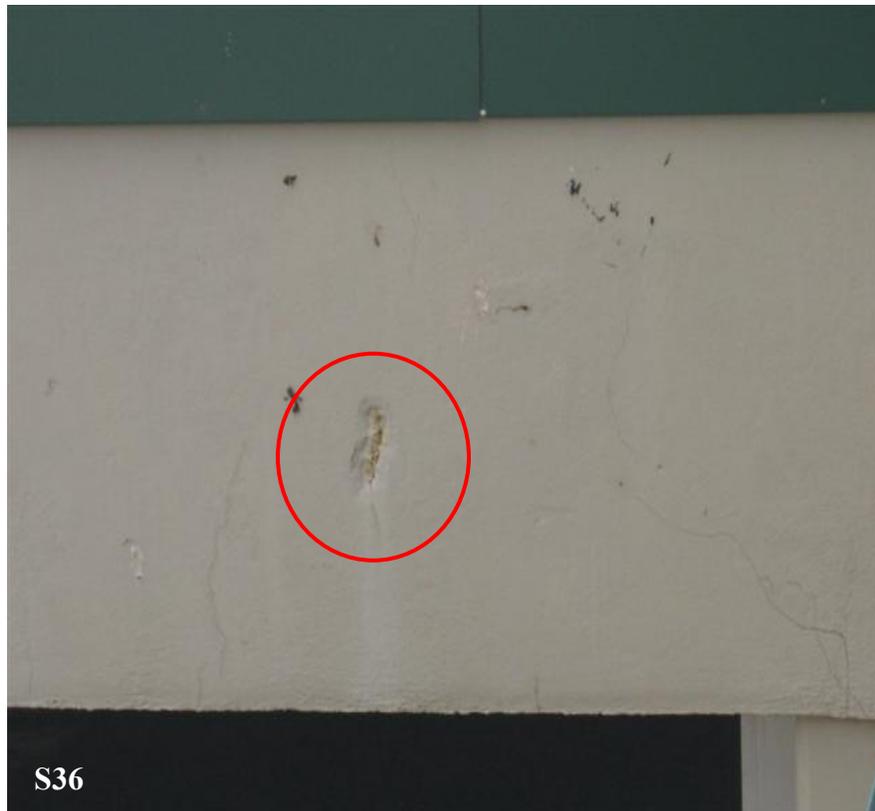
**Spalled Concrete at Reinforcing Steel**

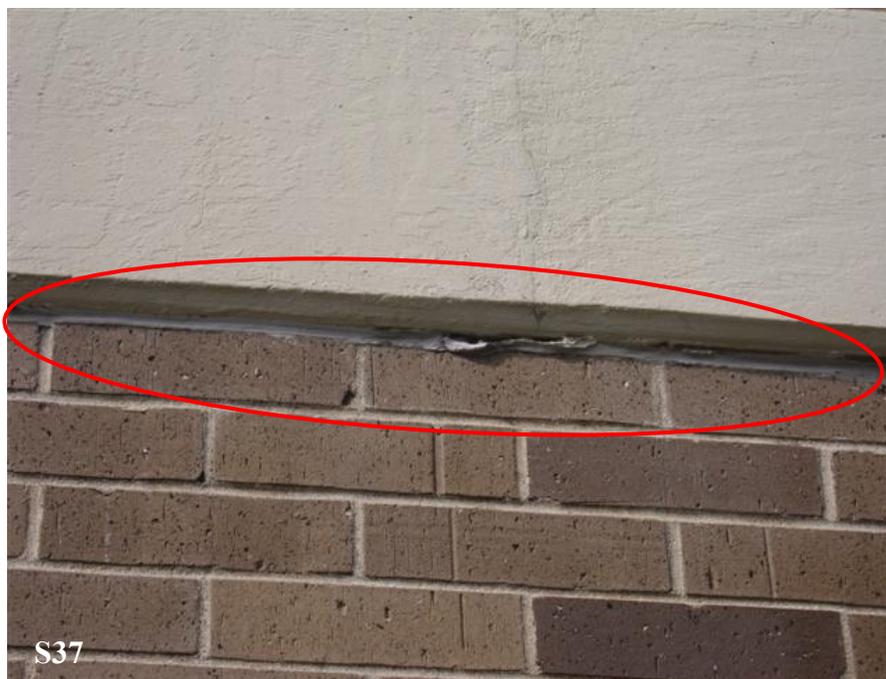
Movement is occurring in the exterior brick wall panels constructed between the concrete columns and beams as observed and documented on the north side of the addition. The movement which is occurring around the edges includes cracked and spalled mortar joints and brick and spalled caulking.

**Spalled Caulk at Joint between Brick and Spandrel Beam**

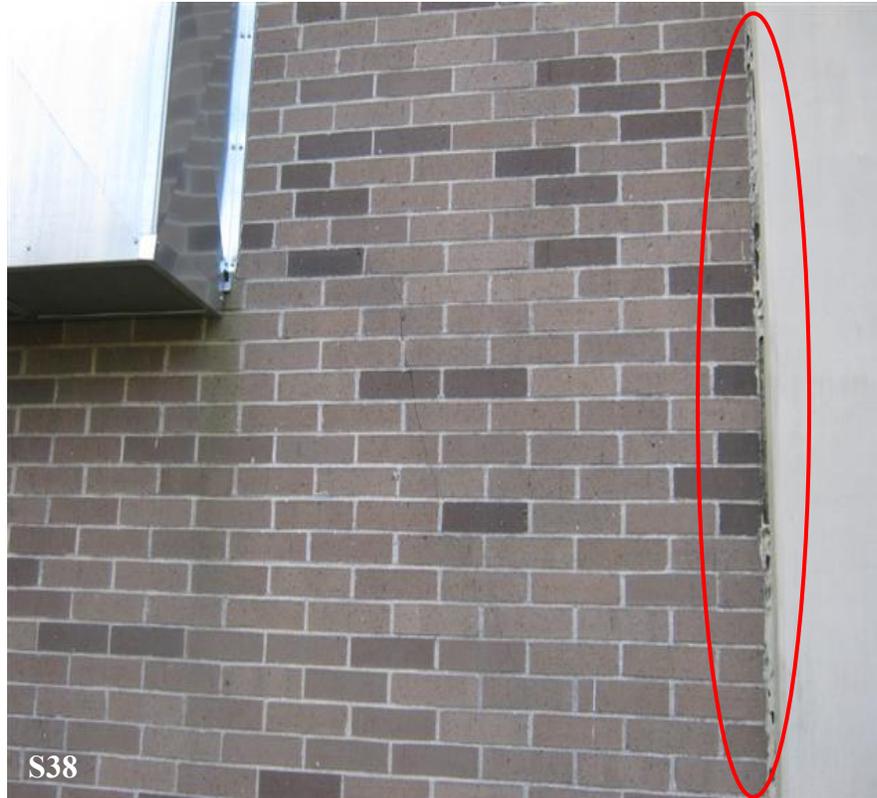
**Spalled Caulk at Brick / Column Interface**

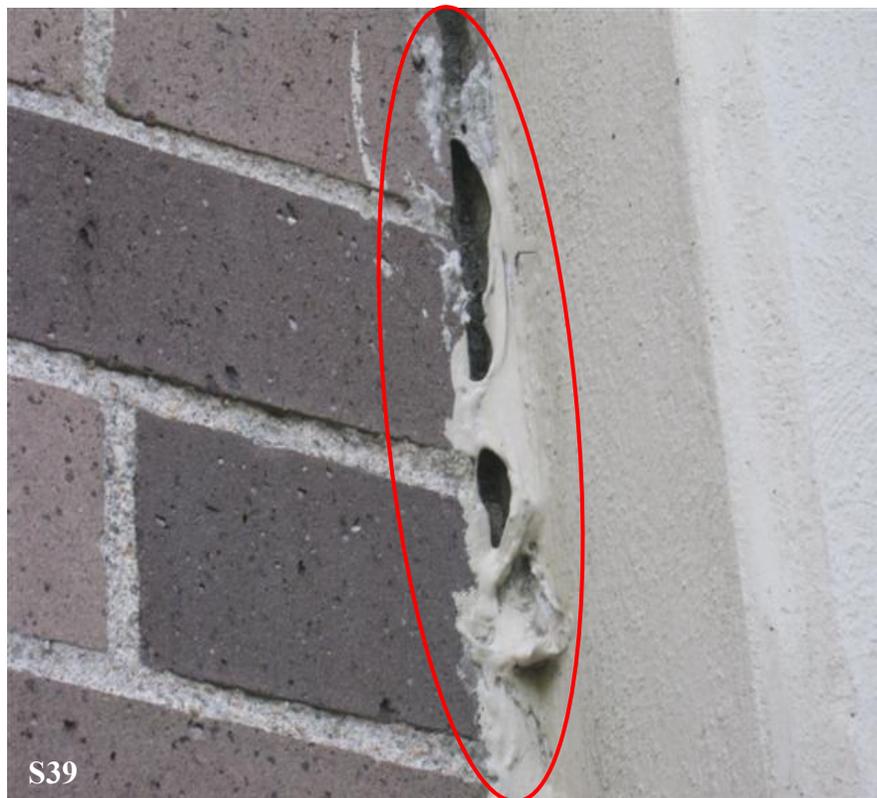
**Close up of Open Joint Allowing Water Infiltration into the Building**

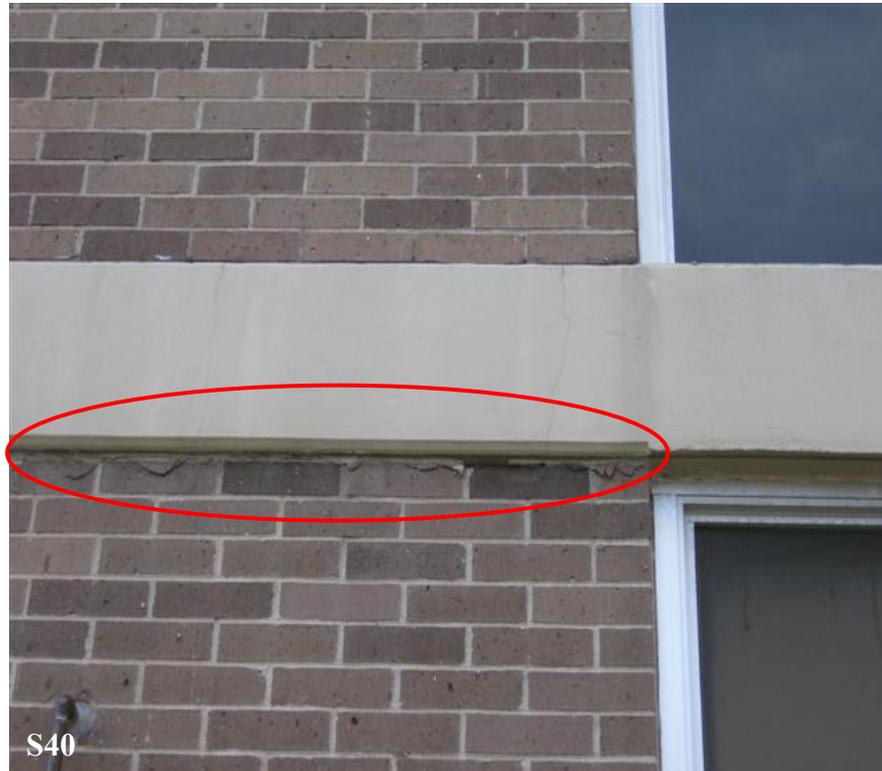
**Spalled Mortar, Brick and Caulking at Brick and Concrete Beam Interface at Underside of Upper Level Spandrel Floor Beam**

Re-pointing of the mortar joints is recommended for areas where the mortar has spalled allowing water easier infiltration in the joints.

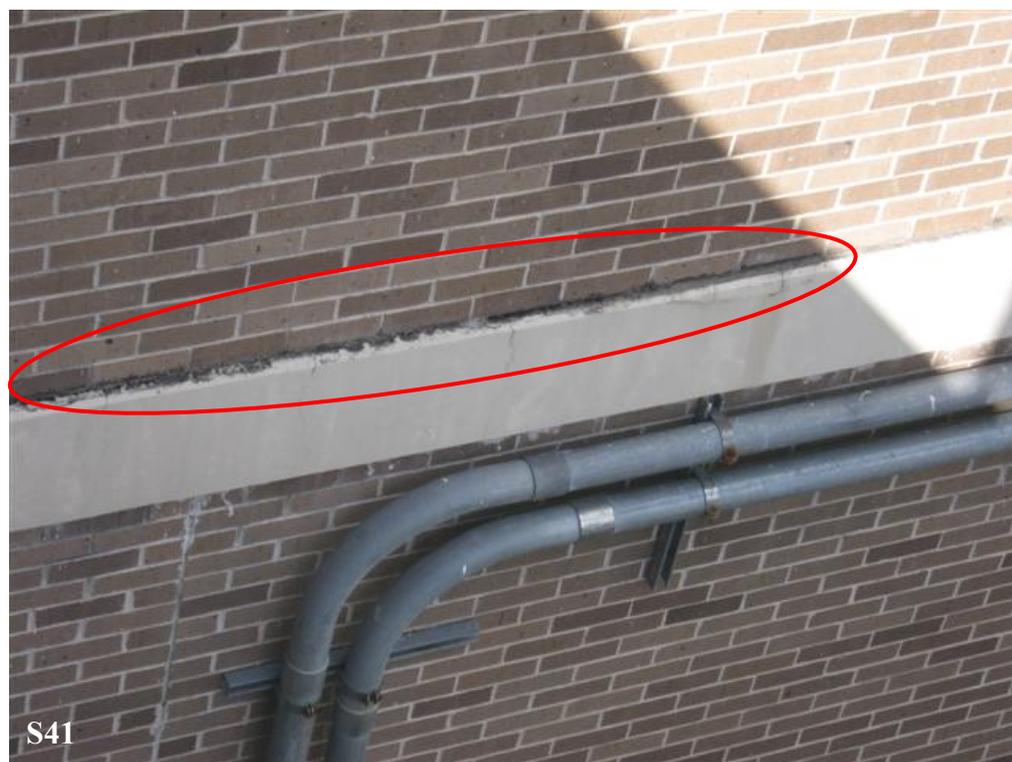
**Spalled Mortar and Caulk looking down at Upper Level Spandrel Floor Beam on South Wall of Courtyard**

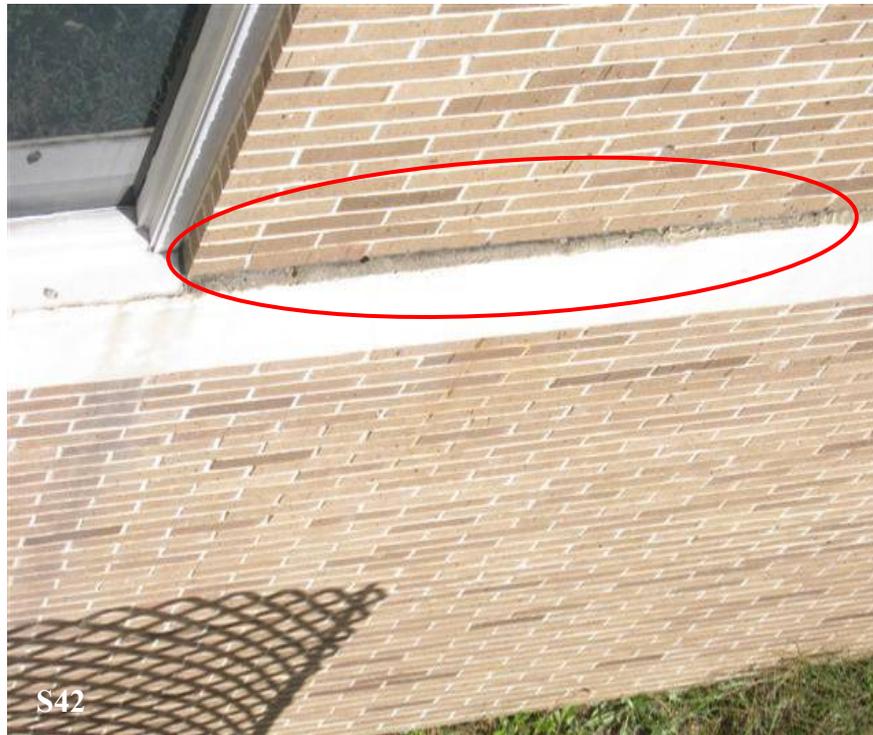
**Spalled Mortar and Caulk looking down at Upper Level Spandrel Floor Beam on South Wall of Courtyard**

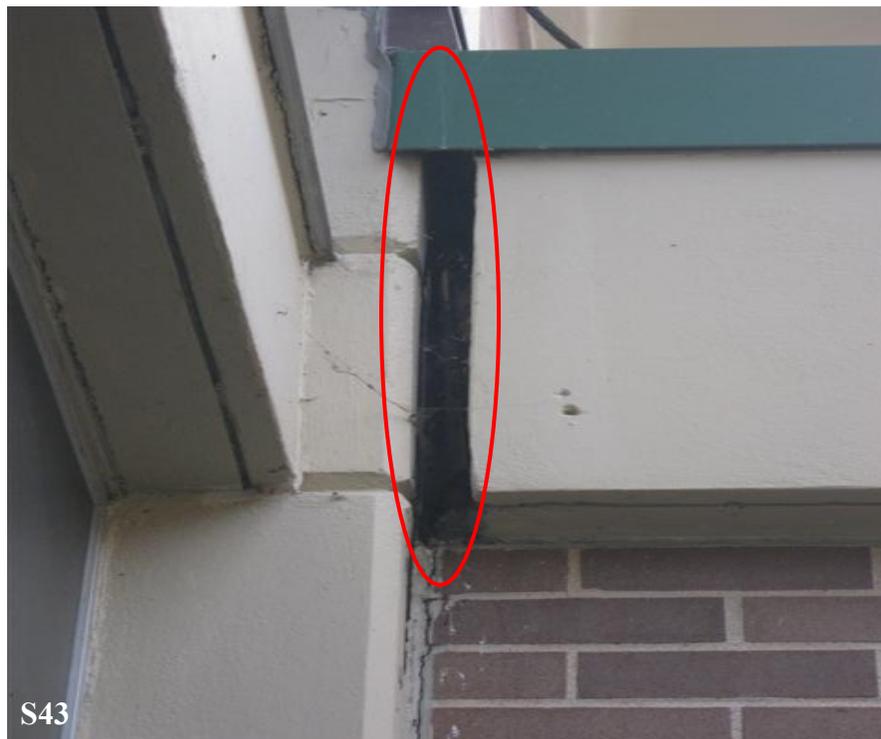
**Open Expansion Joint between Original Building and 1971 Addition**

The large expansion joints between the original building and the 1971 addition should be evaluated. One of the joints is completely open and other has caulking on the vertical surface but the horizontal return is

open. New joint covers should be installed to protect the building from the elements and also allow for differential movement between the buildings.

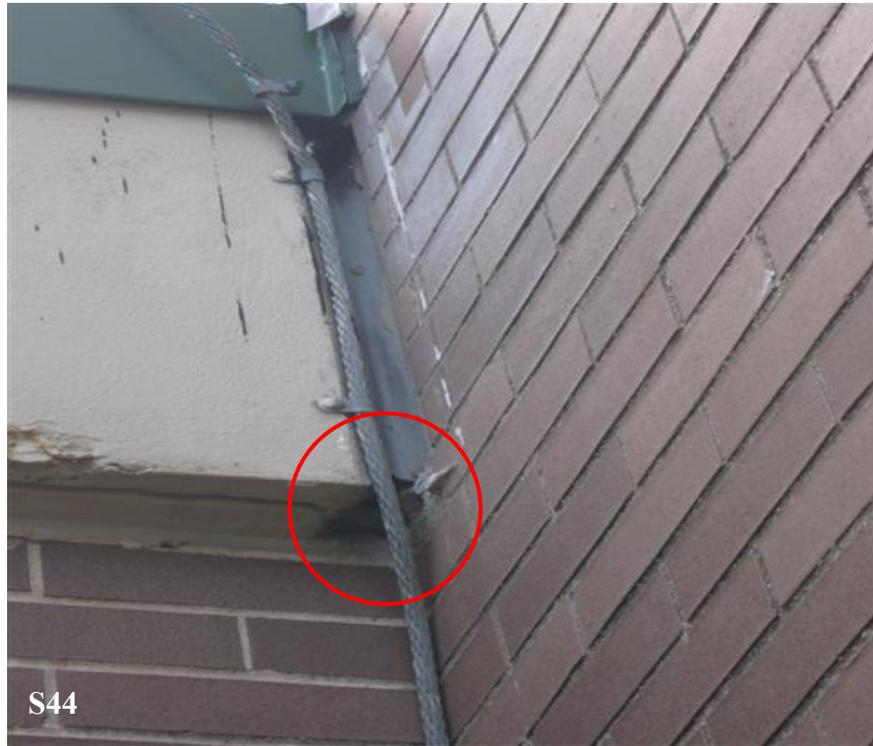
**Partially Open Expansion Joint between Original Building and 1971 Addition**

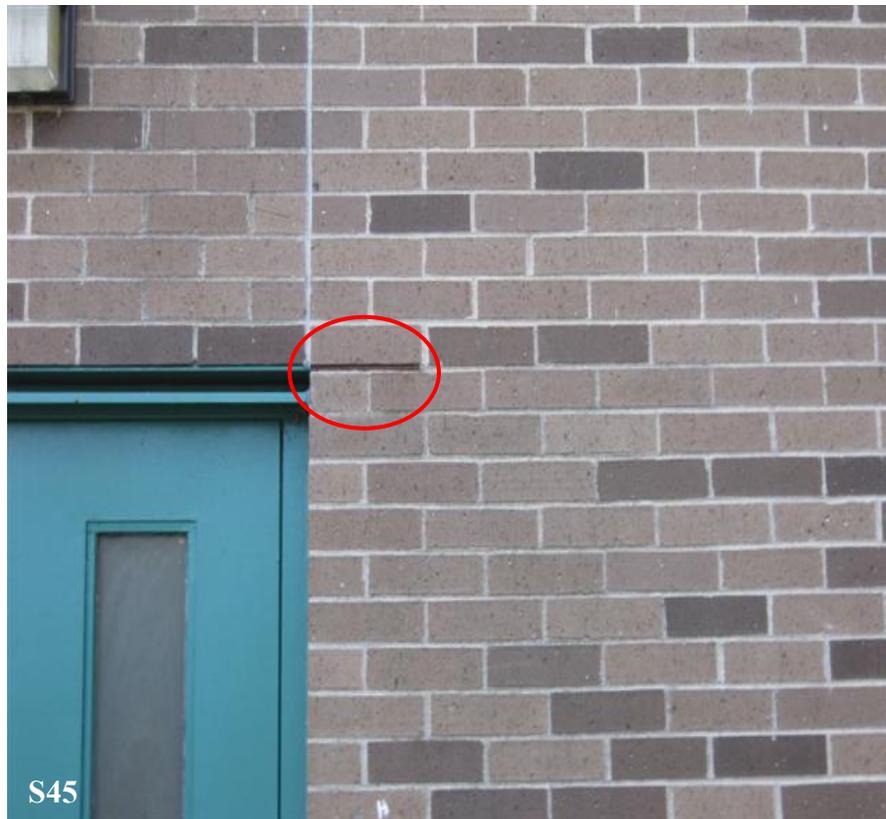
**Spalled Mortar at Door Opening Lintel**

At door, louver or window openings where the steel angle lintels are in various degrees of corrosion that is causing the mortar and brick to crack and spall, Owner's mason should remove a few bricks at these locations so that we can evaluate the extent of the corrosion occurring to the steel lintels. Recommendations for repairing the condition will be developed based on the information gathered.

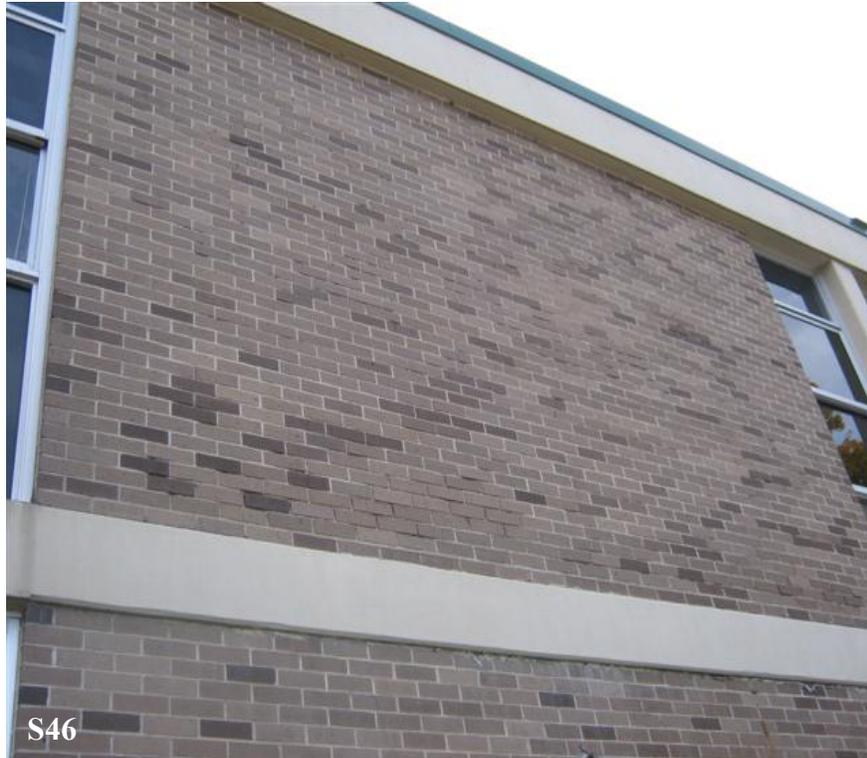
**Mortar Joints Requiring Re-pointing**

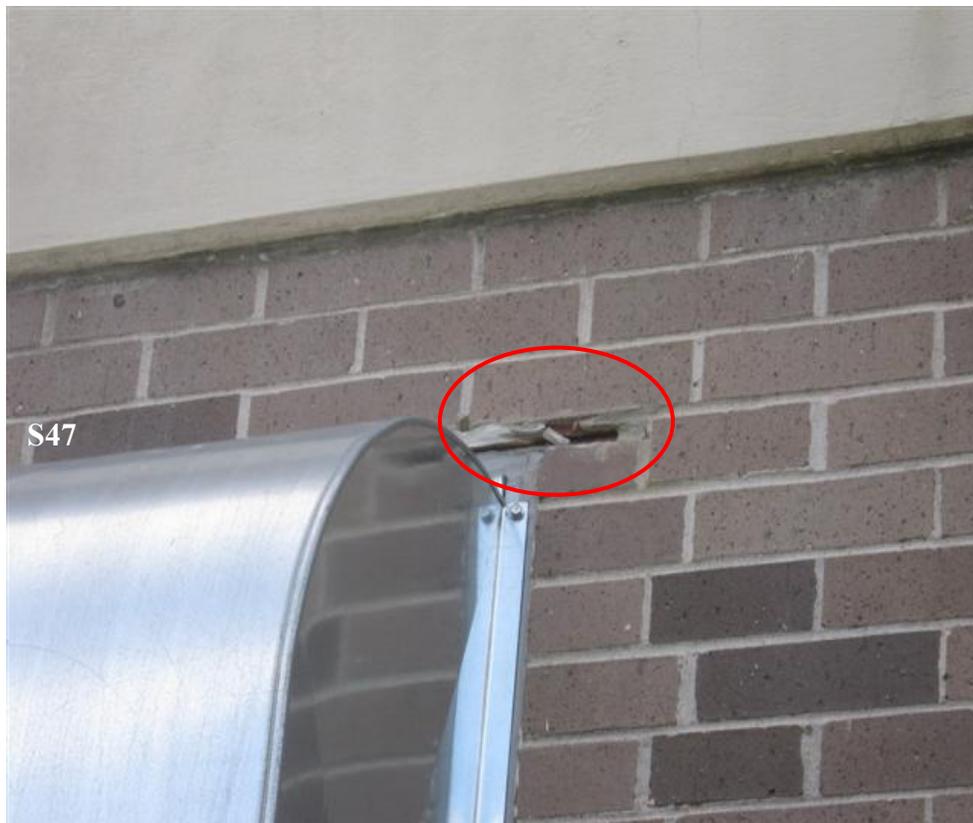
**Spalled Mortar at Exhaust Duct Penetration**

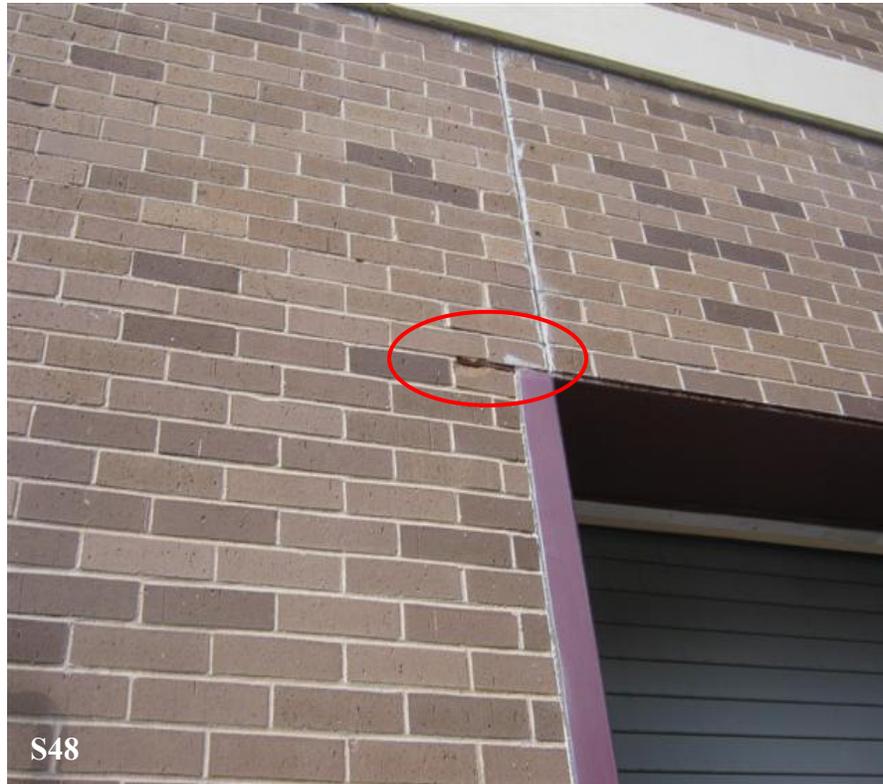
**Spalled mortar at door opening lintel**

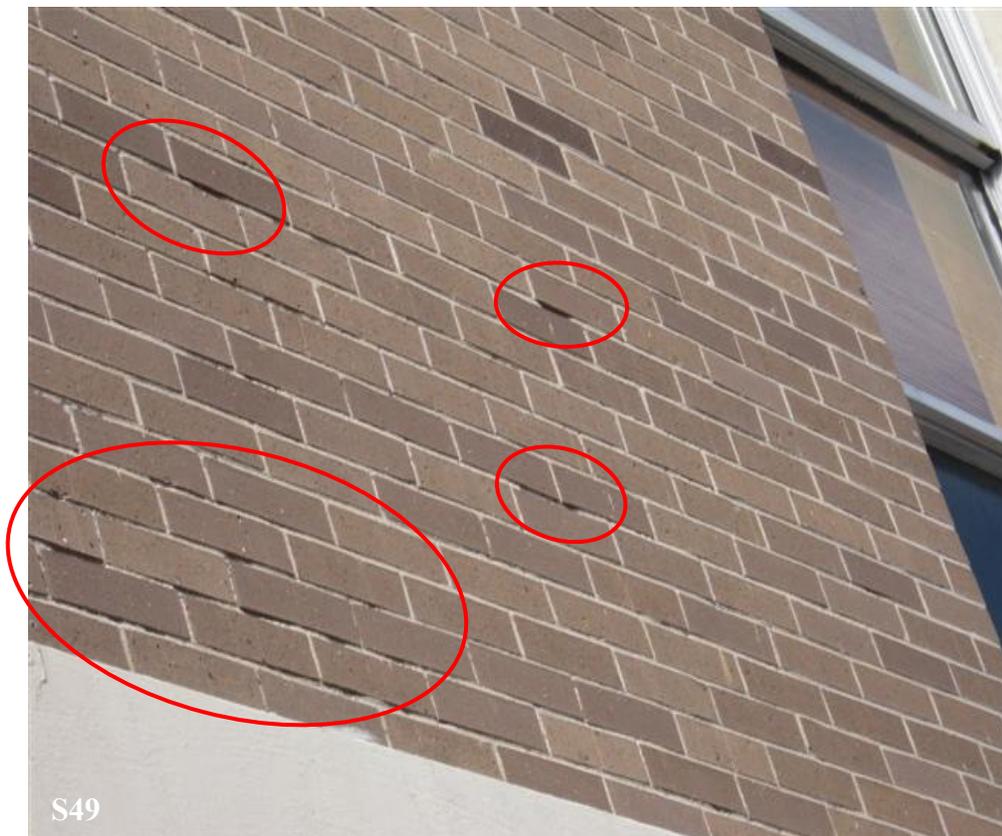
**Spalling Mortar Joints Require Re-pointing**
